Marine Aluminum Plate - ASTM Standard Specification B 928 And The Events Leading To Its Adoption.

During the winter of 2001-2 over 200 aluminum vessels, ranging from four to forty four meters in length were diagnosed as having been built with 5083-H321 temper aluminum plate that was susceptible to intergranular corrosion. This resulted both severe pitting and extensive stress corrosion cracking. Many of the vessels involved will require new hulls and superstructures. This paper traces the discovery of the problem, the forensic process, and the short term aluminum purchase specifications used during the start of the repairs. It also introduces the new ASTM B 928 Standard Specification for High Magnesium Marine Aluminum Alloy Sheet and Plate for Marine Service and discusses the ramifications for the shipbuilding industry.

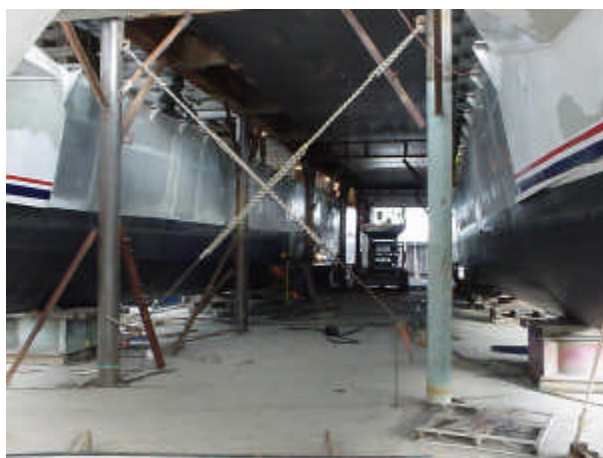
Fig. 1 M/V *JET CAT EXPRESS* under repair with the superstructure raised.

Now that the problem had been defined in our minds, the solution was relatively easy; crop the sensitized 5mm plate and insert with alloy that was not susceptible to intergranular corrosion. All of the side shell plate in the engine room, the jet room and extending into the void forward of the engine room had to be replaced. The Incat designed catamarans feature a floating deckhouse supported on rubber isolation mounts. The foredeck and a single transverse girder aft connect the two demihulls. In order to reduce the

weight on the demihulls during the repairs, the yard elected to lift the deck house and support it independently on wooden cribbing. As the superstructure isolation mounts were unbolted, small pieces of aluminum, approximately the size of a new U.S. dollar coin and between 1/16" and 1/8" thick, were noted lying on the deck of the demihulls. These had fallen out of the spray deflector; a non-structural member running the length of the superstructure immediately above the inboard isolation mounts. Inspection of the spray deflector revealed, in addition to the numerous "missing" pieces, extensive local pitting (see Fig. 4). Also noted were a number of fractures. The spray deflector presented completely different symptoms of corrosion.

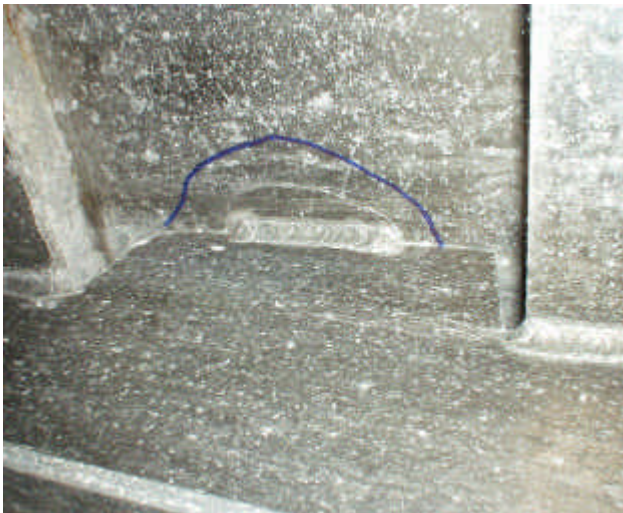
Kvichak was notified and with the assistance of an outside consultant, inspected the vessel in Honolulu December 27, 2001. Cracks were discovered in the 3/16" plate from just below the main deck to the top of the radiused chine on both outer side shells. The cracks appeared to be concentrated fore and aft from about the

Fig. 2 M/V *HULA KAI* - Stress corrosion cracking often referred to as "Smiley face cracks"

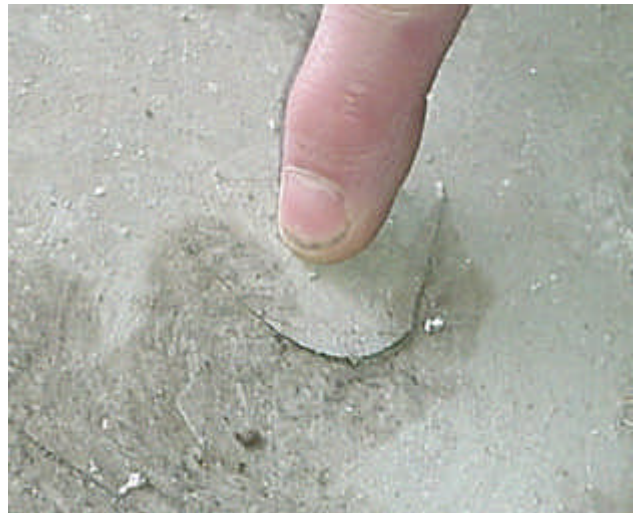
Fig. 3 M/V *JET CAT EXPRESS* - Deck plating showing a section about to pop out

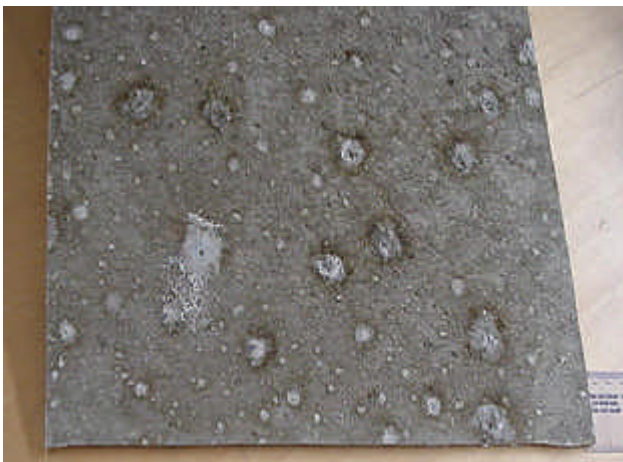
Fig. 4 M/V *JET CAT EXPRESS* - Pitting in a section of spray rail. This plate was in service for less than eight months

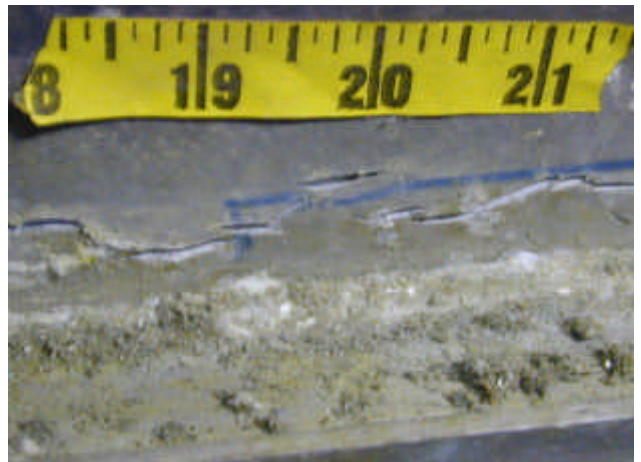
As the doublers were removed, the crack locations were mapped. In addition to the cracks illustrated in Fig. 5, vertical cracks were found in the plating immediately below the deck edge. These did not originate near the heat affected zone of the welds but instead ran vertically from approximately one inch below the deck edge. These cracks were around four inches long and ran parallel to each other spaced between two and four inches apart. Further cracking was found in the inboard plating of the water jet room. The crack maps however were starting to illustrate a trend. The cracks mapped to date were all in 5mm plating. Additionally, Mel Helley (Nichols Bros. welding foreman) noticed that there was a subtle difference in the surface color of the 5mm plate when compared to the surrounding 4mm and 8mm plates. Cracks were mapped both from the interior and exterior of the hull.

Fig. 5 M/V *JET CAT EXPRESS* - Shell plating illustrating both stress corrosion cracking and pitting

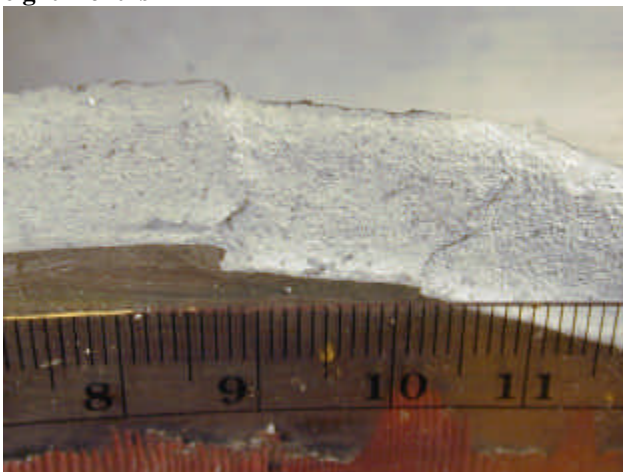
Fig. 6 M/V *JET CAT EXPRESS* - Note multiple fatigue fracture initiation sites

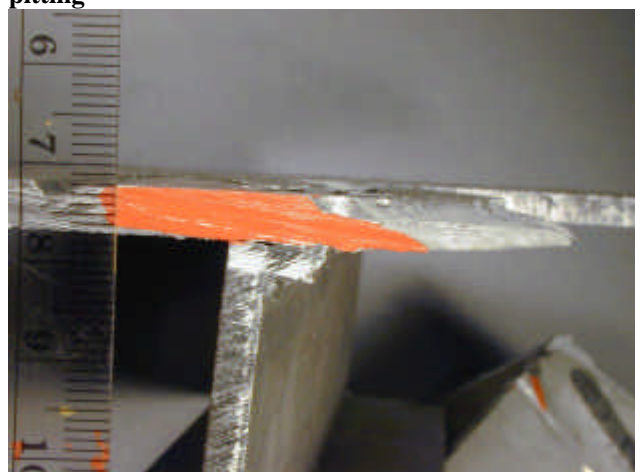
Another trend was noted. The interior and exterior crack maps did not always compare. Sections taken through the plating in way of the cracks showed that the cracks often did not penetrate the plate but ran parallel to the surface and, in some cases, even started to return to the originating surface (see Fig. 7).

Fig. 7 M/V *JET CAT EXPRESS* - Fracture in Fig. 6 viewed from the side

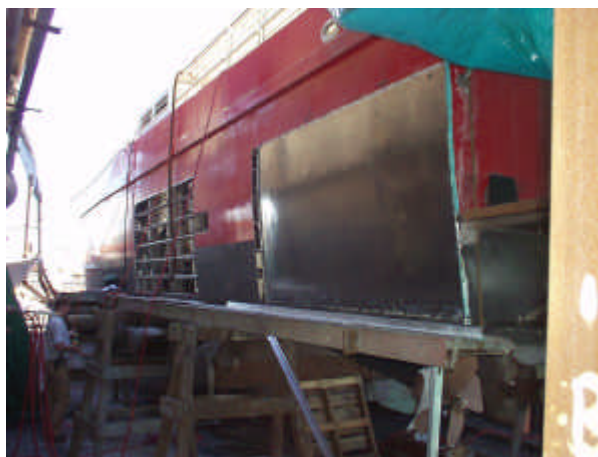
Fig. 8 M/V *HULA KAI* under repair

Meanwhile back in Hawaii, repairs continued apace to the M/V *HULA KAI*. The side shell repairs were done in approximately ten foot sections to maintain the shape of the vessel. As plate was removed, sections were sent to Seattle for testing. The aluminum fitting and welding was completed January 26, 2002, and the painters started work that evening. On the way back to the hotel that night, the repair crew

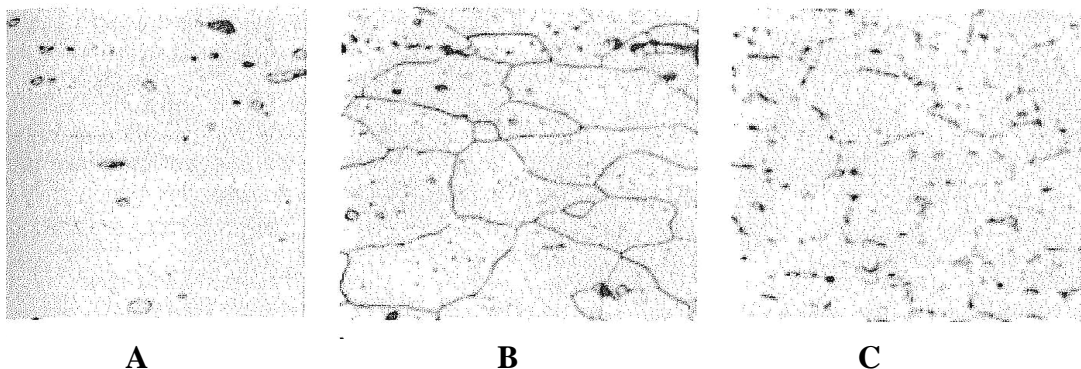
For example, samples of these alloys that are quenched in water from 400°C will show no signs of Beta phase (Photomicrograph Fig. 9A), while this same material when quenched from 400°C and aged 4 days at 100°C will show solid lines of Beta defining the grain boundaries (Photomicrograph Fig.9B). These solid lines of Beta at the grain boundaries are sensitive to intergranular corrosion.

Figure 9, Photomicrographs of 5083-type Al-Mg sheet. *Magnification 130x ratio*

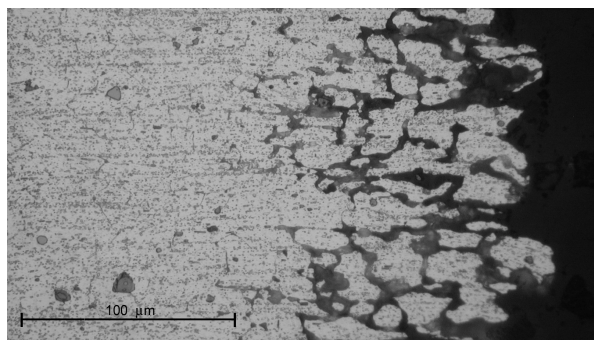
The Photomicrograph in Figure 10 shows an example of intergranular attack. Note how the grain boundaries have been corroded away.

Figure 10, Example of G 67 Corroded Test Coupon Microstructures with Susceptibility to Intergranular Corrosion. *Photograph is an example of an intergranular attack. Taken after testing to ASTM G 67 and etching with modified Keller's reagent (HF, HCL, HNO₃ and H₂O).*
