Composites Science and Technology 59 (1999) 179–200

Mechanical performance of carbon-fibre- and glass-fibre-reinforced epoxy I-beams: III. Fatigue performance

M.D. Gilchrist^{a,*}, A.J. Kinloch^b, F.L. Matthews^c

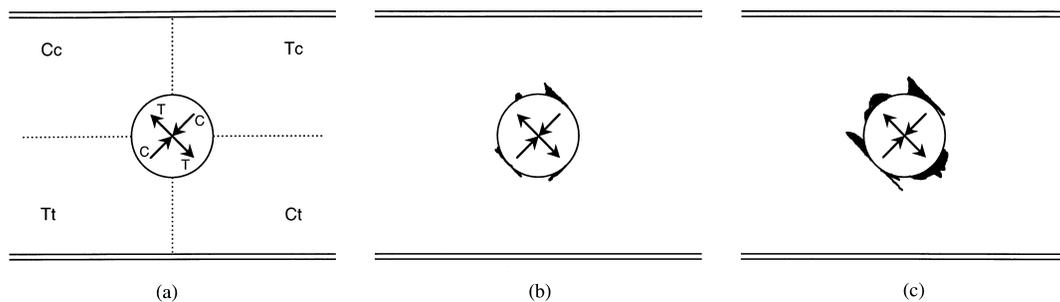
Fig. 3. Schematic of ultrasonic C-scans to identify the development of fatigue damage around the small circular notch (46 mm diameter) in the web of beam Carbon N1 (a) prior to testing, (b) after 0.54×10^6 cycles and (c) after 5.09×10^6 cycles. [The directions of resolved tensile (T) and compressive (C) stresses that act in the four different quadrants around the web notch are identified in (a), and are identical in (b) and (c).] The compressive flange is at the top and the tensile flange is at the bottom of the diagram.

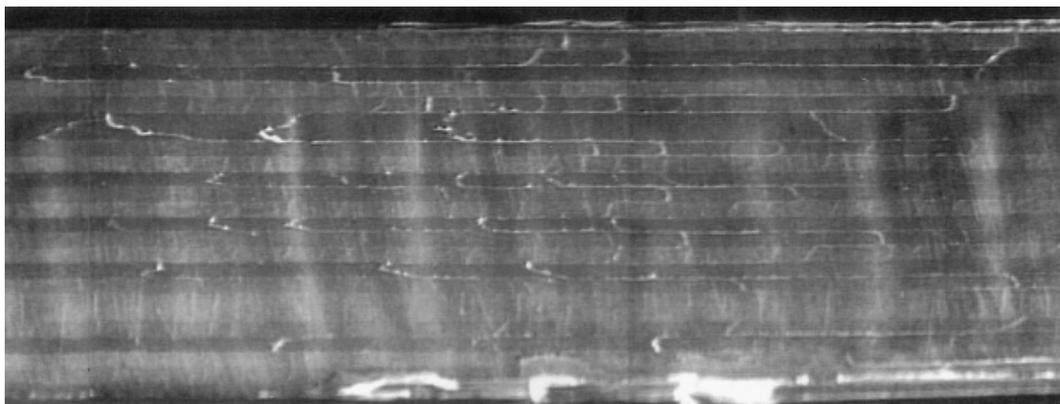
replication method. The density of damage was different in each ply and this is discussed in greater detail in the following section. The damage, however, was clearly evident after 1×10^6 cycles and much of this damage was apparent after 0.54×10^6 cycles. After 5.09×10^6 cycles this damage did not appear to be more extensive around the circumference of the hole. Neither did there appear to be a significantly greater density of matrix cracking or delamination at the end of the test than earlier in the test. This evidence would suggest that the fatigue damage occurred rapidly during the early stages of the test and any subsequent development of this damage was at a much slower rate of propagation. These edge replicates did not provide any indication of the damage away from the edge of the notch, whereas the ultrasonic scans identified broad regions of damage away from the edge of the circular notch. The resolution of the C-scans, however, was inadequate to detect any possible matrix cracks that might have been present more than 5 mm away from the edge of the notch. Neither was it possible to resolve between delamination and a high density of matrix cracking using the ultrasonic methods, since the location of the damage was too close to the edge of the notch.

Fig. 4. Edge replication which identifies through-thickness matrix cracking and delamination around the circumference of the circular notch in quadrant Tt of beam Carbon N1 after 2×10^6 cycles. The thickness of this section is 3 mm (= 24 plies).

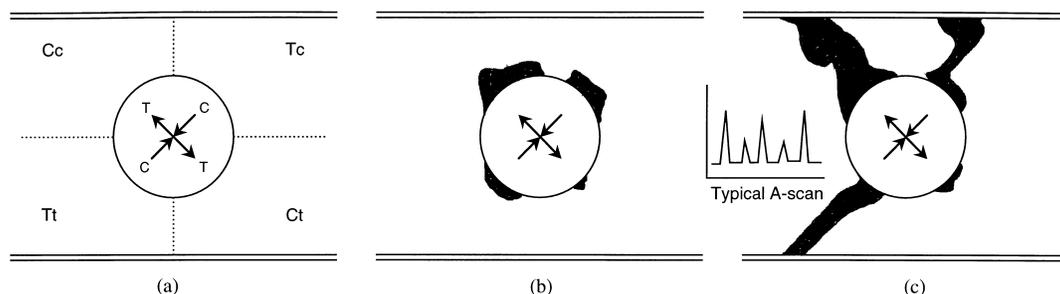
Fig. 5. Extent of damage around the large web notch (60 mm diameter) of beam Carbon N5 as detected using ultrasonic C-scan after (a) 0.74×10^6 cycles, (b) 4.68×10^6 cycles and (c) 4.78×10^6 cycles, i.e. failure. The orientation of each scan is identical. A typical A-scan from quadrant Cc is shown in (c); delaminations are present in this instance at two locations in addition to the midplane, as can be inferred from the oscilloscope image of the front, back surface and intermediate reflections.

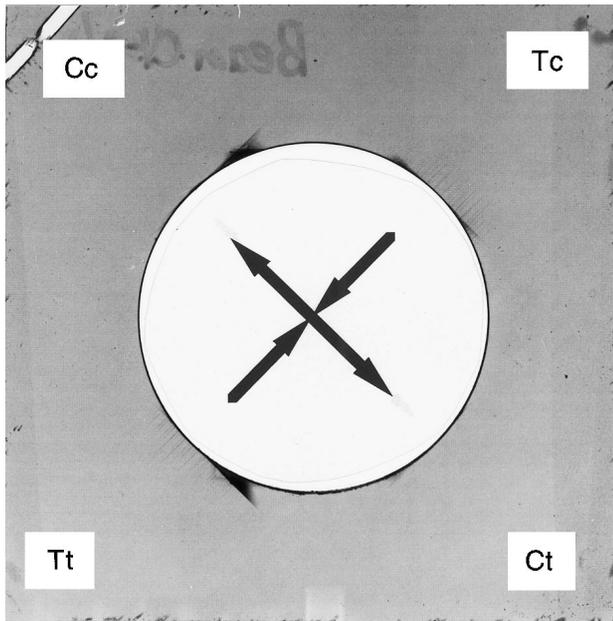
Examination of the X-radiographs was particularly informative, especially when considered in conjunction with the results from the ultrasonic scanning methods. X-radiographs, taken at the end of the test, around the large web notches in beams Carbon N2 (0.5×10^6 cycles), Carbon N4 (4.5×10^6 cycles) and Carbon N5 (4.78×10^6 cycles) and the small web notch in beam Carbon N5 are detailed in Fig. 6. (Note that in Fig. 6(b), (c) and (d), the strain gauges which were bonded onto the I-beams may be seen.) X-rays were taken (≈ 20 kV for 5 mins at 3 mA) using both dibromomethane and zinc iodide as the dye penetrants. Whilst the former penetrant did not leave a saline residue on the fracture surface, it did not identify as much damage as the zinc iodide. A saline residue can mask the fractographic features from view during subsequent SEM investigations and, consequently, dibromomethane was used during most of this project. Fig. 6(c) shows the fracture around the large web notch after failure of beam Carbon N5 and reveals almost too much damage to be particularly informative since it is not immediately clear which damage mechanisms are the more critical. The compressive damage is particularly extensive and appears in the form of major delaminations with some matrix cracking being visible, although this is completely within the boundary of the delamination area. Similarly, the tensile damage appears to extend as a clean fracture from areas round the edge of the notch which contain matrix cracks. However, the radiographs of the small notch Fig. 6(d), and the large notches in the beams which did not fail [Fig. 6(a) and (b)] are more informative. These identify a dense concentration of matrix cracks in the 0 , $+45$ and -45° plies, very close to the

Fig. 6. (a) X-ray radiograph of fatigue damage around 60 mm diameter notch in beam Carbon N2 (0.5×10^6 cycles). Tensile matrix cracks are evident in quadrants Tc and Tt (top right and bottom left, respectively) spanning a width of some 20 mm for a distance of up to 6 mm away from the edge of the notch. The compression flange is along the top of the photograph and the tension flange along the bottom. The local directions of resolved tensile and compressive stresses are indicated.

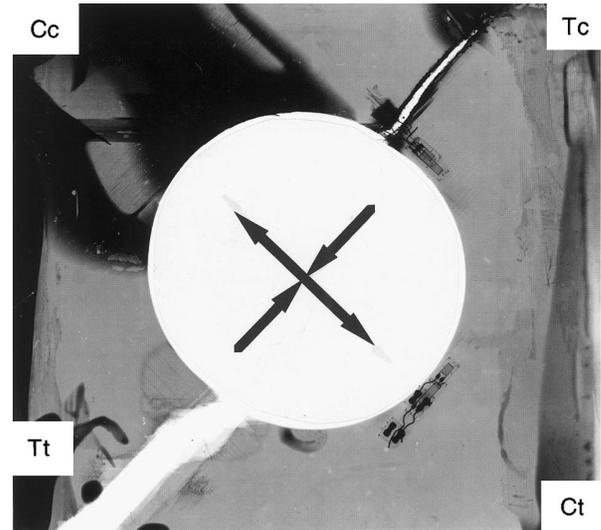
Fig. 6. (c) X-ray radiograph of fatigue damage around 60 mm diameter notch in beam Carbon N5 (4.78×10^6 cycles). The web section has completely fractured due to the local tensile stresses in quadrants Tt and Tc (fracture spans bottom left and top right quadrants). The damage in quadrant Tt (bottom left) has more clearly propagated to the tension flange than in quadrant Tc, where some few plies have not completely fractured close to the compression flange. There is extensive delamination in quadrant Cc (top left) but none in quadrant Ct. The width of this delamination is approximately equal to the diameter of the notch and it extends directly to the compression flange. The compression flange is along the top of the photograph and the tension flange along the bottom. The local directions of resolved tensile and compressive stresses are indicated.

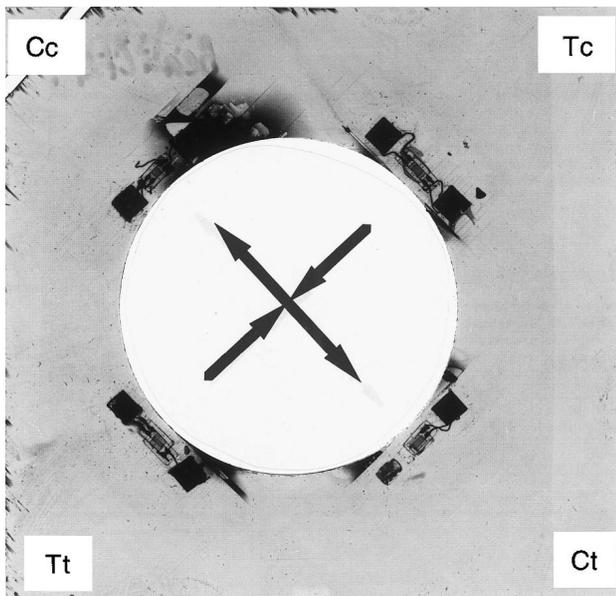
Fig. 6. (b) X-ray radiograph of fatigue damage around 60 mm diameter notch in beam Carbon N4 (4.5×10^6 cycles). Tensile matrix cracks are evident in quadrants Tc and Tt (top right and bottom left, respectively) spanning a width of some 27 mm for a distance of approximately 8 mm away from the edge of the notch. Delamination is greater in quadrant Cc ($\approx 30 \times 10 \text{ mm}^2$) than in quadrant Ct. The compression flange is along the top of the photograph and the tension flange along the bottom. The local directions of resolved tensile and compressive stresses are indicated.

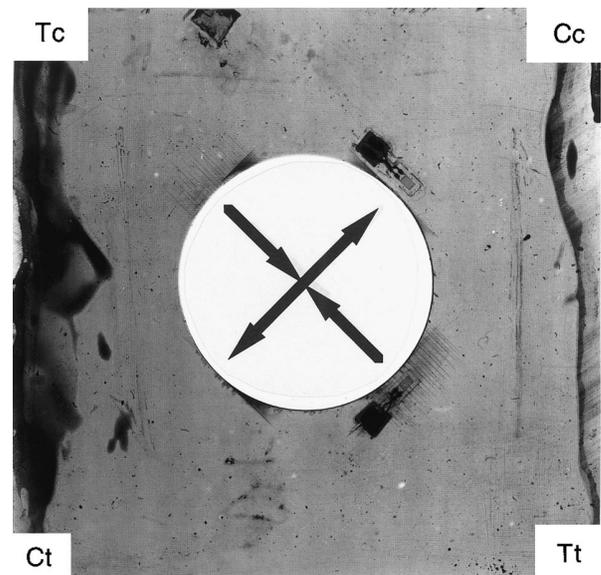
Fig. 6. (d) X-ray radiograph of fatigue damage around 46 mm diameter notch in beam Carbon N5 (4.78×10^6 cycles). Tensile matrix cracks are evident in quadrants Tc and Tt (top left and bottom right, respectively) for a distance of up to 10 mm away from the edge of the notch. The compression flange is along the top of the photograph and the tension flange along the bottom. This notch was at the opposite end of the I-beam to the notch of Fig. 6(c) and consequently the local directions of resolved tensile and compressive stresses appear to act in opposite directions to those shown in Fig. 6(c).

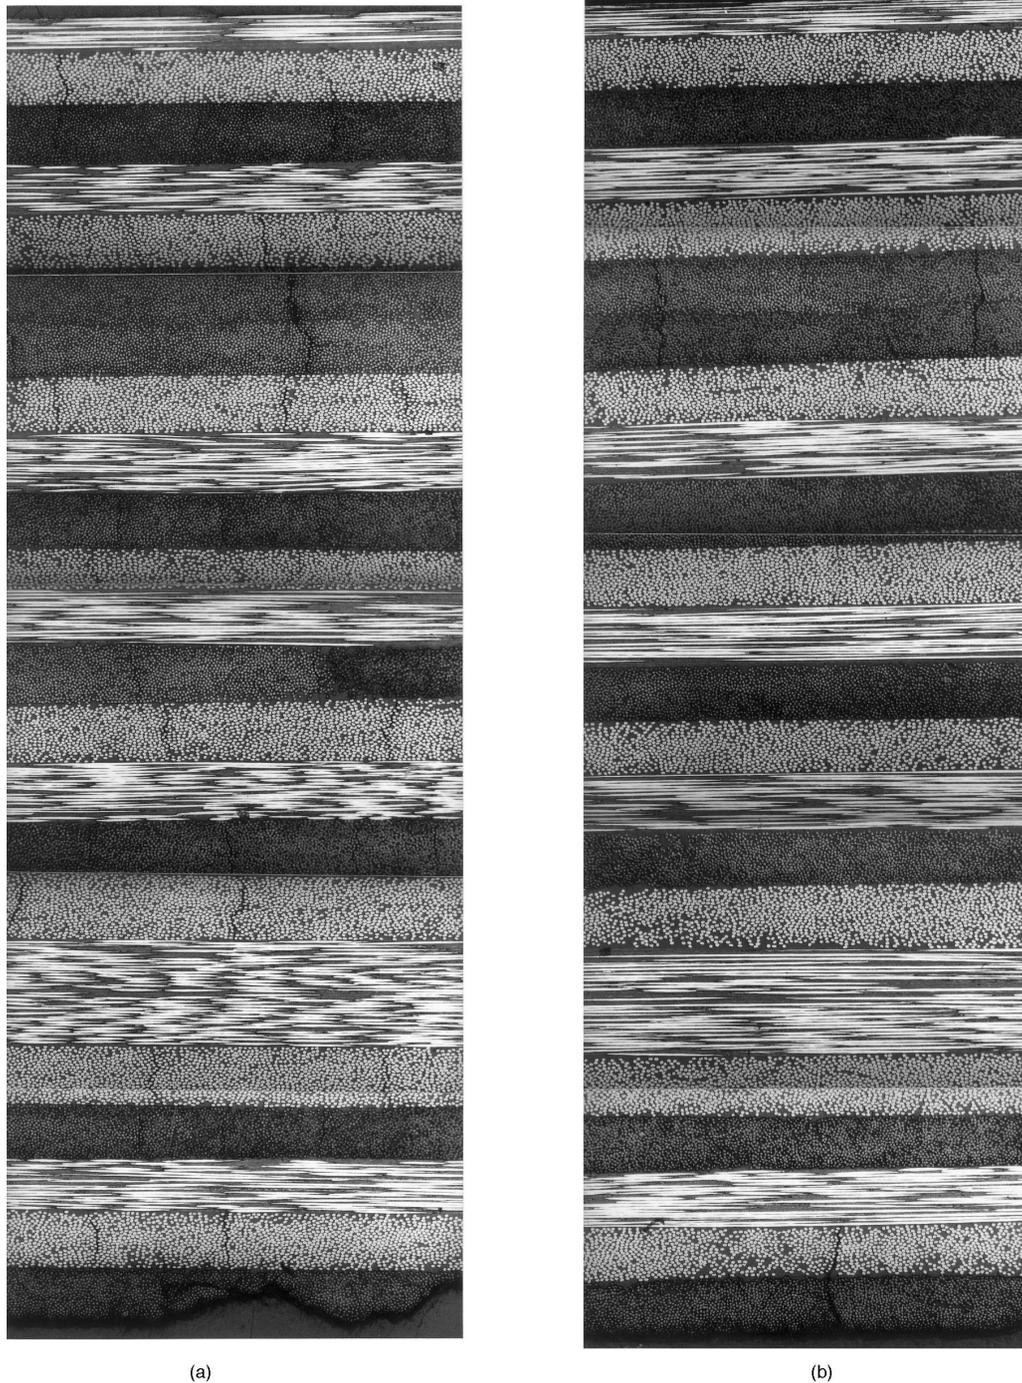
Fig. 7. Optical micrograph of through-thickness damage around the small notch of beam Carbon N2 (0.5×10^6 cycles) taken after test (a) at edge of small notch and (b) 6.5 mm ahead of the small notch. Note that the local orientation of the plies in these micrographs is $(0/-45/90^\circ)_{2s}(90/-45/0^\circ)_{2s}$ whilst the global orientation of these same plies is $(-45/0/45^\circ)_{2s}(45/0/-45^\circ)_{2s}$. This is because the sections were cut normal to the direct tensile stresses within quadrant Tt and this orientation is parallel to the global 45° direction (cf. Figs. 1 and 2).

density of matrix cracks (and any other damage mechanisms) in terms of both loading cycles and distance away from the free edge of a notch. The optical micrographs of Fig. 7 have been taken from two different positions in the vicinity of the small hole (46 mm diameter) of beam Carbon N2. The first section [Fig. 7(a)] is tangential to the edge of the hole whilst the second section [Fig. 7(b)] is parallel to the first but some 6.5 mm away from the edge of the hole. Both sections are in the tensile quadrant that is adjacent to the tensile flange of the beam. It should be noted that the local orientation in which these micrographs have been cut is different from the global coordinate system of the I-beams [i.e. the local orientation in Fig. 7 is $(0/45/90^\circ)$ whilst the global orientation is $(-45/0/+45^\circ)$]. Matrix cracks are evident at the edge of the hole [Fig. 7(a)] in all local 45 and 90° plies but at some 6.5 mm away from the edge of the hole [Fig. 7(b)] matrix cracks are only evident in the local double 90° plies. Some cutting damage, due to back surface breakout of the diamond cutter, is apparent in the bottom ply at the edge of the hole.

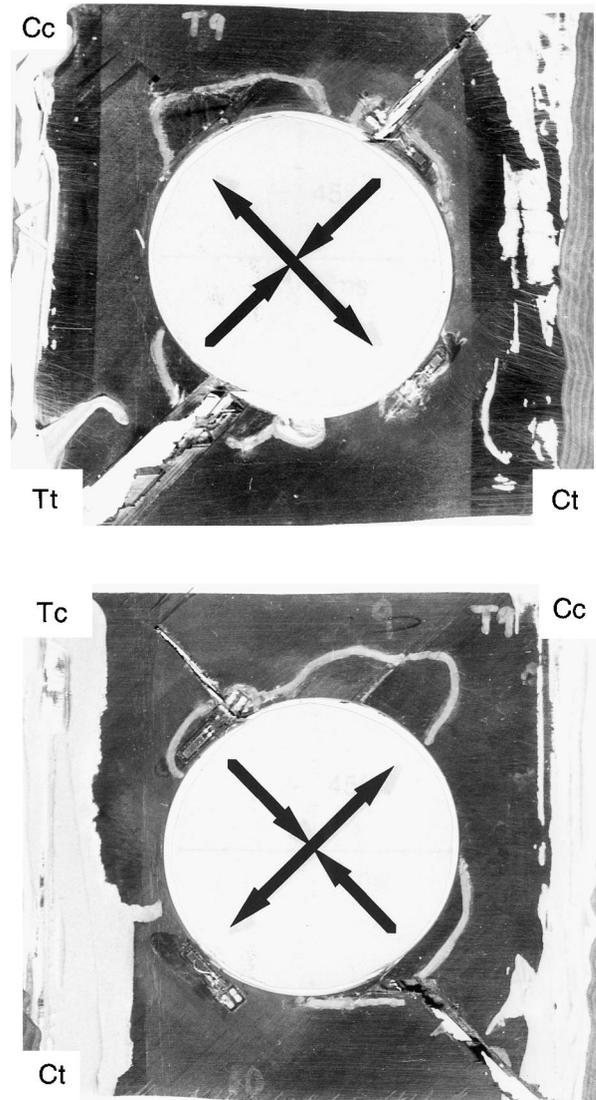
Fig. 8. Visually identified damage after failure around the front and back of the large web notch (60 mm diameter) in beam Carbon N5. The compression flange is along the top of the photograph and the tension flange is along the bottom. The local directions of resolved tensile and compressive stresses are indicated.

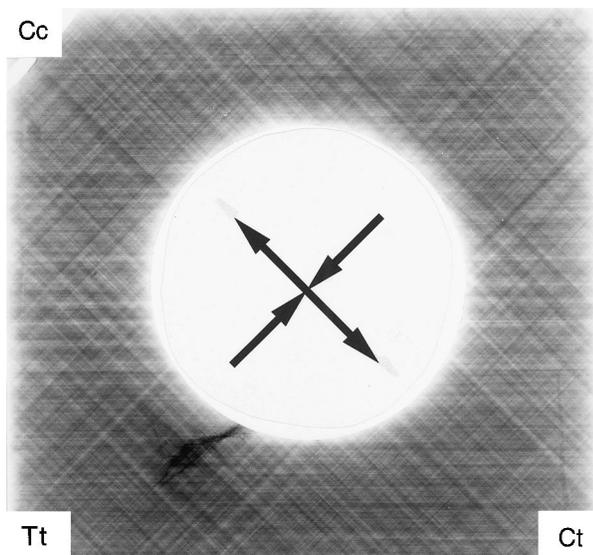
Tensile damage has been identified in two quadrants around the large notch. This was apparent visually and ultrasonically but was not fully identified using X-radiography, as shown in Fig. 9. Indeed, it was more difficult to identify the extent of damage within the glass/epoxy beams than within the carbon/epoxy beams when examining the through-thickness damage using optical microscopy. This is due to the lack of contrast obtained between the damage and glass/epoxy system when compared with the high contrast obtained between the damage and the carbon/epoxy system. However, no damage in the two compressive quadrants was identified in the glass/epoxy I-beams.

Fig. 9. X-ray radiograph of fatigue damage around 60 mm diameter notch in beam Glass N1 (0.96×10^6 cycles). Tensile damage, in the form of matrix cracks and delamination, exists in the two tensile quadrants Tc and Tt (top right and bottom left) although the damage is only visible in quadrant Tt (bottom left). The compression flange is along the top of the photograph and the tension flange along the bottom. The local directions of resolved tensile and compressive stresses are indicated.
