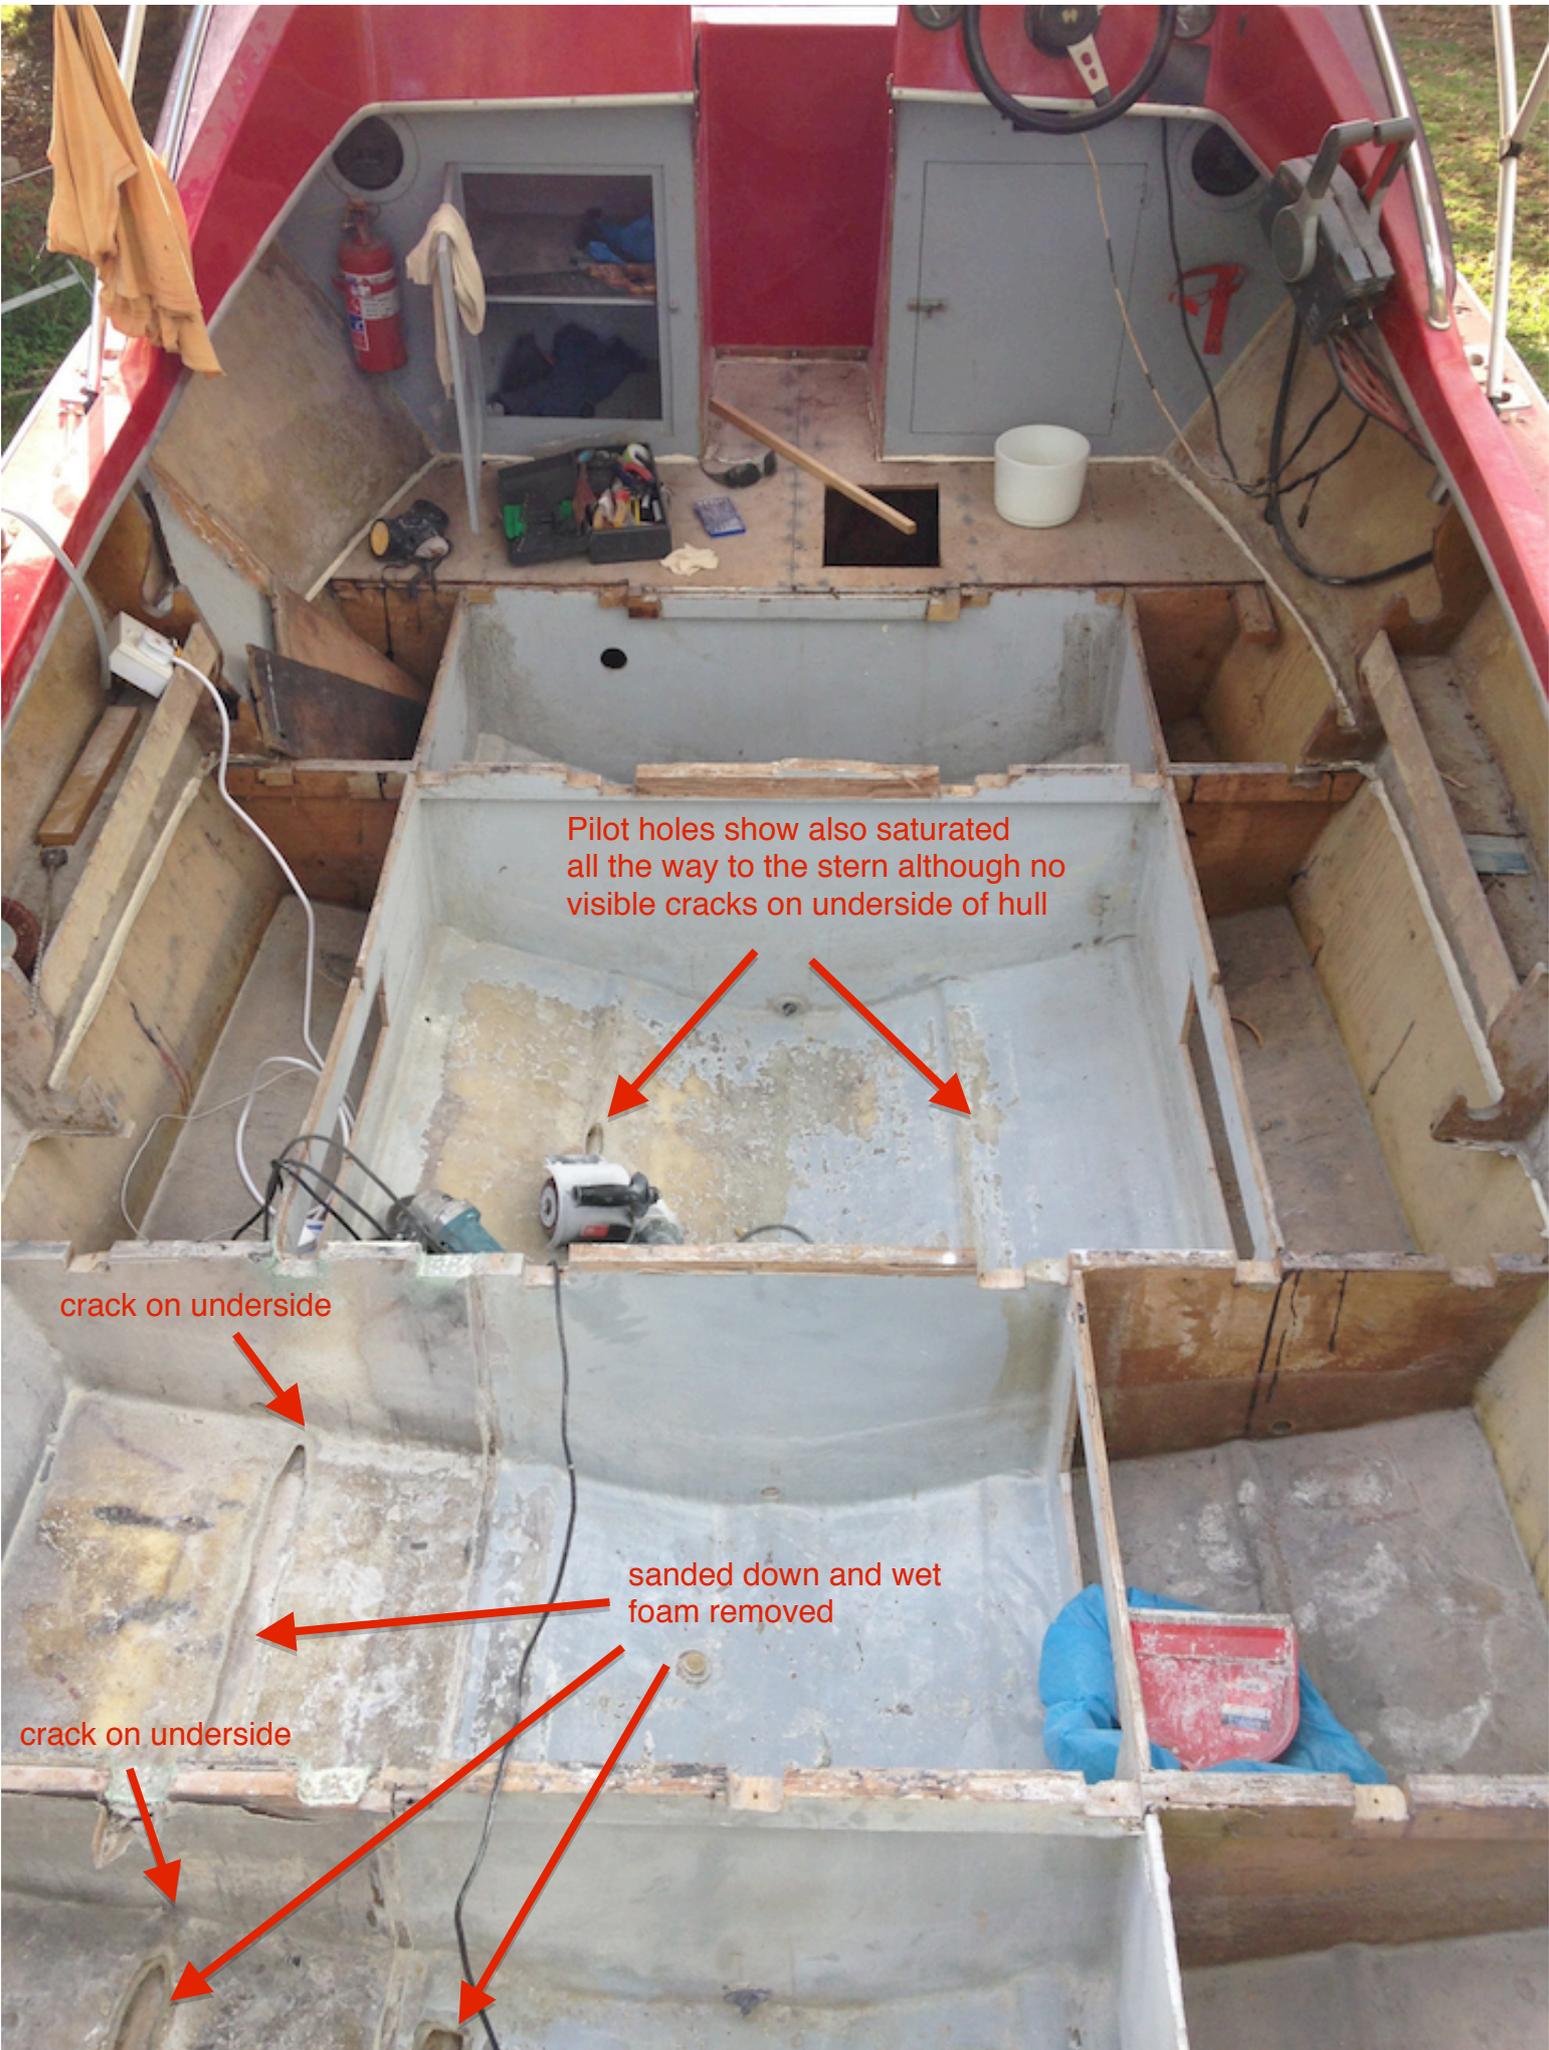
Pilot holes show also saturated all the way to the stern although no visible cracks on underside of hull

crack on underside

sanded down and wet foam removed
