Keel Failure Leads to Loss of Life

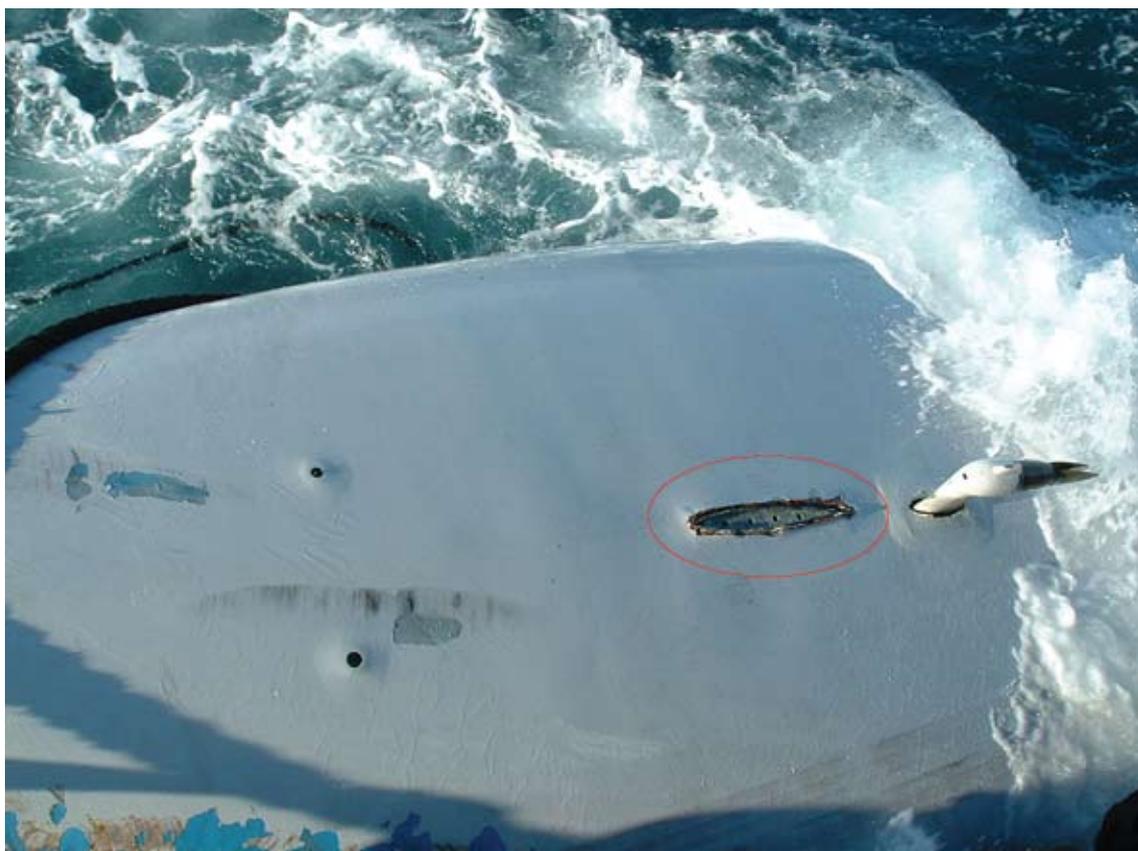
Figure 1

Investigations found that the fabricated steel keel had failed just below the fillet weld connecting the fin to the taper box (see Figure 1). Laboratory metallurgical analysis confirmed that the keel had suffered fatigue failure due to reverse bending stresses. Defects were also found in the keel taper box welds, and two of the three keel bolts had also failed.

It was further discovered that the boat builder had sub-contracted the hollow keel construction to a steel fabricator who had no marine experience. The fabricator changed the original design, and incorporated a fillet weld in a critical area. He did so to ease manufacture and reduce costs, but without the supporting calculations to assess the stresses to which the keel would be subjected. He did not consult with the designer on the changes. In 2005, 160kg of lead was added to the keel bulb for racing optimisation reasons. Once again there were no supporting calculations, nor were there detailed checks made against the “original” or “as built” designs to ensure that the modification was safe.

It was found that none of the designs achieved the required Safety Factor of 2. The addition of

the extra bulb weight exacerbated the problem and the keel was unable to withstand the “in service” bending stresses, and this led to the conditions of failure.

1. Yacht designers should ensure component designs satisfy the appropriate standard safety factor requirements. In this case, the keel steel’s full ultimate tensile strength was used in the calculations instead of yield strength, and thus an artificially high safety factor was achieved.

2. Changes to critical parts such as hollow, highly stressed keels, should be properly worked through and supported with calculations to ensure their suitability. Owners should seek expert professional advice, and wherever possible, reference should be made to design drawings, and the designer/builder consulted to check construction details and suitability of the modification.

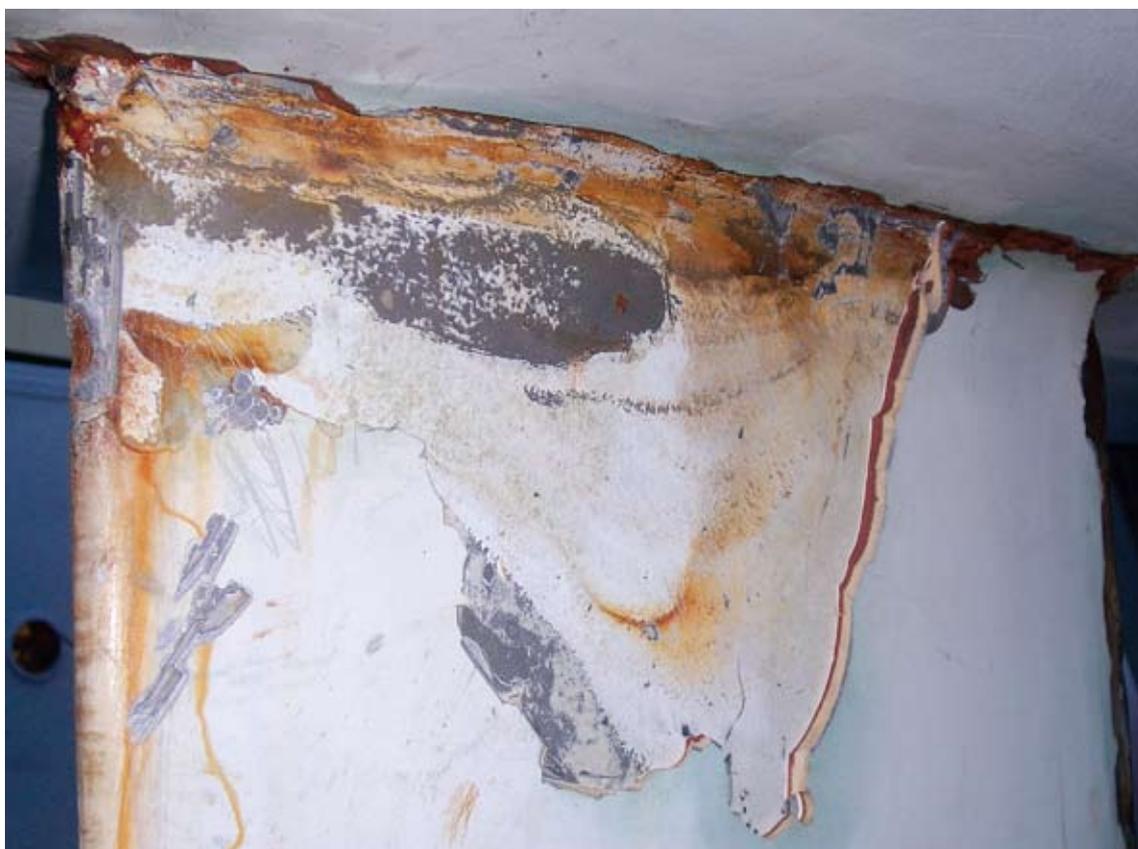
Figure 2

considerable detachment of the keel’s epoxy filler and anti-fouling was found (see Figure 2). There was also evidence of the likelihood of fine cracking in the steel adjacent to the fillet weld, but this went undetected by the repairer, so the last chance to prevent the accident was missed.

3. Do not dismiss the importance of keel coating detachment, or evidence of cracking of the coatings at the keel to hull interface; this may indicate more deep seated keel structural problems.

- Seek expert advice – you may need to use non-destructive procedures to check that the keel structure is sound. Also, regularly check the tightness of keel bolts and thoroughly investigate the cause of any failures. **Remember**, action at this stage could save your life.
