PRELIMINARY REPORT OF SURVEY

Jack-up Rig THULE POWER

Fode Ltd

Dates: 5 - 11 April 2009

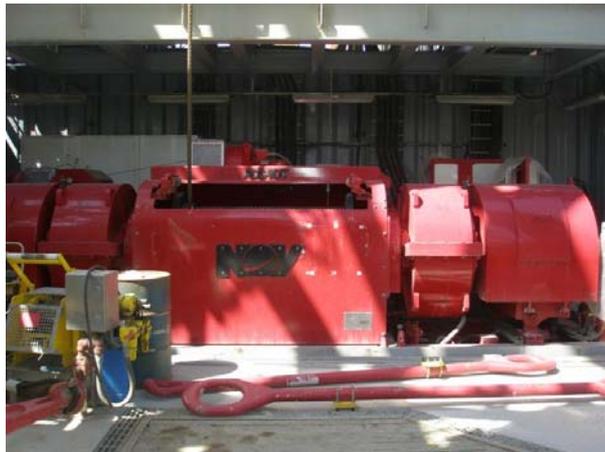
The drawworks was visually inspected and did not appear to have been used for any drilling operation in the past. As the drawworks has not been run for an unknown period of time it is recommended to carry out an internal inspection of the gearboxes, lube oil and cooling system prior start up as well as it must be ensured that all the grease points are greased and the correct oil level is maintained. It was also noted that the crown saver toggle switch was not set correct as it had loose securing bolts, the Crown-O-Matic should be adjusted and secured in accordance with API RP 54 section 9.4.8

5.1 Drawworks general.

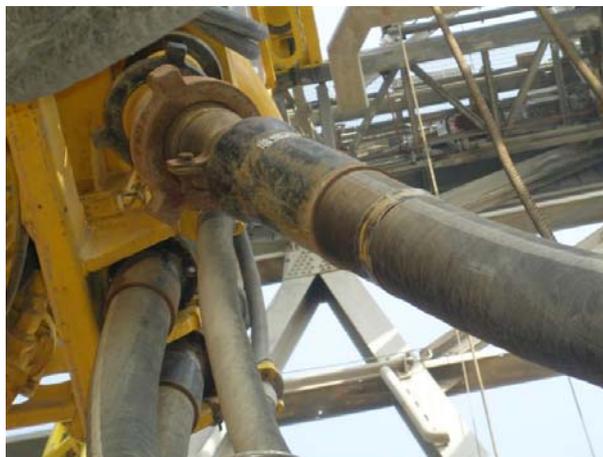
The rig was equipped with a Varco TDS8SA top drive which was observed visually from the rig floor while it was located approximately seven meters above the rig floor. There was no accessibility to the top drive. It was noted that the installation of the mounted Varco PH100 pipe handler was not complete as the actuator for the IBOP valve was missing as was the cylinders for the link tilt system. Due to the fact that the top drive has not been running for an unknown period it is our recommendation to review the commissioning procedures and carry out re-commissioning of the safety and operational related points of the original commissioning procedure. It was also noticed that the high pressure mud jumper hose connected to the goose neck did not have any kind of safety sling installed in order to catch the hose and prevent possible injuries if the hose for some reason should fail.

5.3 Top drive HP jumper hose has no safety sling fitted.

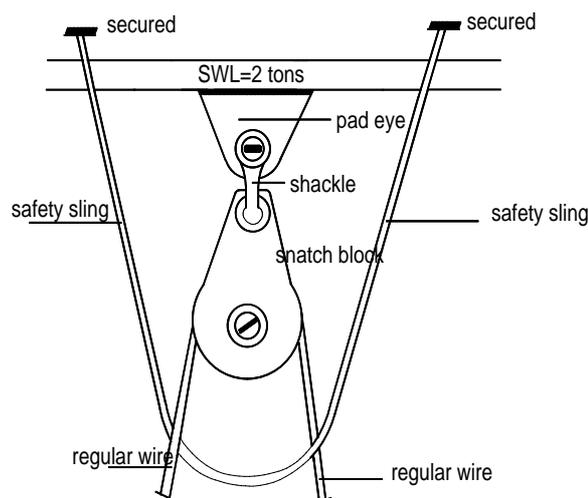
The correct way of installing safety slings on sheaves are showed below in order to have them installed correct when provided:

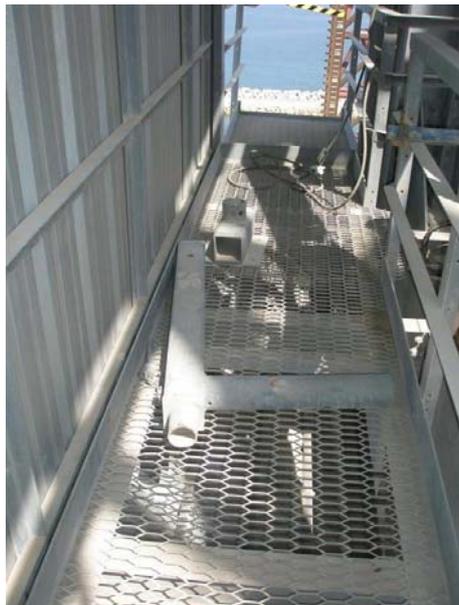
5.11 Monkeyboard scaffold.

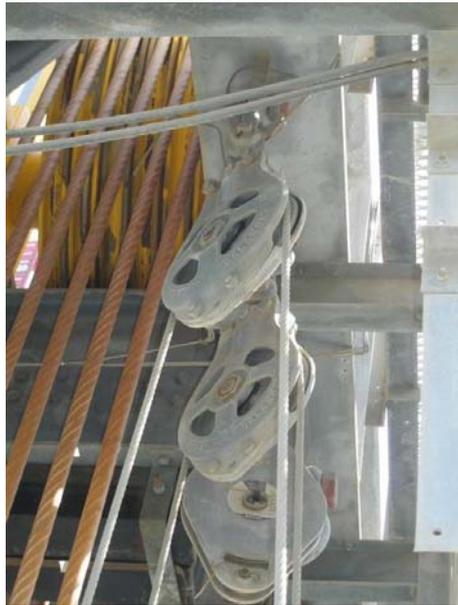
5.11 Monkeyboard poor housekeeping.

| 5.11.1.8 | Major | Install or remove loose tugger on monkeyboard. |

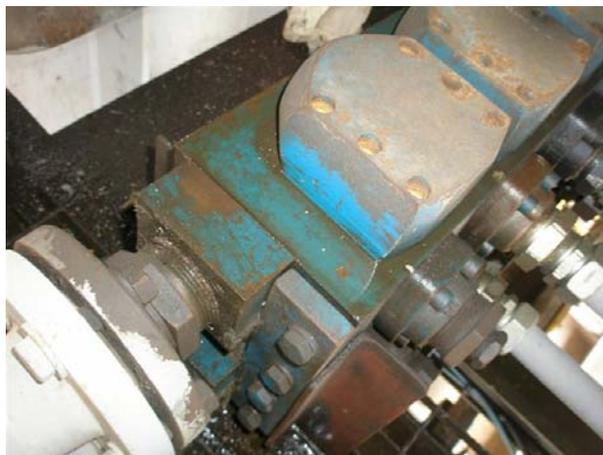
The hydraulic power unit was a Varco HPU with the capacity of 160 GPM at maximum 3000 PSI. The unit was placed beneath the rig floor and were visually inspected. The unit was in as new condition however it was found to be very dirty on the externals. The nearby return manifold was leaking oil.

5.19.10 Hydraulic Power Unit manifold leaking.

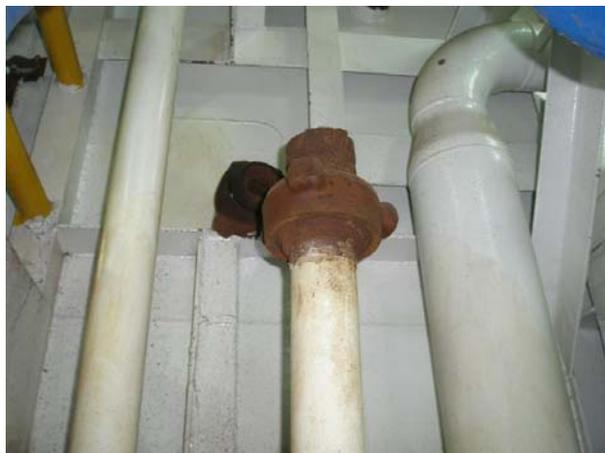
6.1 Pop off missing.

<u>Mud Pumps Recommendations:</u>		
6.1.1.1	Critical	Install missing pop off valve at pump 11301H.
6.1.1.2	Major	Re calibrate pop off valve at pump 11302H.
6.1.1.3	Minor	Repair oil leaks in oil supply line at pump 11302H.
6.1.1.4	Minor	Include the lifting appliances in an inspection scheme and colour code accordingly.
6.1.1.5	Minor	Calibrate the discharge pressure gauges.
6.1.1.6	Minor	Stencil the pump numbers at a visible place on the pumps.
6.1.1.7	Minor	Replace desiccant air breather cartridges.
6.1.1.8	Minor	Review the commissioning procedures and evaluate if full commissioning has been carried out.

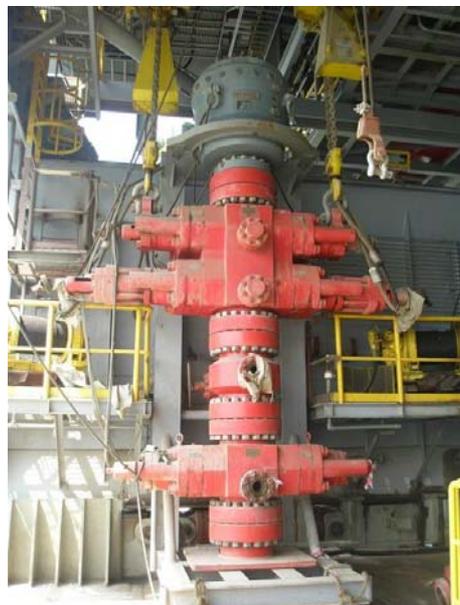
The rig was equipped with a Cameron BOP stack consisting of a single and a double ram preventer of the size 13- 5/8" the stack was manufactured in 2006 and has as such not been in use. As there were no access to the double rams and no possibility of testing or opening up the BOP for internal inspection it is recommended to have the bop inspected and pressure tested before use. The lower ram preventer were visually inspected and it was found with open flange connections for the gate valves, by looking into the bores it appeared that debris was present inside. This should be cleaned out as well as should the ring gasket surfaces as these had started to rust slightly. As the original plugs for the control lines were still installed it does not appear that the BOP stack has been tested and commissioned onboard.

7.1.2 BOP stack.

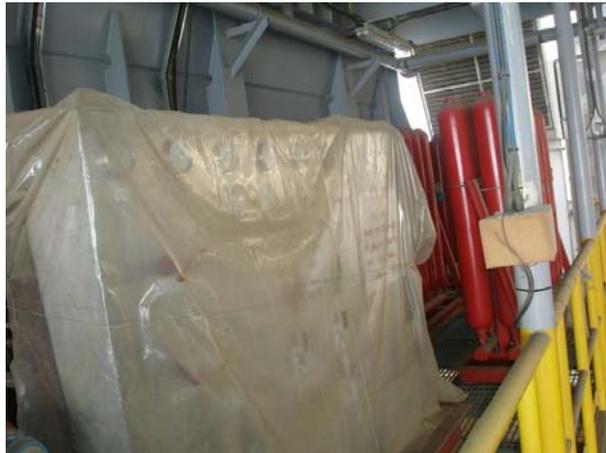
The diverter system was not inspected as there were no diverter observed on the rig and the diverter panel was covered up in plastic foil. The view of the diverter panel did not give us the confidence that the system has been commissioned which should be verified.

7.8 BOP diverter panel not accessible.

- 7.8.1.1 Major Diverter System Recommendation:
Carry out full commissioning of the diverter and diverter control panel prior to drilling operation if not already carried out and documented.

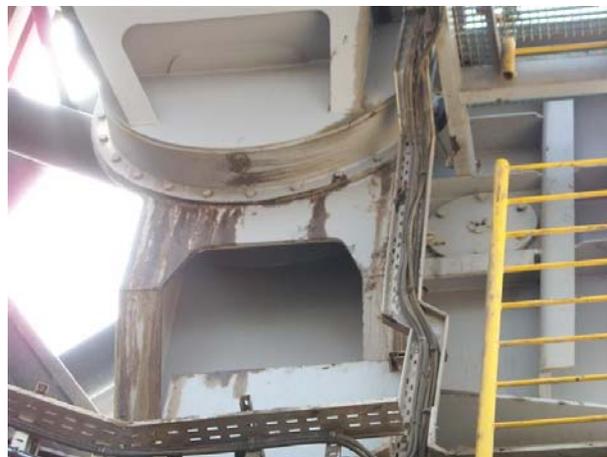
- Nine Electric motors located on each 3 jacking legs, 27 in total.
- Each motor is 600 Volts, 3 phase, 60 Hz, 40 h.p.
- The system motors were overhauled by Southern Technology & Services in Houma, Louisiana, in the U.S.A. under Job number: 19290 in 2006.
- The electrical jacking console located inside the jacking control room on level 3 of the main accommodation requires the internal wiring to be completed and the whole jacking system requires commissioning.
- The jacking gearboxes which are leaking oil need to be repaired.

8.8 Leaking oil from various jacking leg gearboxes.

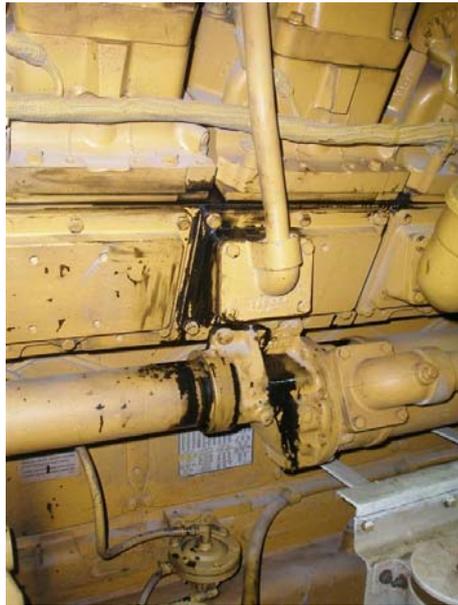
9.1.3 Main engine oil spill

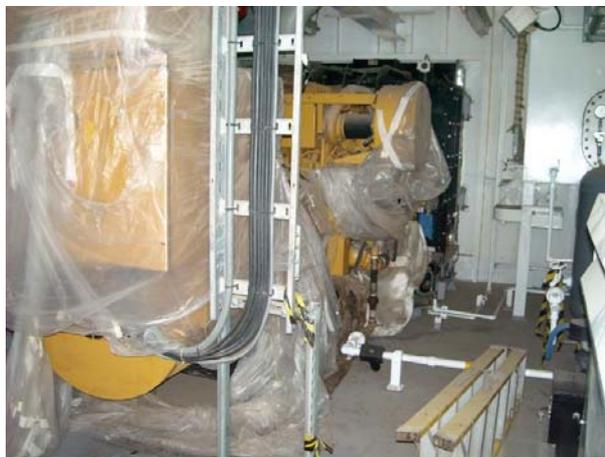
The Emergency Generator Set was located inside a dedicated room which contains the diesel engine and generator and emergency switchboard. The engine/generator is covered with transit packaging at the time of the Inspection and requires running and commissioning. The room is adequately ventilated for the operation of the emergency generator. The Caterpillar diesel engine has two independent methods of starting, one being a 24 VDC. Electrical battery starting system and a dedicated diesel engine driven air start system.

9.2 Emergency generator to commission.

9.2.1.1 Major Emergency Generator Set Recommendation:
The transit packaging needs removing and the emergency generator set needs running and commissioning.

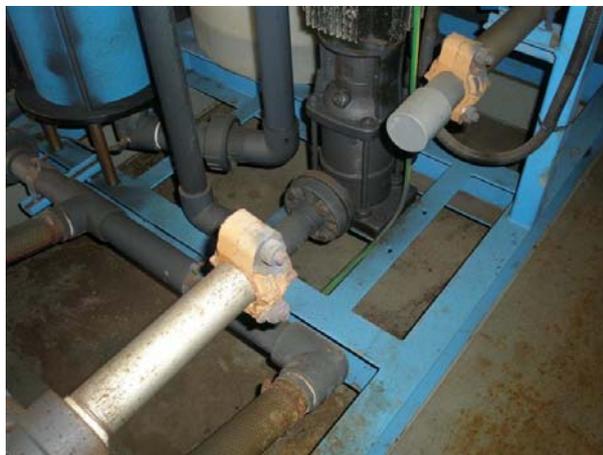
The rigs water makers was told to be fully commissioned however the visual inspection raised concerns towards this statement. Pipe sections were taken out of one of the units discharge pump lines, fittings were missing on filter cartridge vent lines, the visual appearance of the units was not in a state that one could expect for a portable water producing plant. The chlorination plant associated to the water makers would also need to attention as chlorine container was not installed in their respective racks. The S.W pipe work of the water makers were found to be rusted. Once the units are brought into an acceptable and working condition it is recommended to have a waters sample send to a laboratory for testing of the produced water.

9.7 Watermaker piping missing.

<u>Watermaker Recommendations:</u>
9.7.1.1	Major	Bring the water makers back to operational order.
9.7.1.2	Minor	Remove rust from pipe work and paint same.
9.7.1.3	Minor	Clean up the units in general.
9.7.1.4	Minor	Place chlorine containers in their respective racks.
9.7.1.5	Minor	Repair broken fitting on filter cartridge vents.
9.7.1.6	Minor	Send in a water sample for analysis.

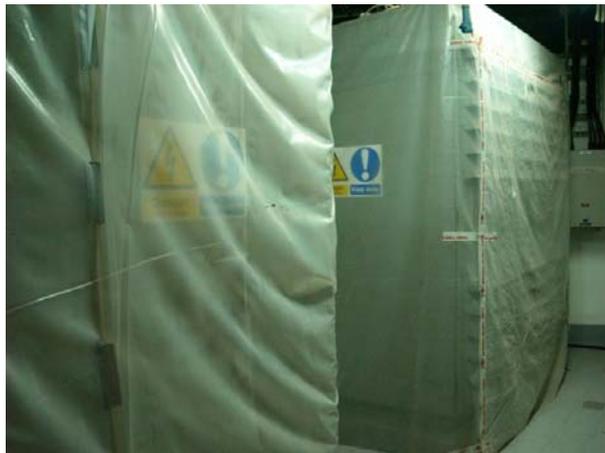
The main transformers were located below main deck level in dedicated dry locations. The transformers could not be inspected because they need to be commissioned and the transportation packaging needs to be removed for to allow external and internal inspections.

10.3 Main transformers require transit packaging to be removed and commissioning.

10.3.1.1 Major Main Transformer Recommendation:
 All transformers need to be released from the transit packaging and commissioned for general use.

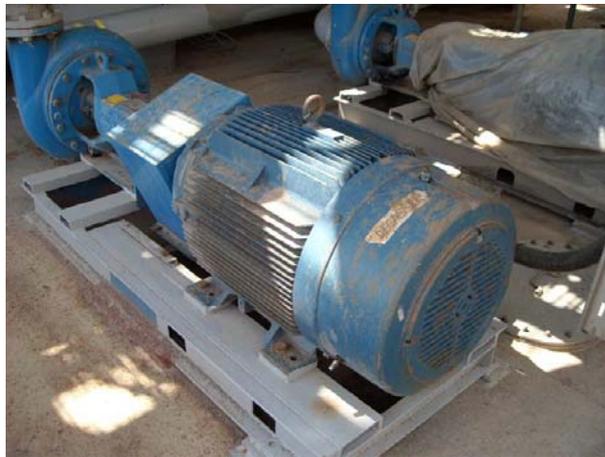
10.5 A.C. Motors. Corrosion and bad explosion proof flame paths.

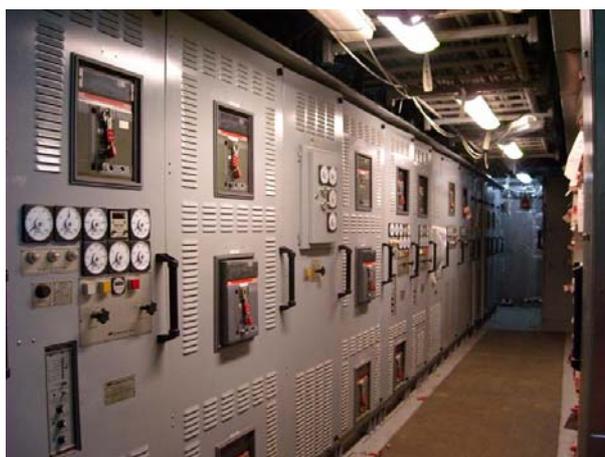
The main switchboard was located below the main deck inside a dedicated switch room. The main bus-bar incoming voltage being a planned 600 A.C. volts, 3 phase, 60 Hz. No visual or internal inspections were carried out as the main switchboard is needed to be commissioned. Rubber insulating matting must be fitted in front of all switchboards to restrict electrical shock hazard.

10.5 NOV main switchboard.

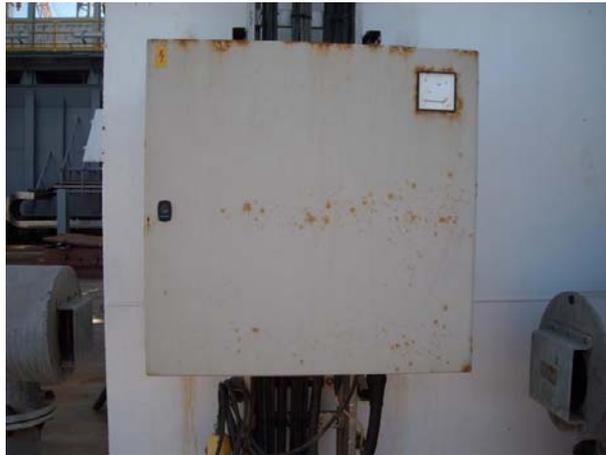
There was various locations on the THULE POWER with dedicated rooms for the installation of the various types of Motor Control Centres (MCC's). No visual or internal inspections were carried out because of the transit packaging in place and the respective electrical panels and circuit breakers being in the locked off position prior to commissioning. All panels need the correct labelling fitted to their respective doors. All of the MCC equipment needs to be commissioned before application.

10.9 Electrical equipment has no labels fitted.

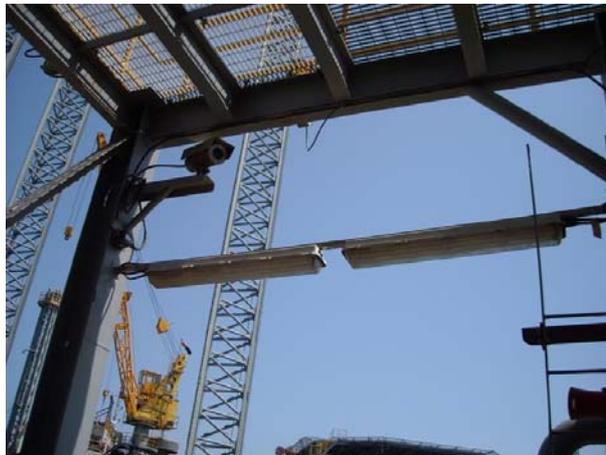
The lighting system was not inspected for operation due to the system needs commissioning. The external visual inspection revealed that all the lighting fittings are in good clean condition and there are plenty of fittings located above decks and below decks in the machinery rooms and work spaces. There was no safety wires attached to any light fitting throughout the THULE POWER.

10.10 Lighting fittings without safety wires.

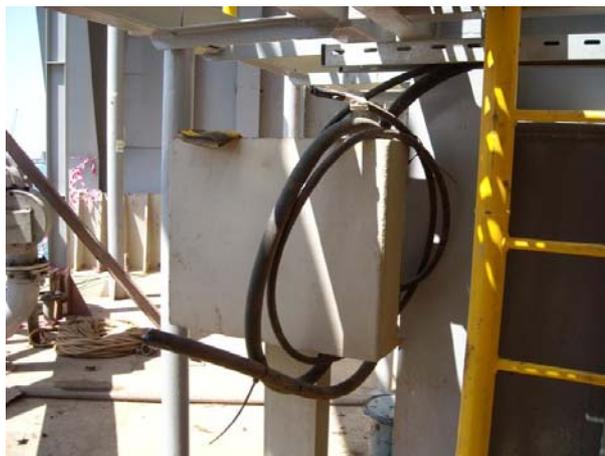
All cable trays were found to be in good corrosion free condition with the correct earth straps and installed correctly. There was numerous cables required termination into junction boxes and electrical equipment and the system requires commissioning before rig power is applied to the various circuits.

10.13 Numerous electrical cables and circuits need connecting and commissioning.

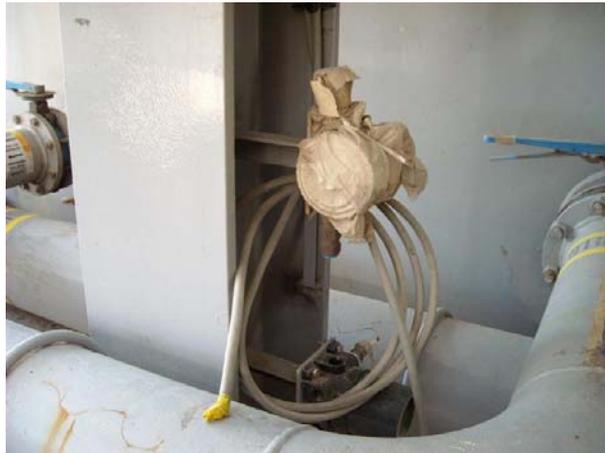
10.15 Gas detection systems need connecting and commissioning.

10.15.1.1 Major Alarm Systems: Fire, Gas, General and Flooding Recommendation:
Systems require installation and commissioning.

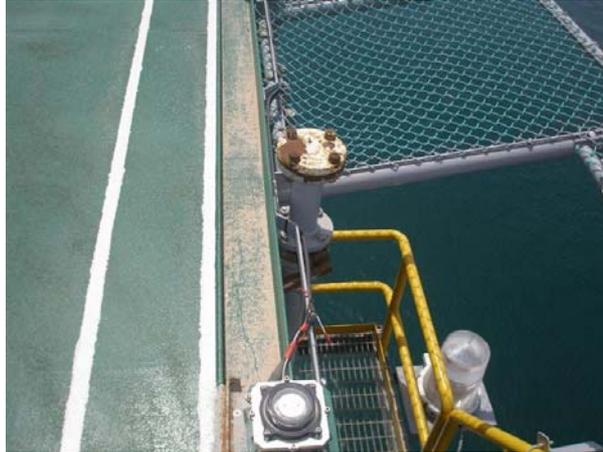
The foam system for the helideck consisted of three monitors with foam tanks and a fire booster pump placed beneath the helideck. It was noted that a relief valve had

been disconnected from the booster pump and also one of the three foam monitors was missing as the pipework was found blanked off. It must be verified that the rigs are in compliance with MODU Code section 9.11.2.2 before operations starts up.

11.1.6 Helideck foam monitor missing.

<u>Foam System for Helideck Recommendations:</u>
11.1.6.1.1	Critical	Install missing safety relief valve on helideck booster fire pump.
11.1.6.1.2	Major	Install missing foam monitor.
11.1.6.1.3	Major	Ensure the foam tanks are filled up.
11.1.6.1.4	Major	Verify compliance with MODU Code section 9.11.2.2.

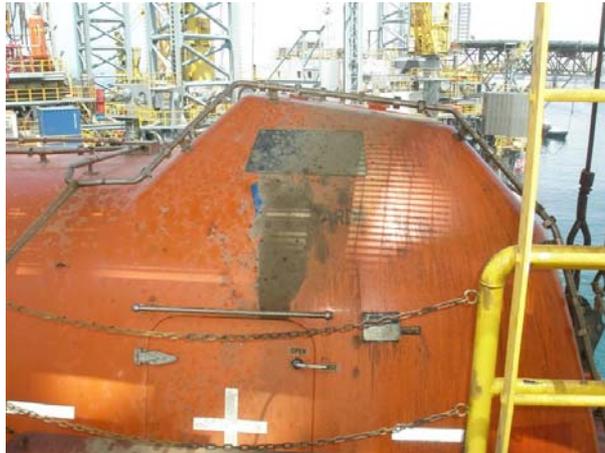
The lifeboats could not be inspected at the time of the survey due to no rig crew onboard and no procedures for safe entry, close standby boats etc were in place. The lifeboats were however visually inspected from the outside and it was noticed that the brackets holding the grab/step line around the boat was damaged so the line was hanging down. It was also noticed that there was no wheel mark on the boats which should be verified further. Parts of the starboard lifeboat was found covered in oil which on closer inspection appeared to be from a leaking oil sight glass on the life boat davit on top of the boats. It must be ensured that the lifeboats are approved and inspected closer before the rigs goes into operation. The charges were not hooked up to the lifeboats at the time of the survey wherefore the battery condition should be checked.

11.2.1 Lifeboat covered in oil.

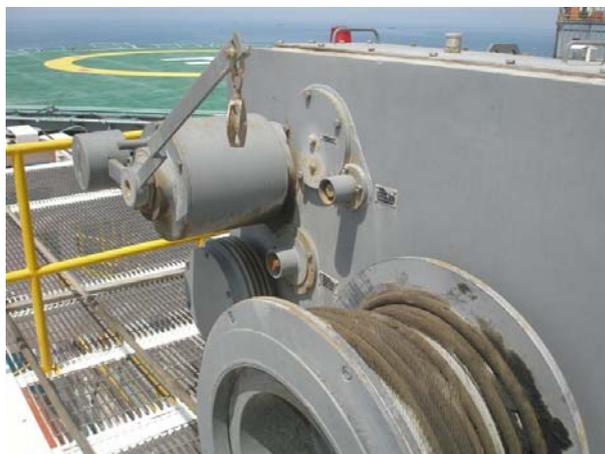
It was not possible to inspect the release mechanism as there was no access to the lifeboats, it was however noted from the outside that the release line was not installed in the boats. It is recommended to have the release wires installed and also have the certificates for the release mechanisms verified.

11.2.1 Lifeboat davit no release wire.

<u>Release Mechanism Recommendations:</u>
11.2.1.1.1.1	Critical	Install release lines on the lifeboats.
11.2.1.1.1.2	Major	Verify the certificates for the release mechanism.

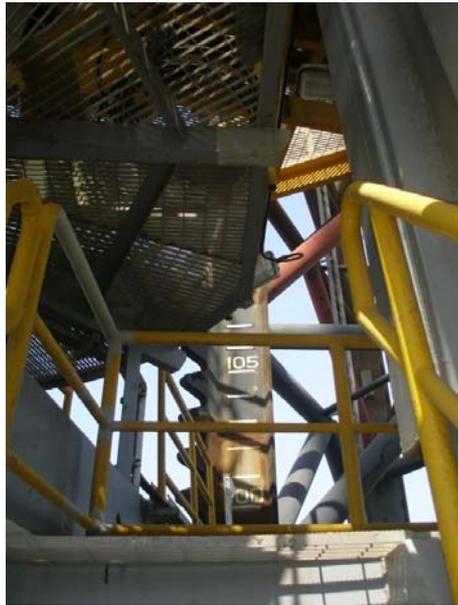
The stairs and walkways were in general in good condition as the grating had been changed out and new stairs installed however there were a number of unsafe conditions noticed which should be addressed. The ladder to the starboard crane did not have a safety cage installed; the same was noted for all the ladders to the top of the jacking structures. The stairs from the starboard side of the cantilever top to the rig floor was arranged too close to the starboard crane platform which meant that one had to bend down in order not to hit a beam in head height when passing the platform. The problem could be solved by means of painting the beams in the warning colours yellow/black however the most sensible and safe way would be to rearrange the stairs slightly to avoid the beam in head height.

11.11.3 Low free height on walkway warning colours to be painted.

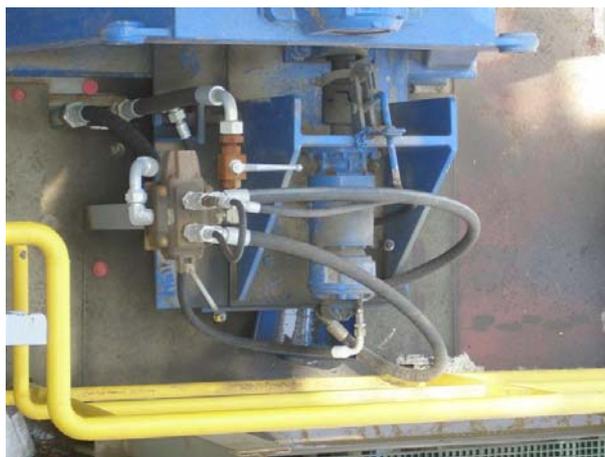
The drilling line spooler deck appeared to be too small to fit the drill line spooler as one has to climb over hydraulic hoses near to the handrails which create a fall hazard. It is recommended to change the design to accommodate more space for the operator of the spooler. The chains used at hand rails to the cantilever stairs (removable stairs) should be of a bigger size in order to feel secure when using the stairs. The access way to the HPU which was through the drill floor deck should be covered by a hinged self closing cover.

11.11.3 Restricted walkway drilling line spooler.
