Woodwork Refinishing

Fulmar Concerto FR38

Westerly Owners Association

Zoom Clinic 24 February 2021

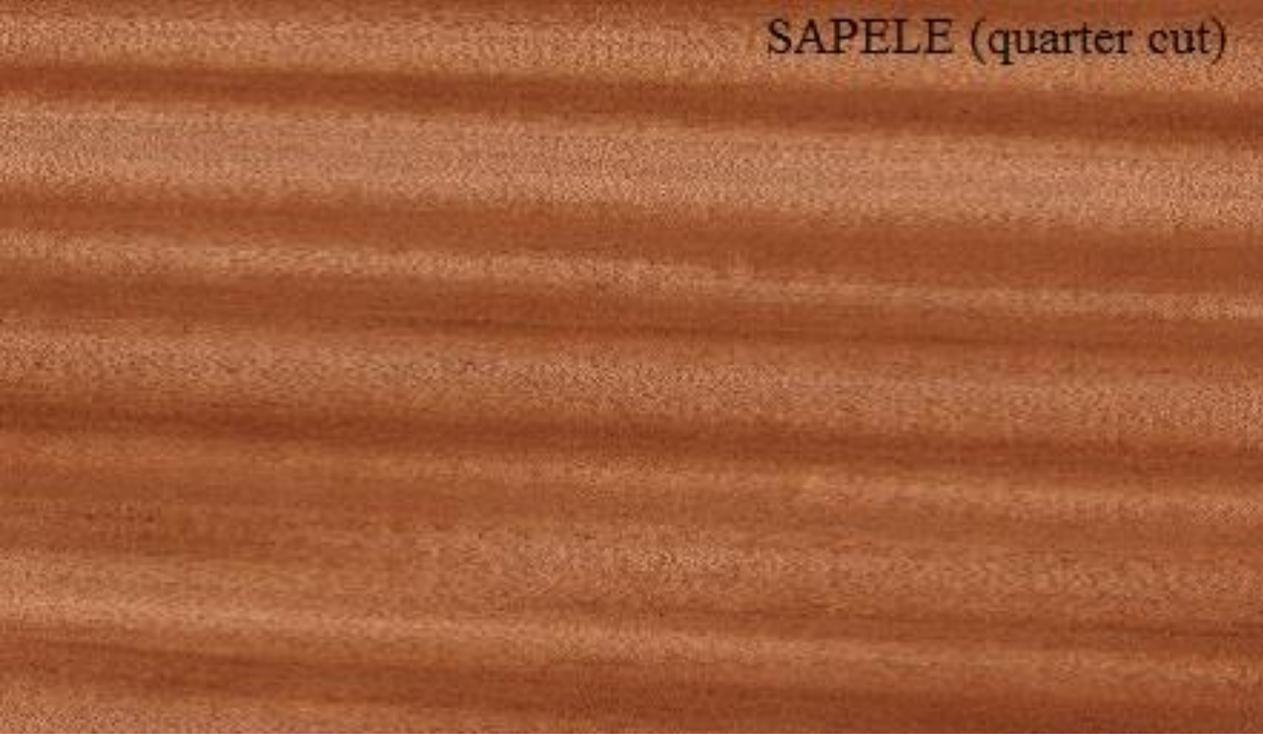
SAPELE (quarter cut)

Westerly used sapele marine plywood for interior woodwork until about 1982 and then they changed to using teak faced plywood.

The original lacquer can degrade, along with some fading due to long exposed to light, and can make sapele look the colour of teak, but the grain pattern tells them apart.

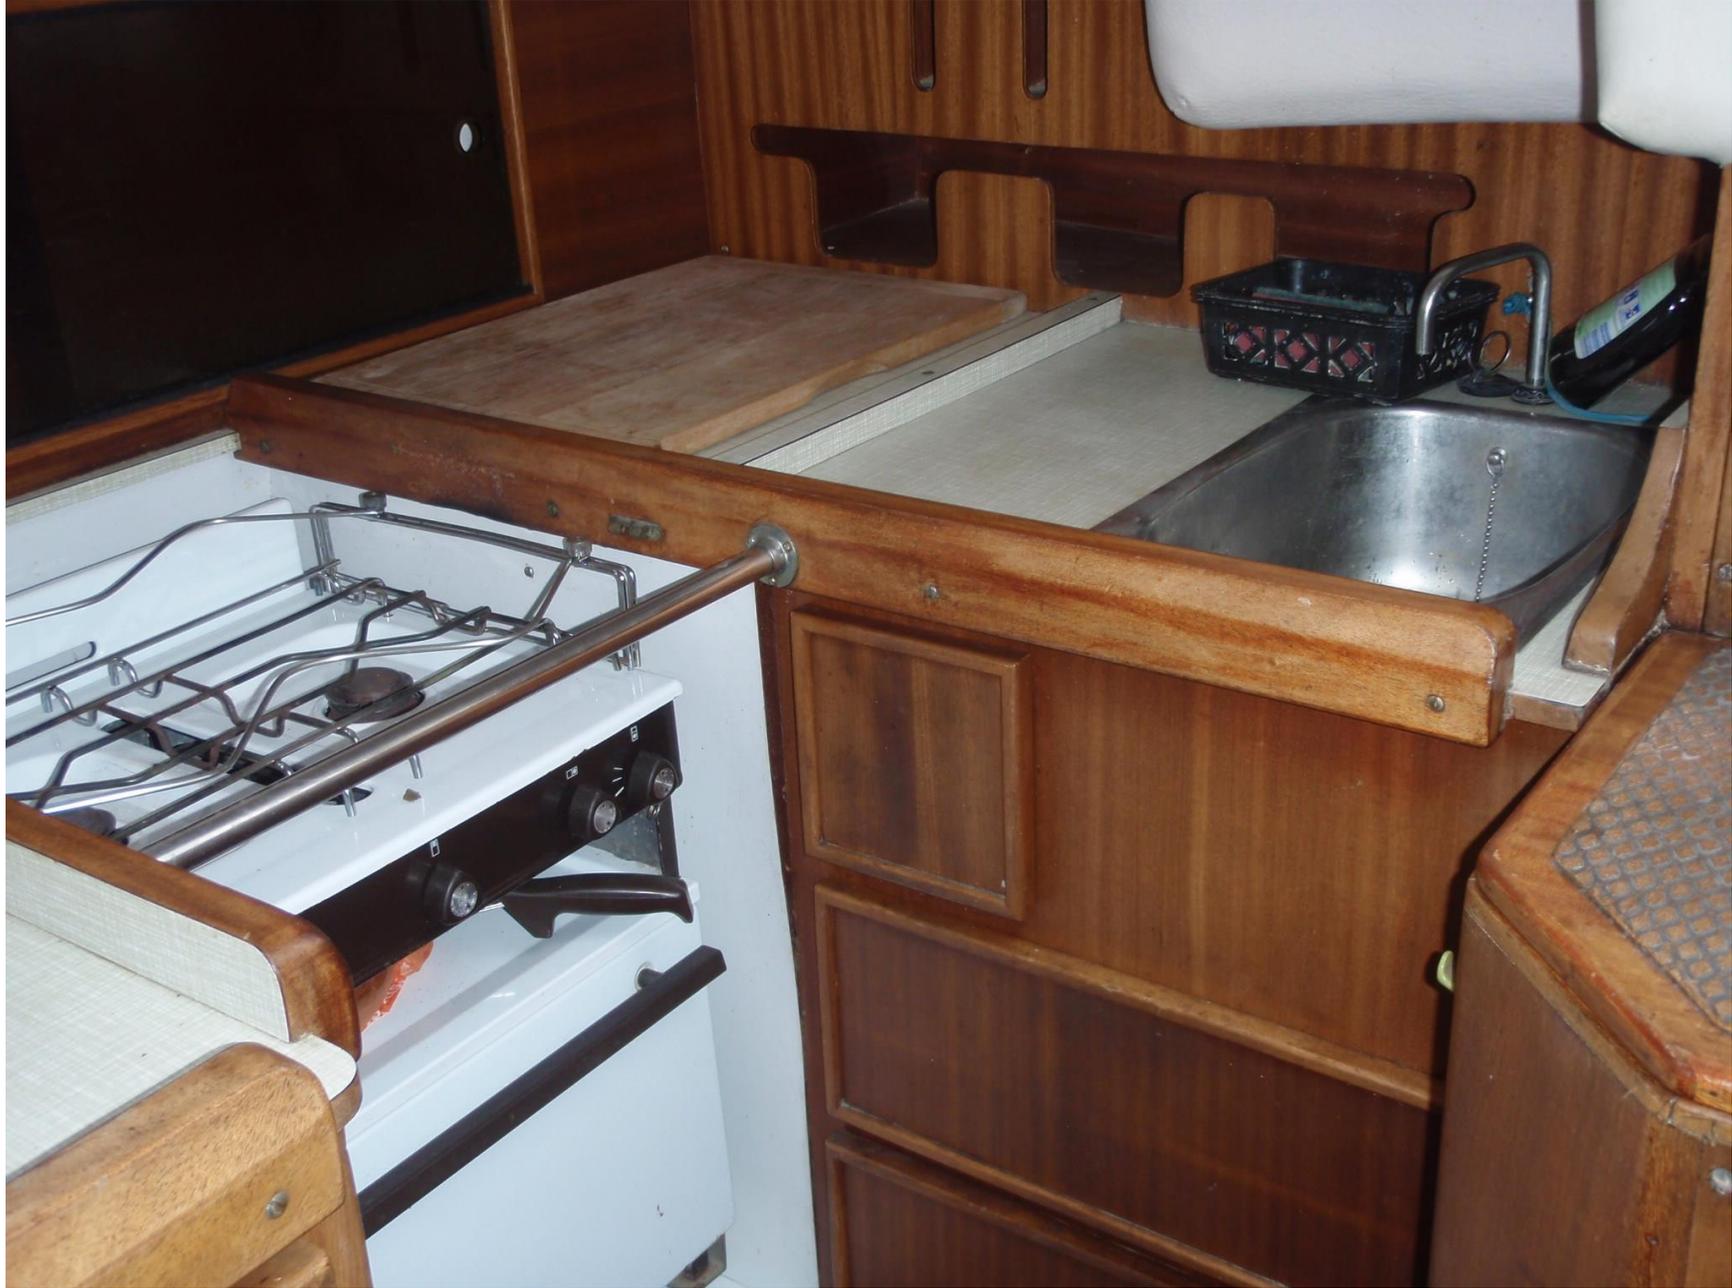
Concerto's
galley when
viewed in Dec
2013

The fiddle rail has been sanded and refinished with the original lacquer and looks a lot brighter and fresher.

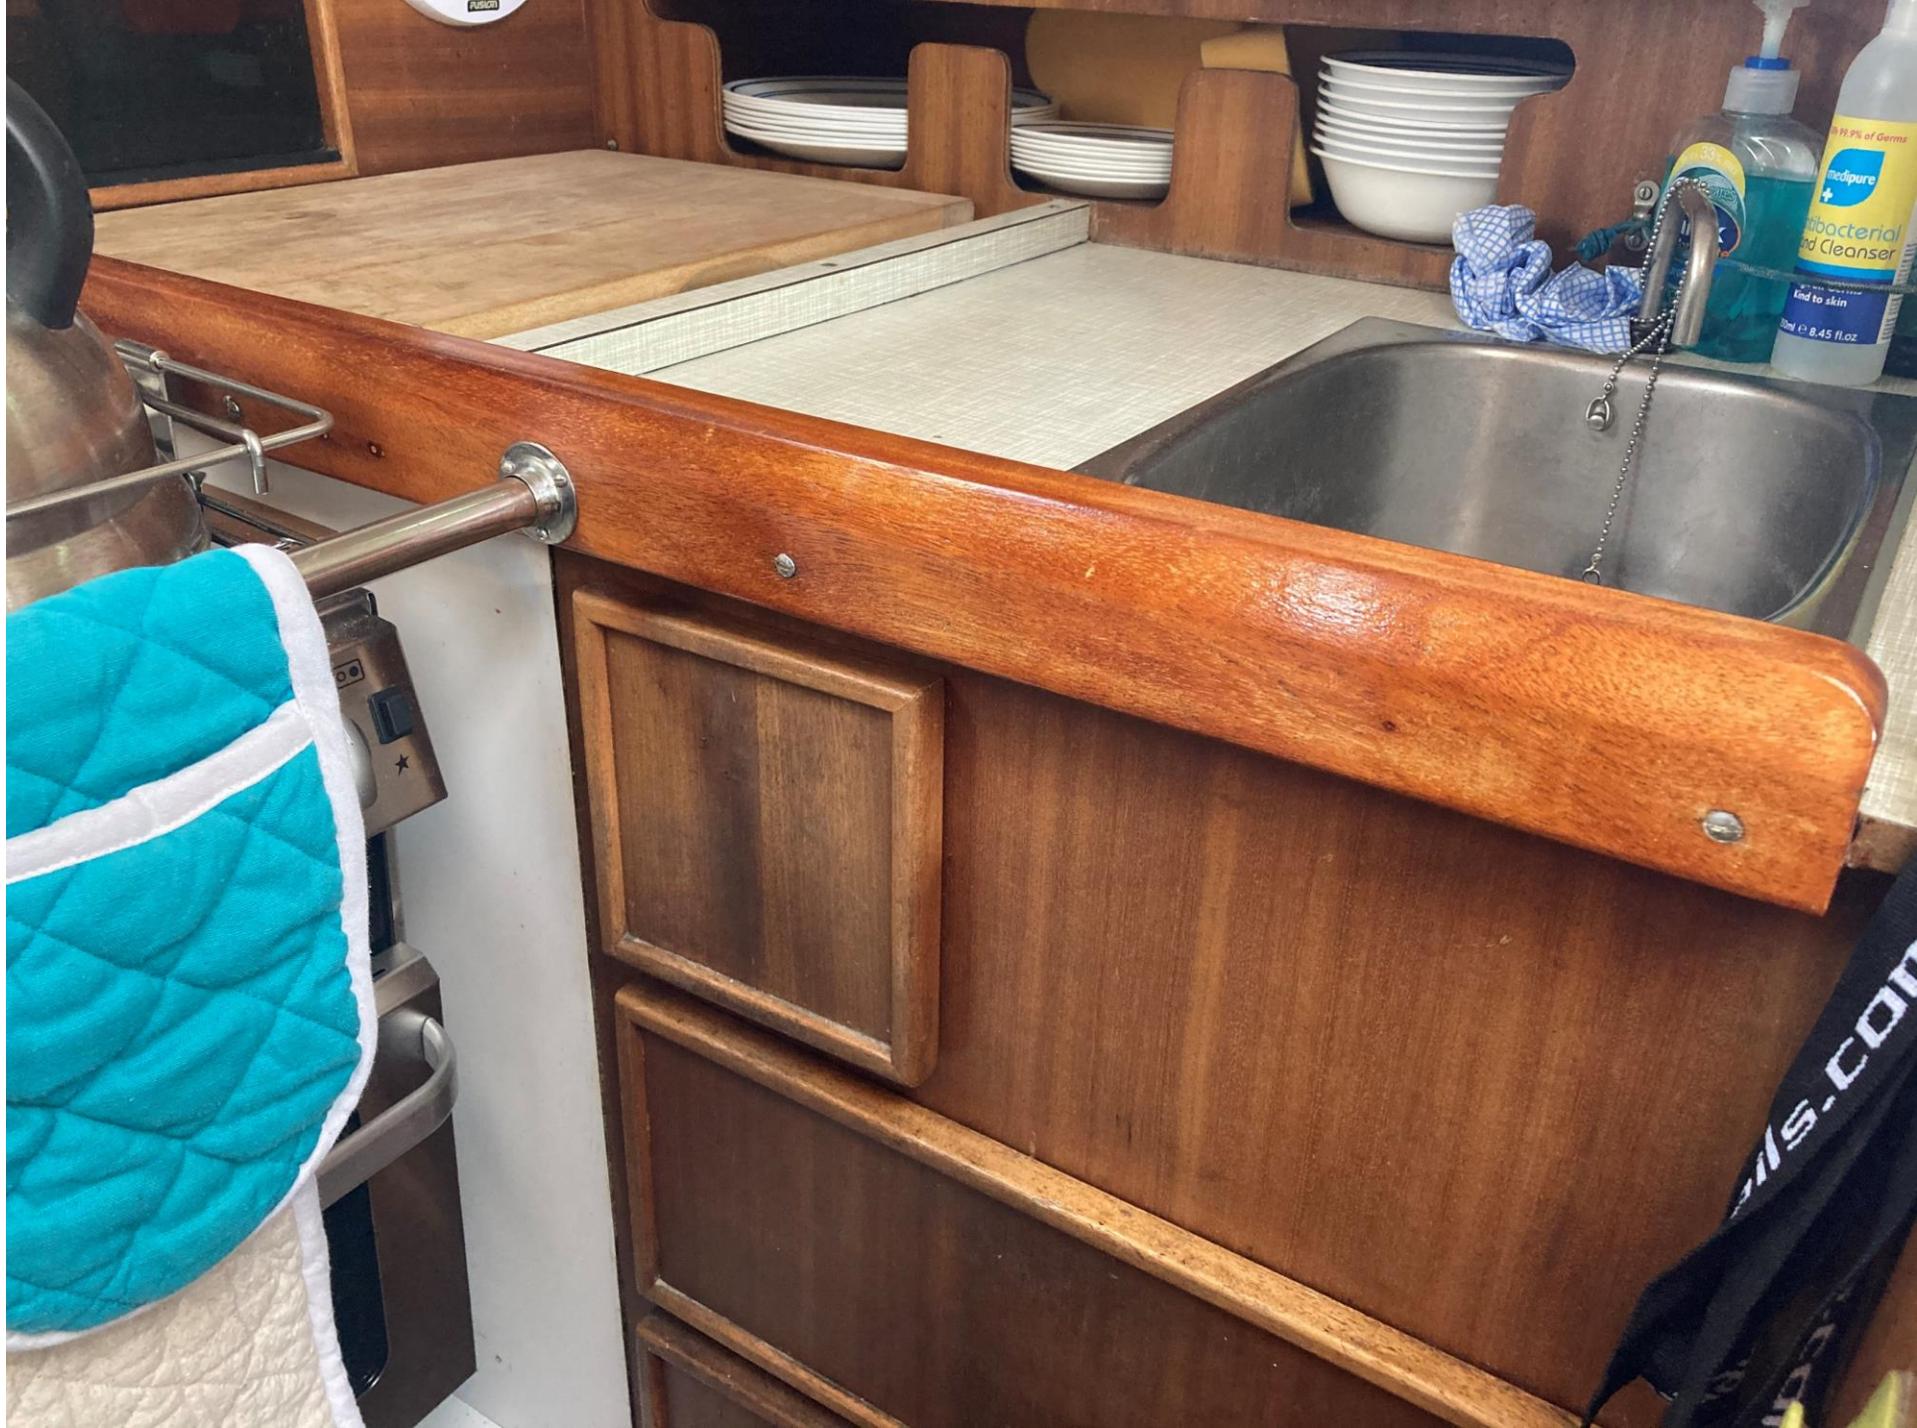
This fiddle shows how different the woodwork can change in colour. The pillar on the left will become the same colour.

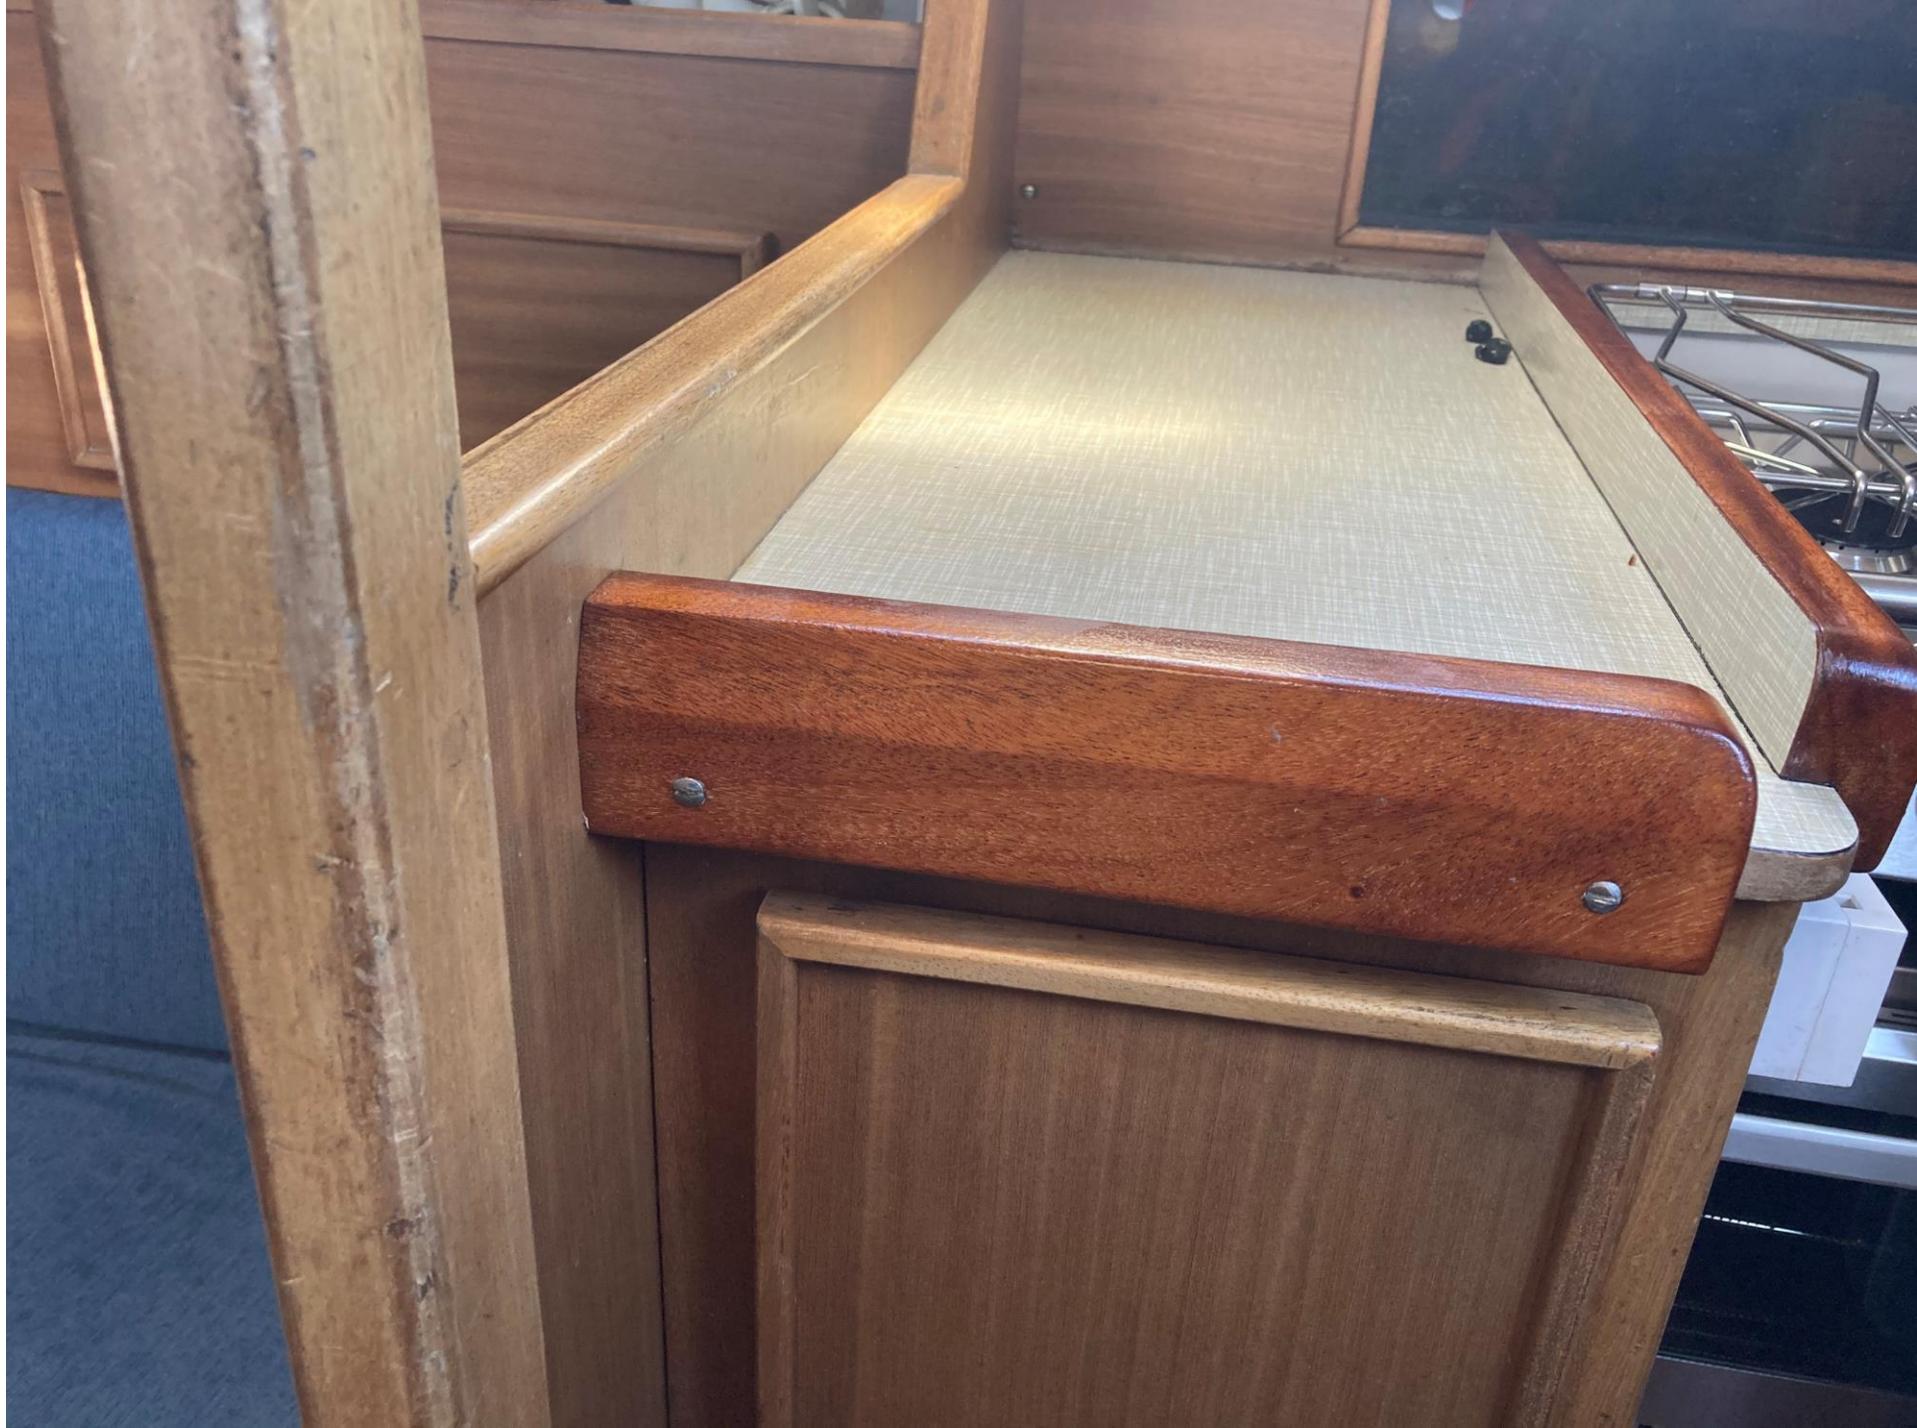
This is the port shelf in the forward cabin that has been relacquered. The colour of the plywood has been brought out by the lacquer.

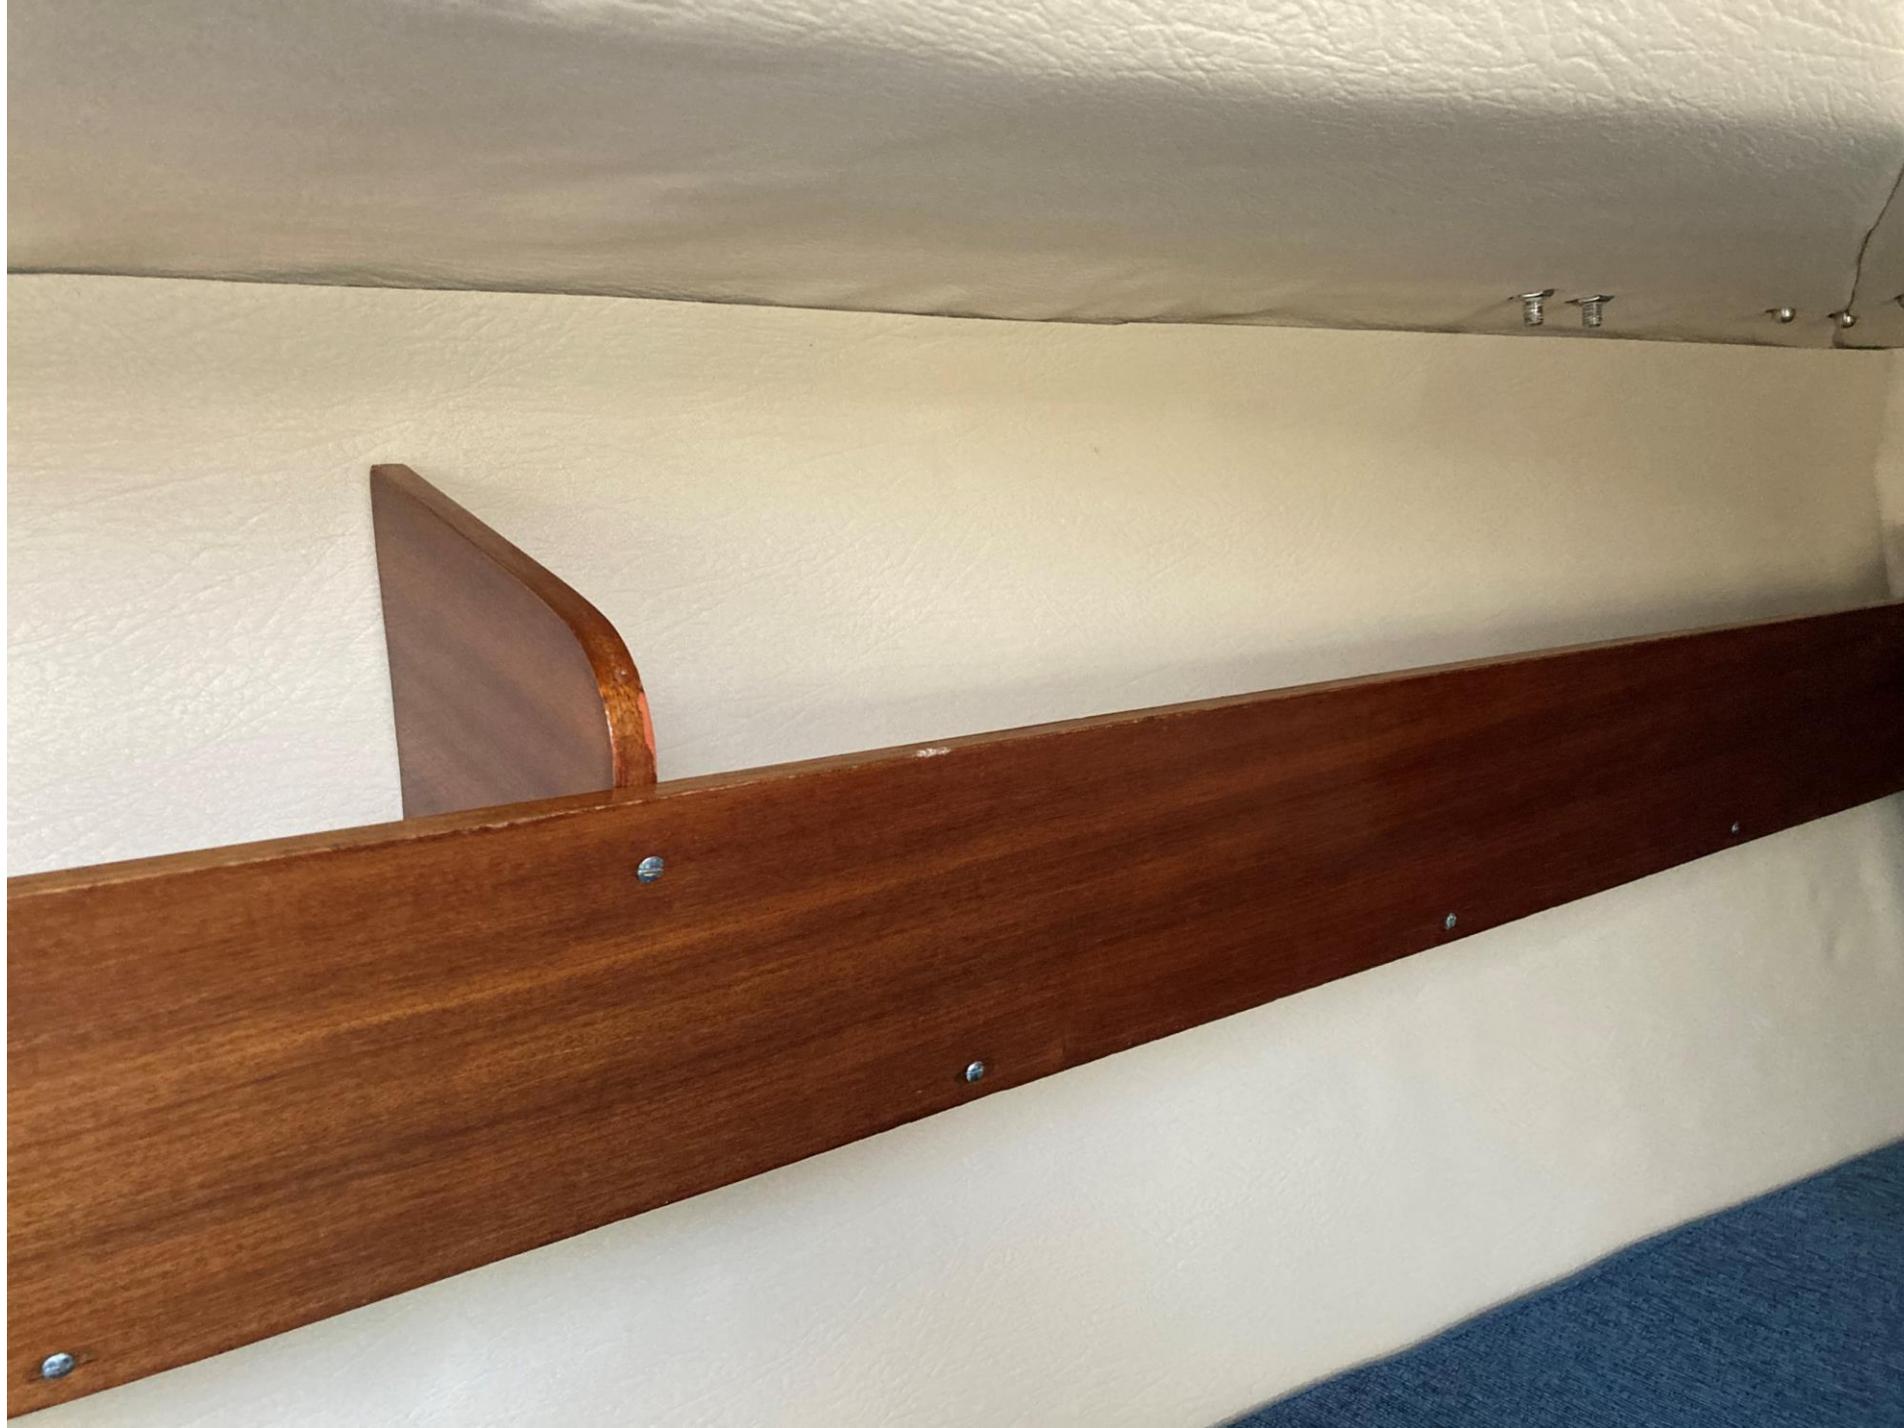
Westerly finished all the internal
woodwork except sole boards with
a lacquer, not varnish.

Supplied by Morrells and the
current description is

**450 Low Odour High Build Acid-
Catalyst Lacquer**
with a 30% sheen.

It can be sprayed or brushed and 3
coats is recommended.

5 litres is sufficient for a Fulmar.

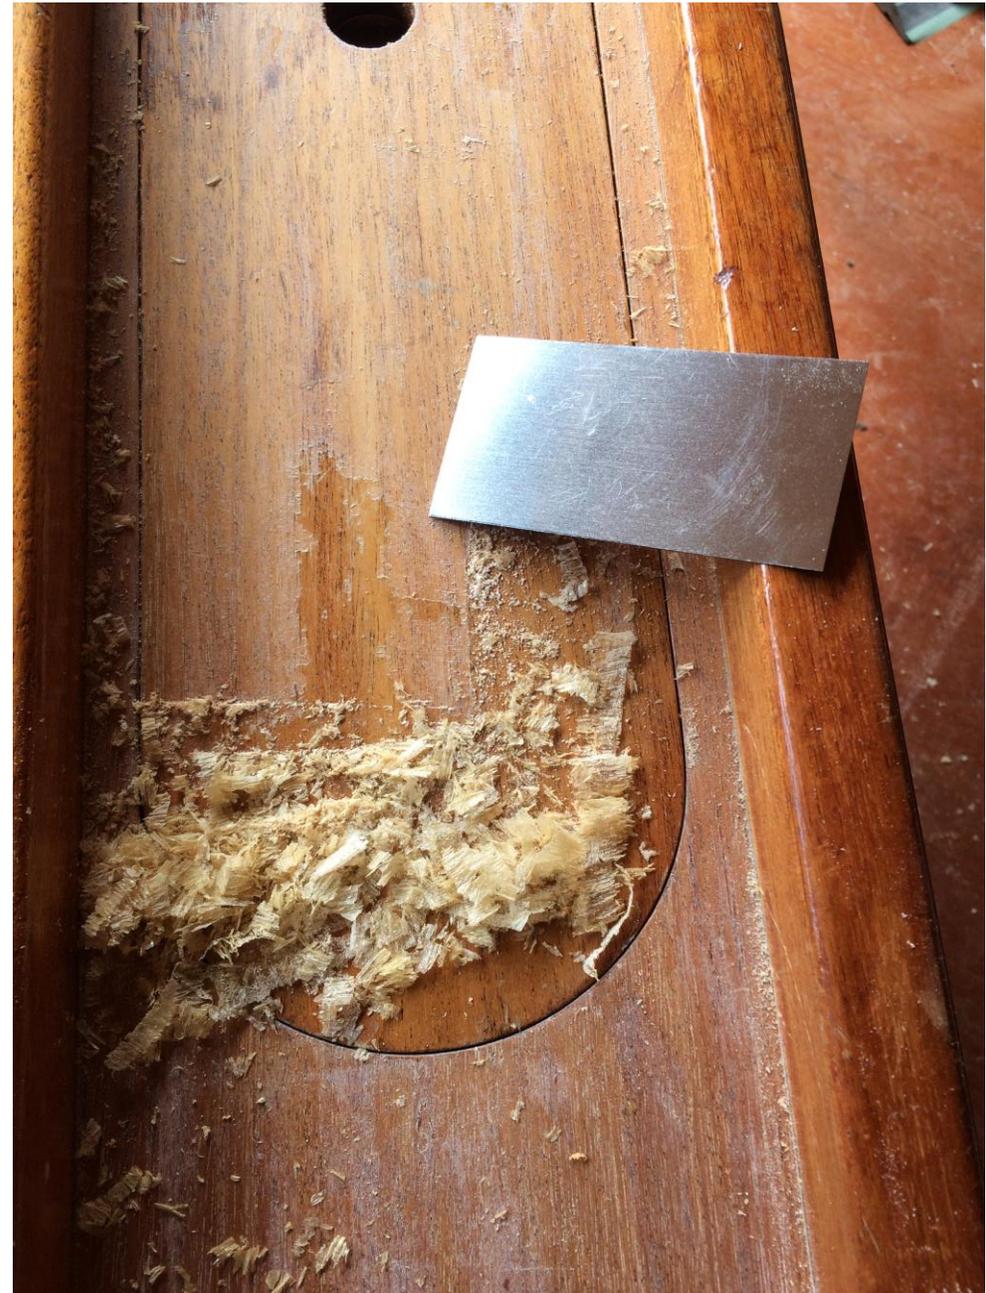
For a perfect finish, it is best to remove all existing finishes as a previous owner may have used varnish or a wax that will affect any new application.

For gentle removal, use a cabinet scraper. However, I prefer to sand carefully with an orbital to remove most of the finish and complete by hand. This photo shows the dust is yellow but will change to brown as you touch any veneer or solid wood.

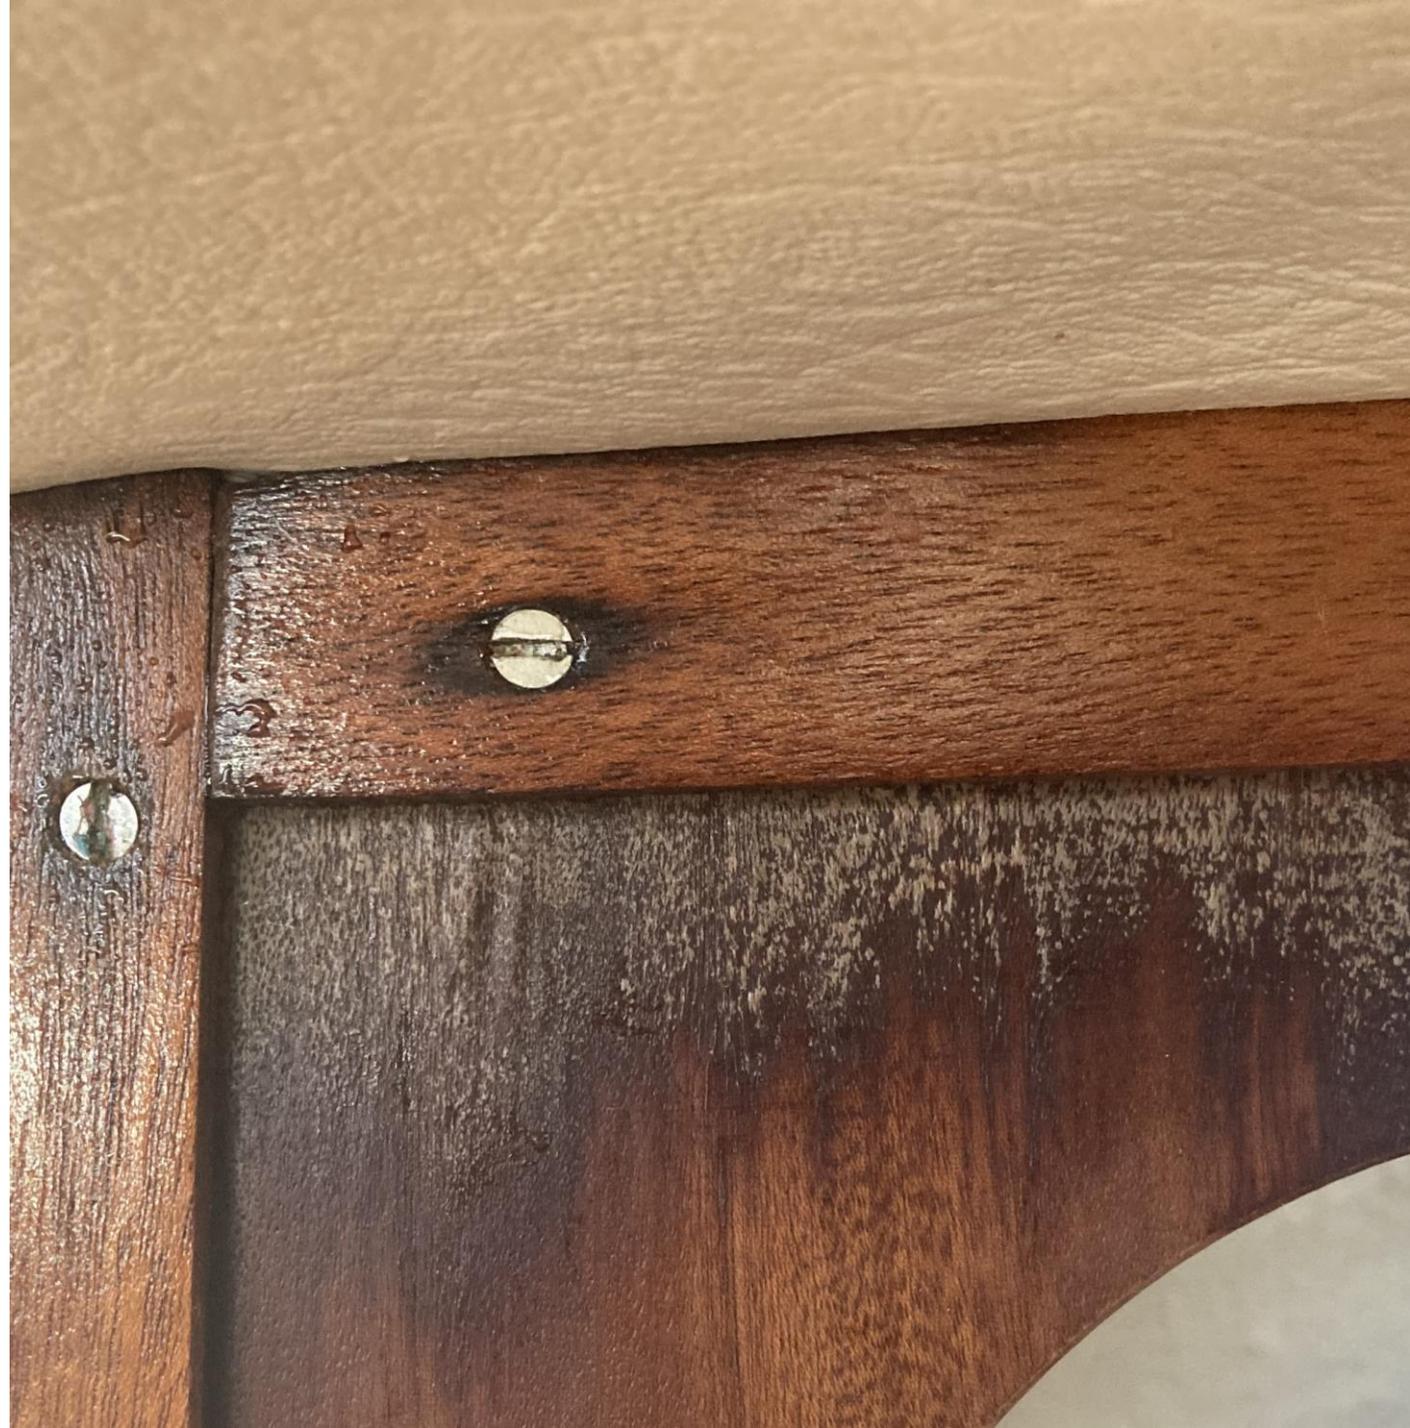
If there is any water damage to the woodwork like this, then it must be treated before lacquering.

The wood must be bleached to remove the dark staining.

Use cheap supermarket bleach diluted 1 part to 5 parts water. Brush on and cover with some polythene. Leave for about 20 minutes and wash off with water.

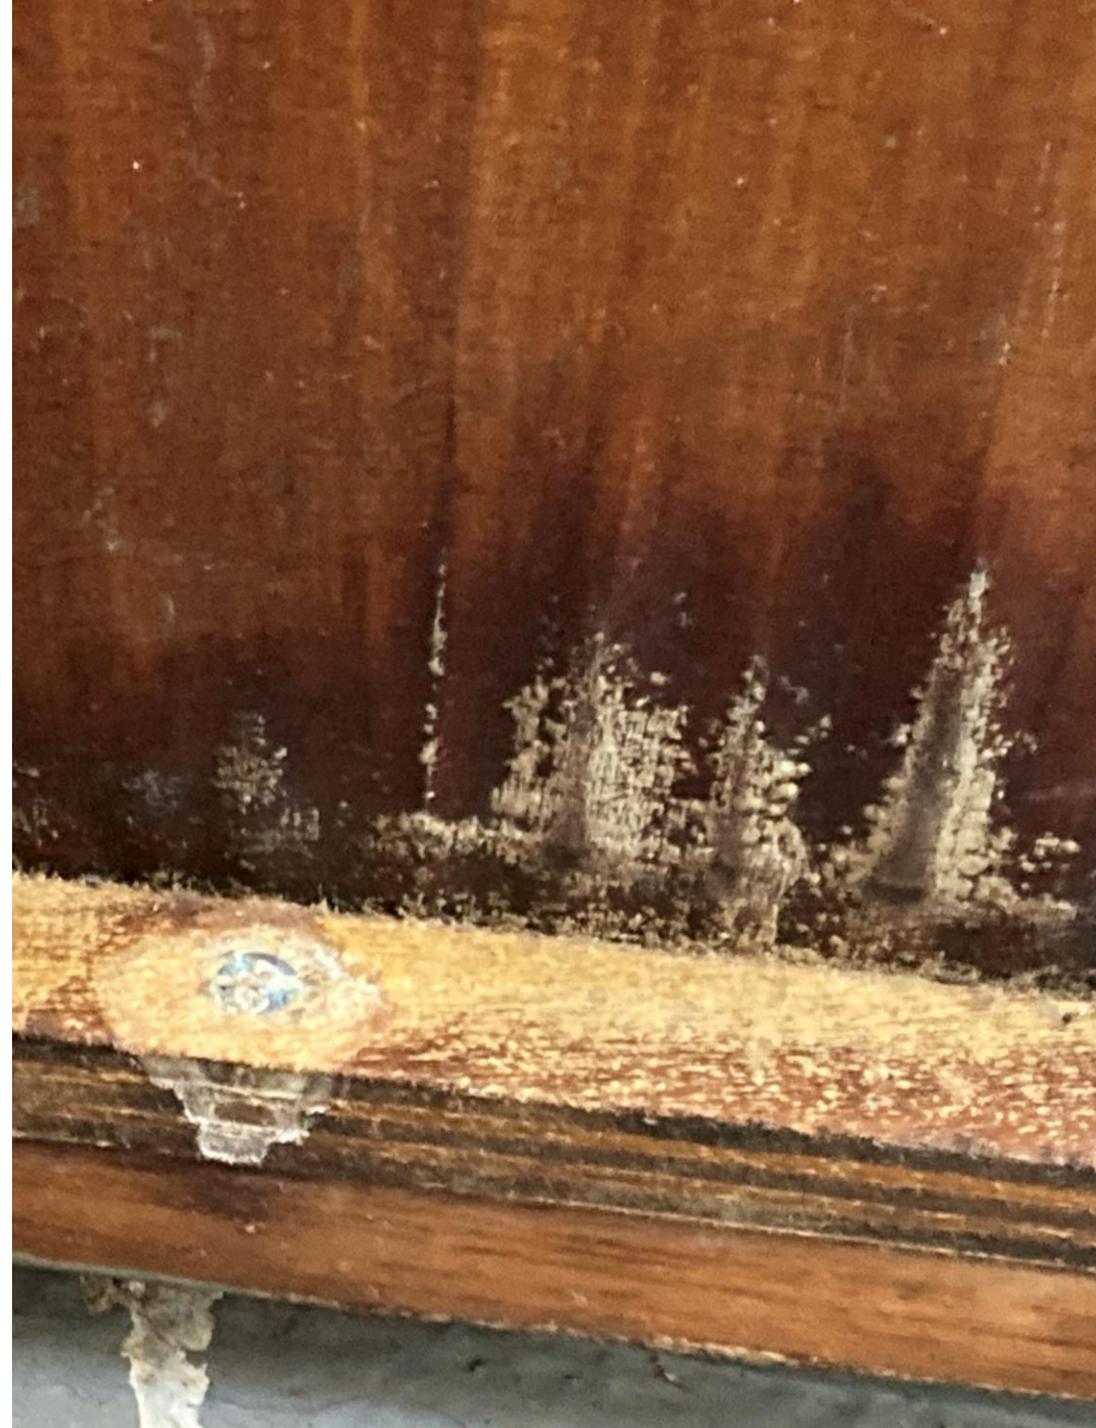
If an area has been subject to long term trapped moisture and lifted the veneer, this requires slightly different treatment. The veneer must be refixed before any treatment. My method is to dry the area. Then take a sharp knife to carefully split the lifted veneer along the grain. Now glue the veneer down with a waterproof wood glue. Make sure all excess glue is removed before covering with polythene and hold flat with a timber chock. Once dry treat as previous slide.

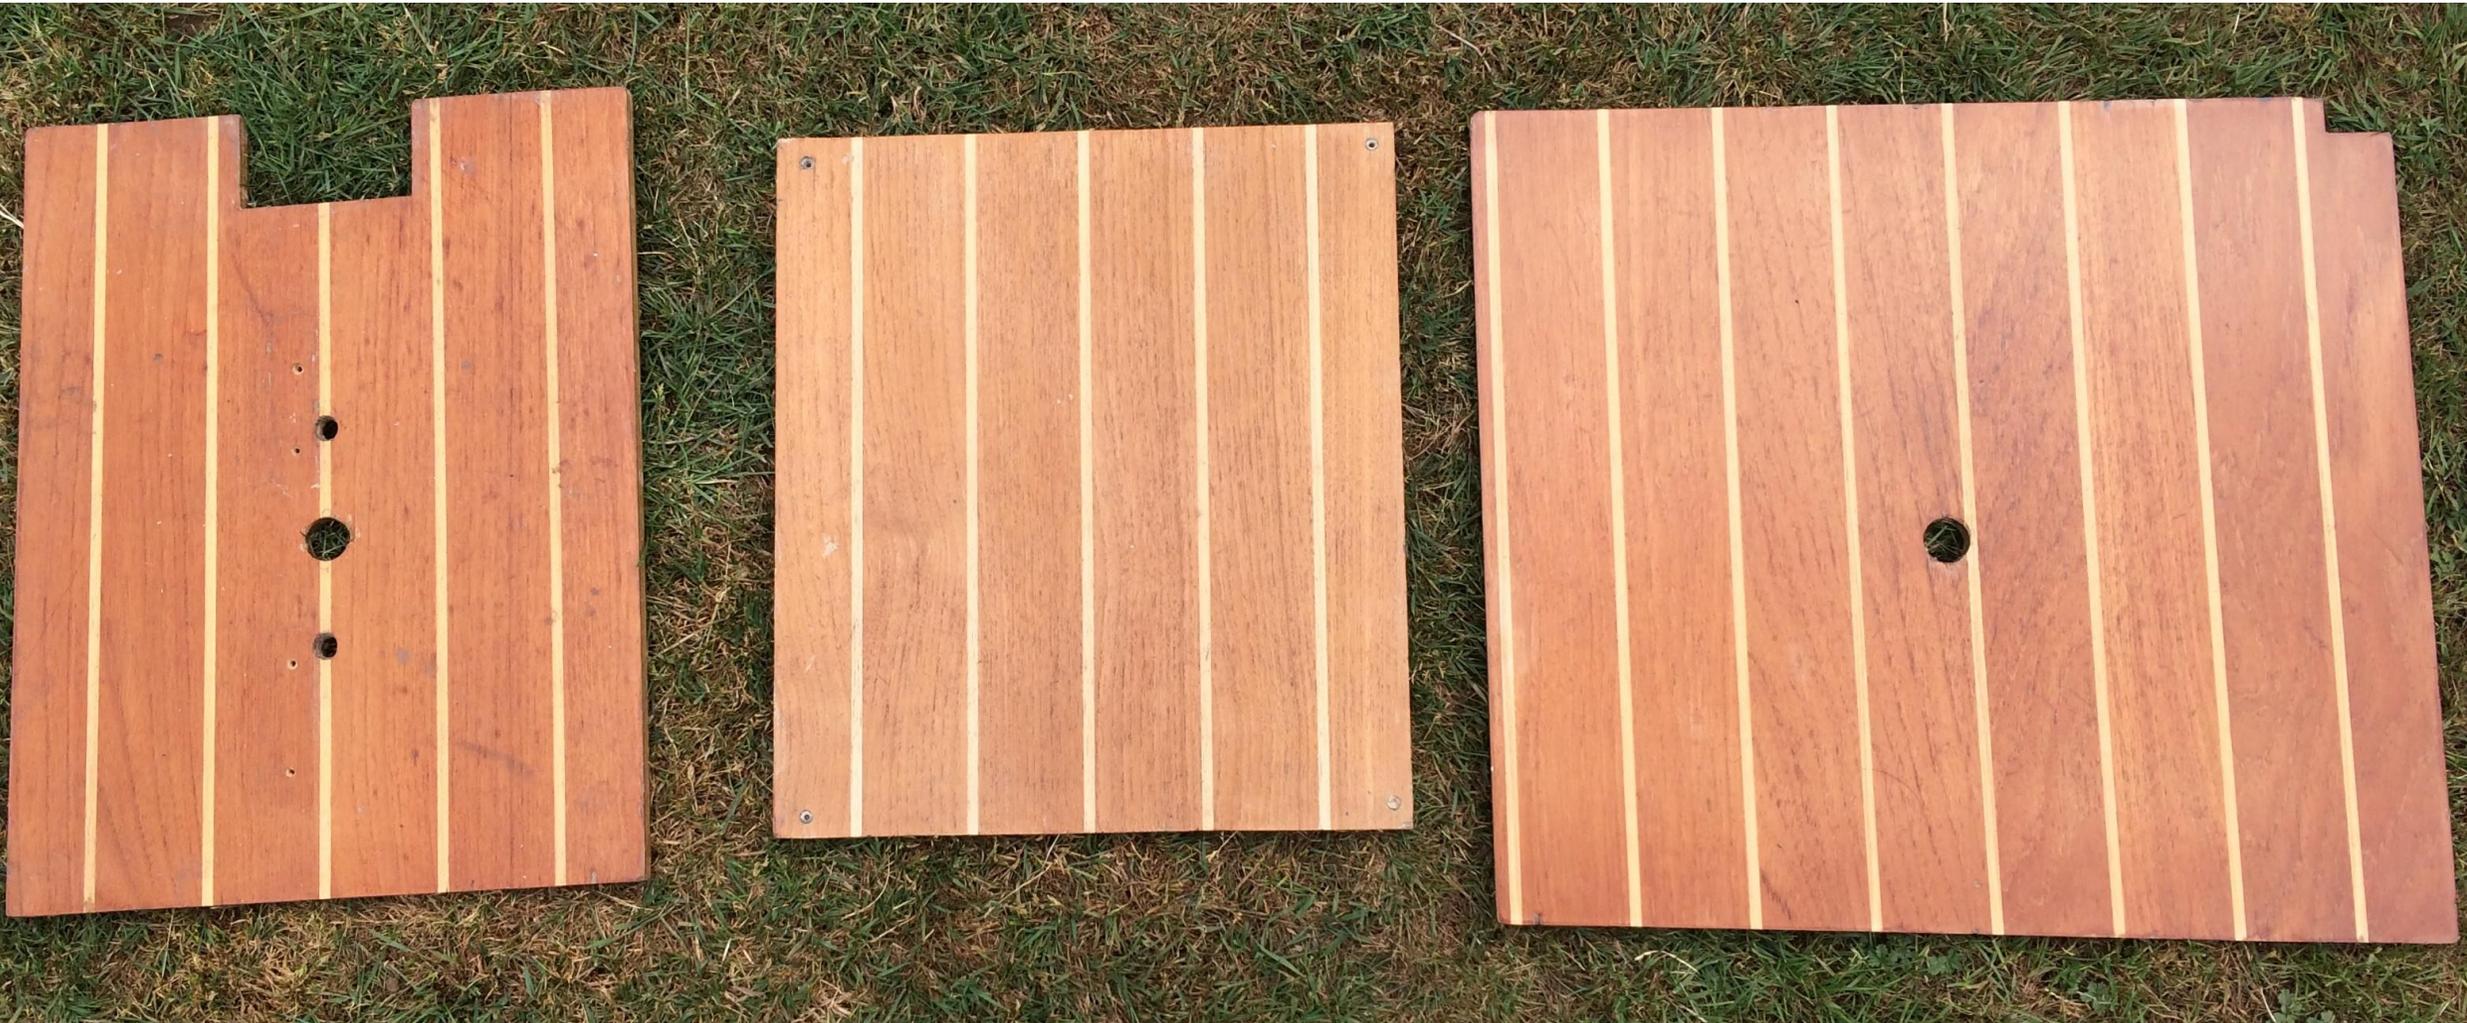
Three sections of teak and holly sole board. The left is scuffed and marked, the middle is sanded and the right is fully finished.

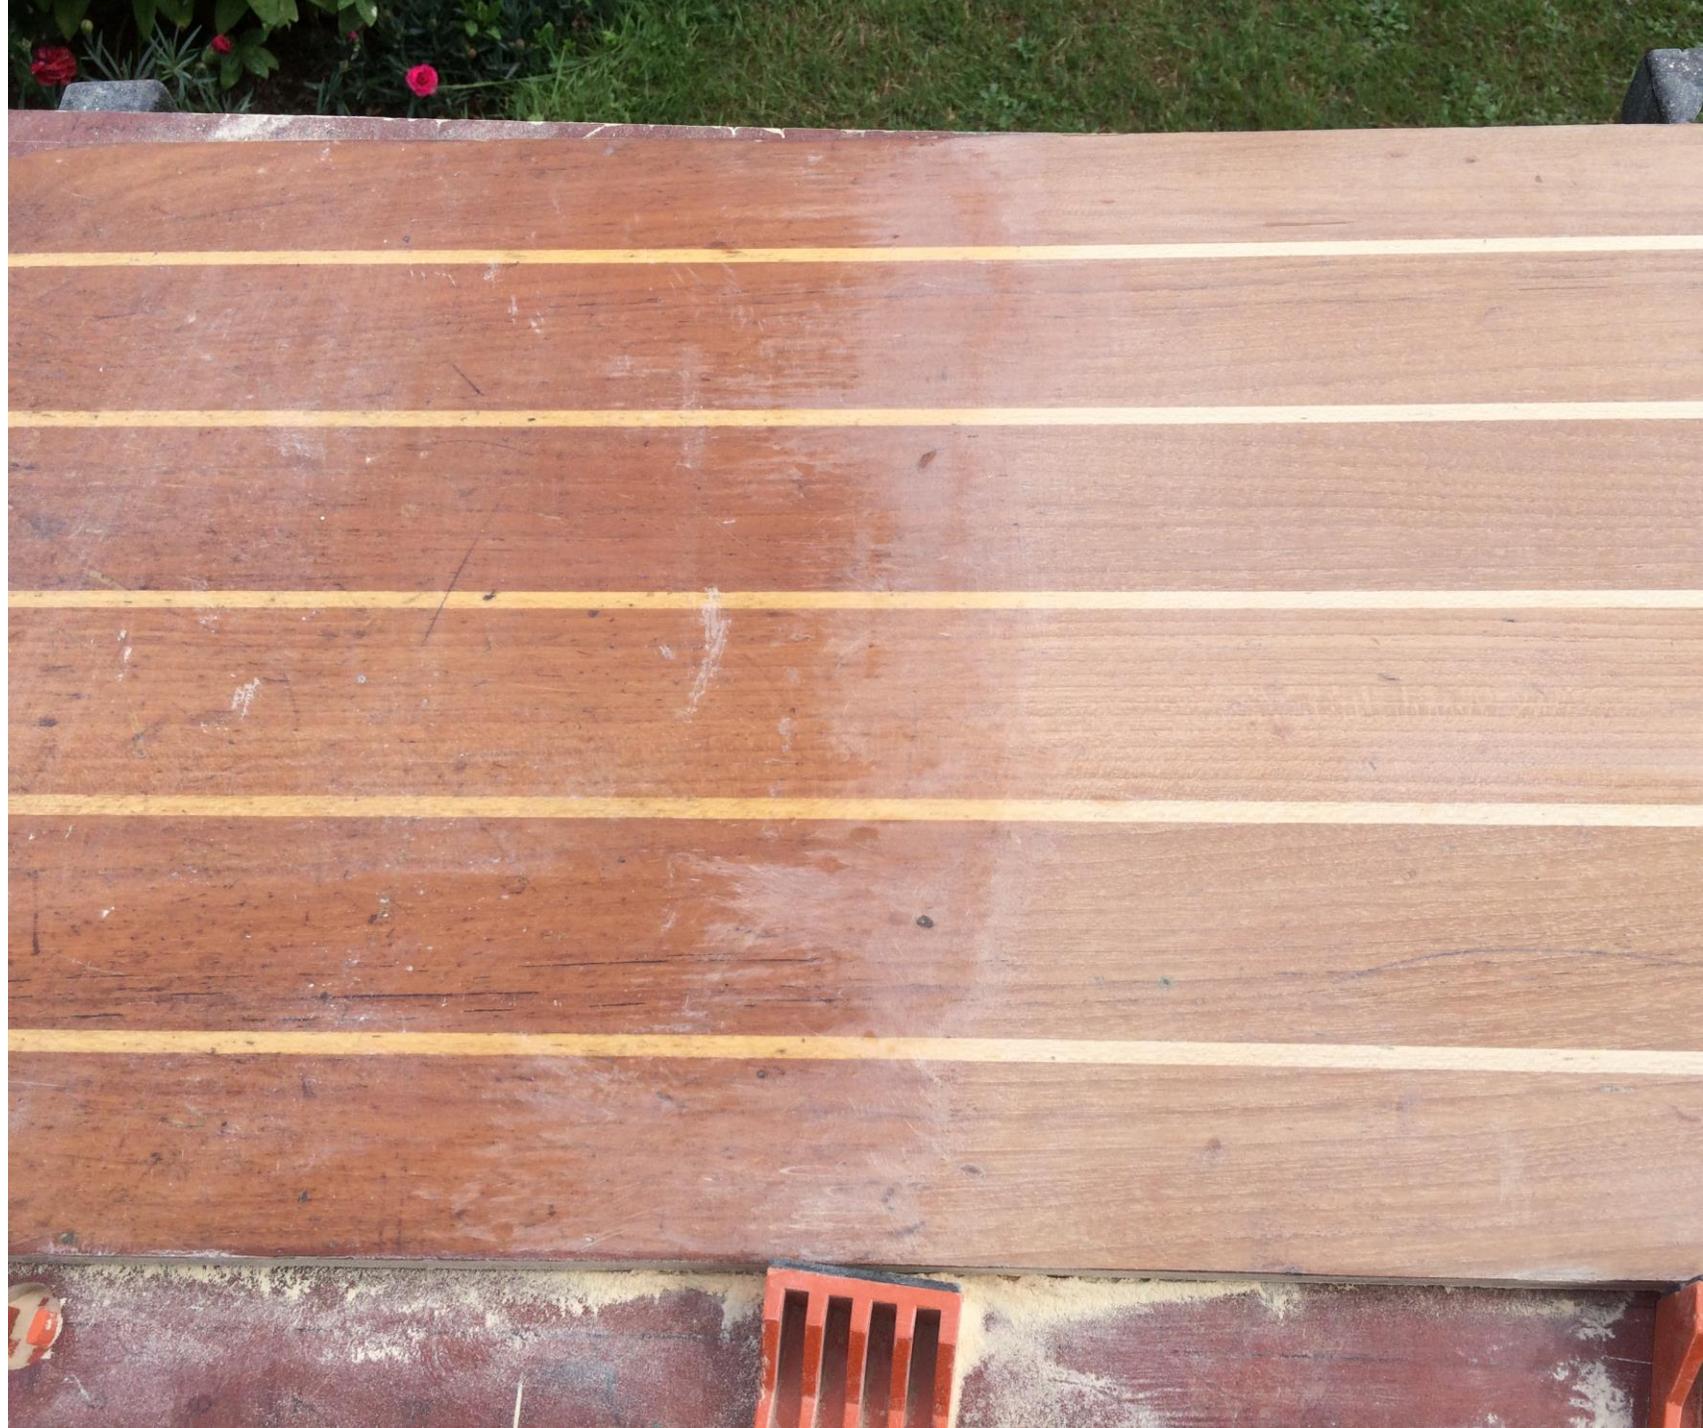
This shows the sanding in progress. There are still marks in the sanded portion that need individual preparation. For orbital sanding I use 180 grade at a slow speed.
