Woodwork Refinishing

Fulmar Concerto FR38

Westerly Owners Association

Zoom Clinic 24 February 2021

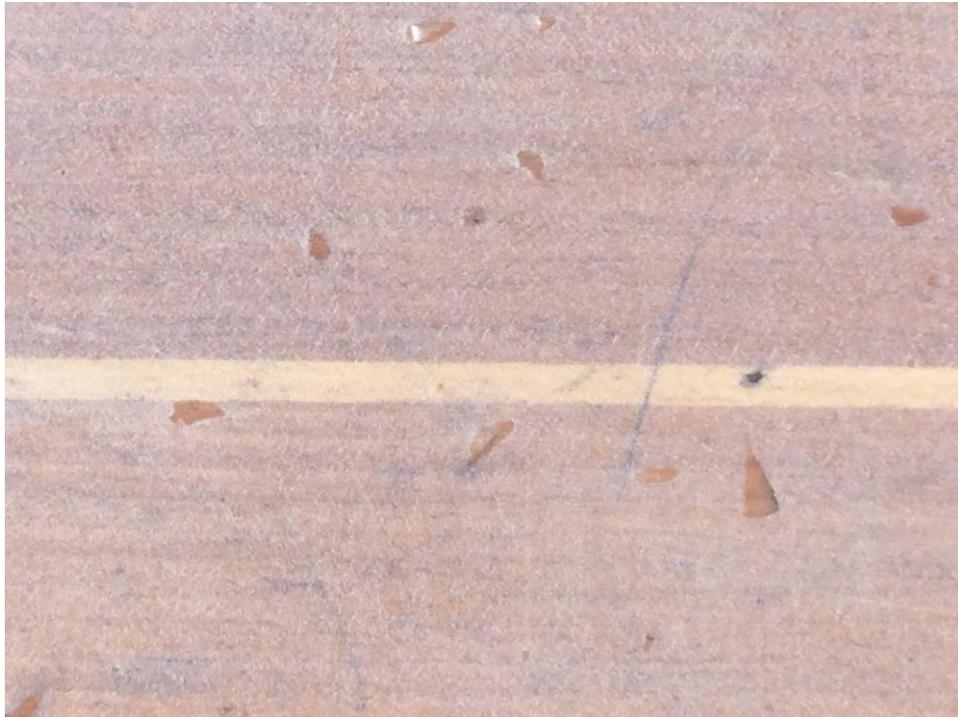
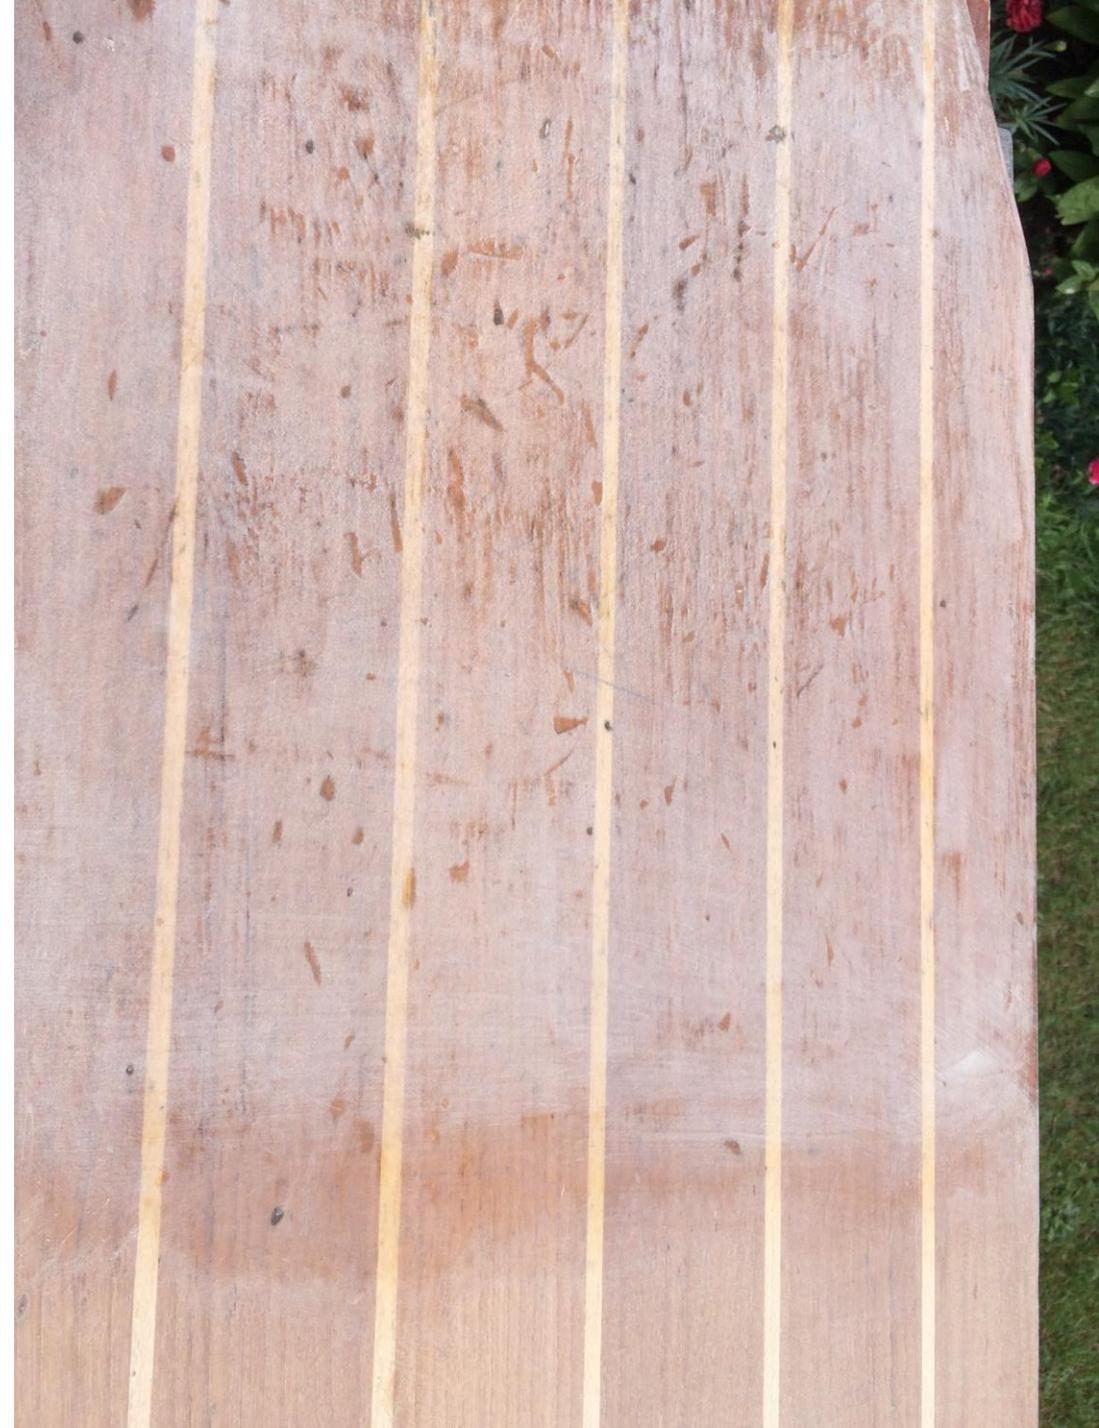
The sanding clearly shows how dented the sole boards can get. Notice along the sanding edge how the colour of the finish changes colour, this is very helpful to see how much finish has been removed.

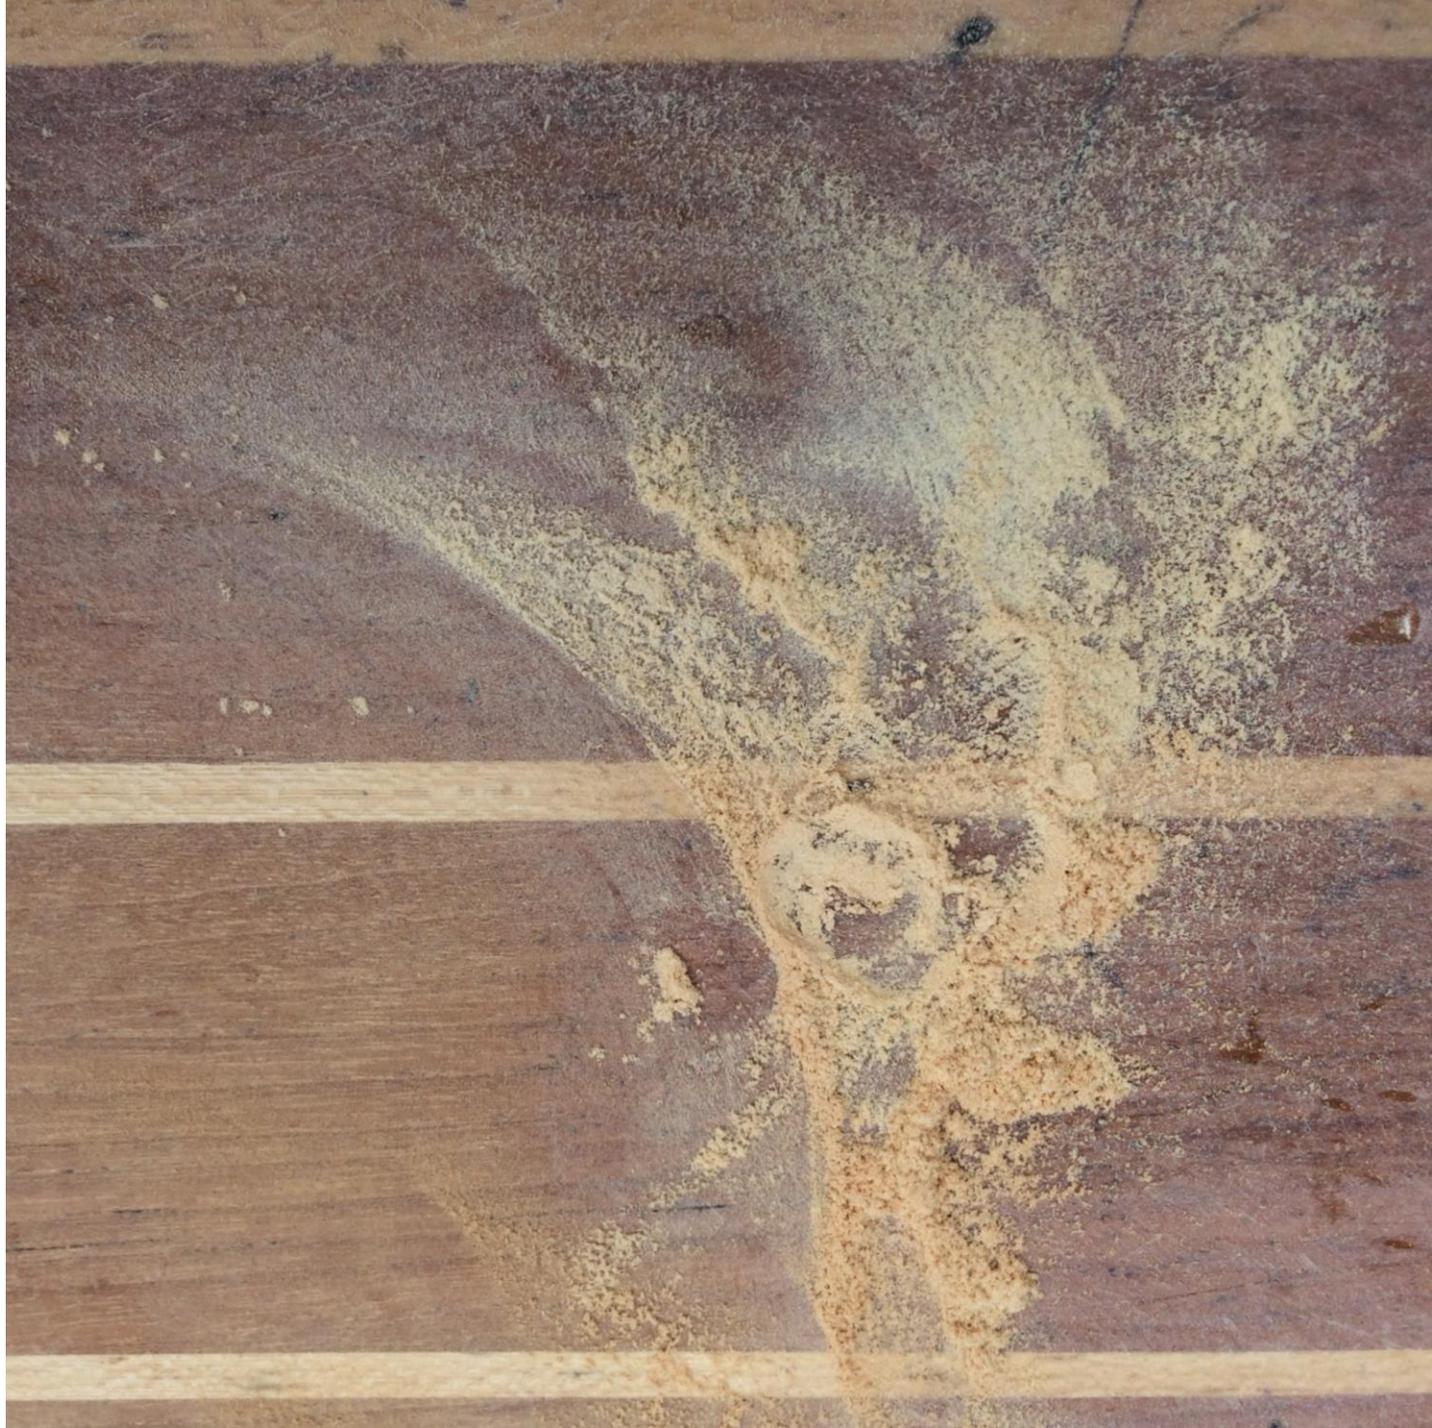
The colour of the dust changes from a light yellow at the top to slightly brown at the bottom. So the surface in the left corner will only need hand sanding along the grain.

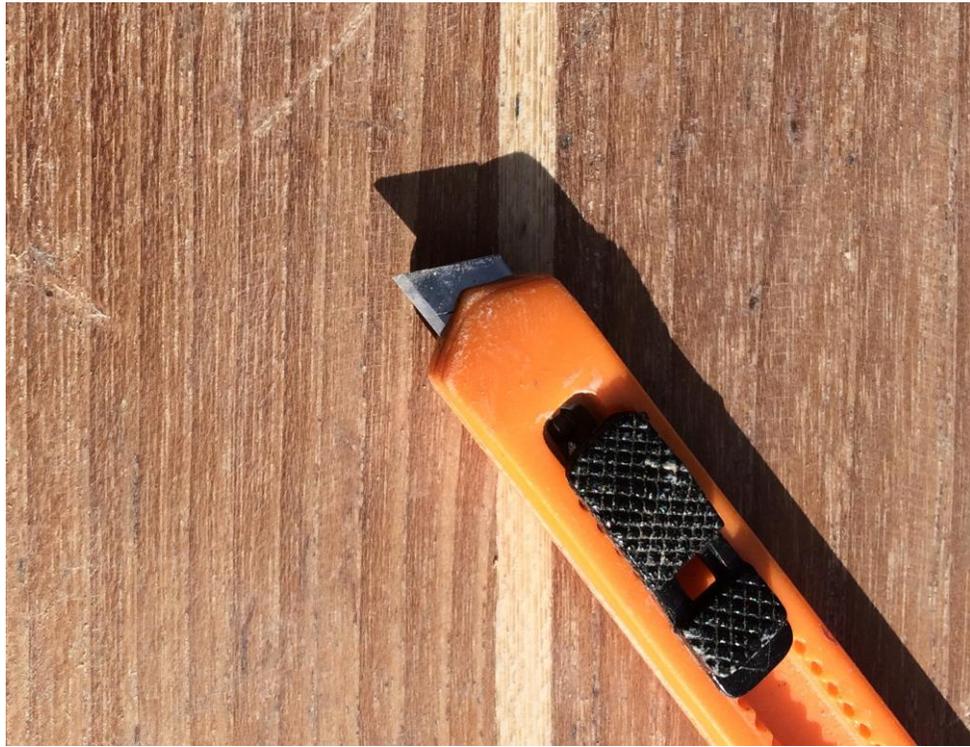
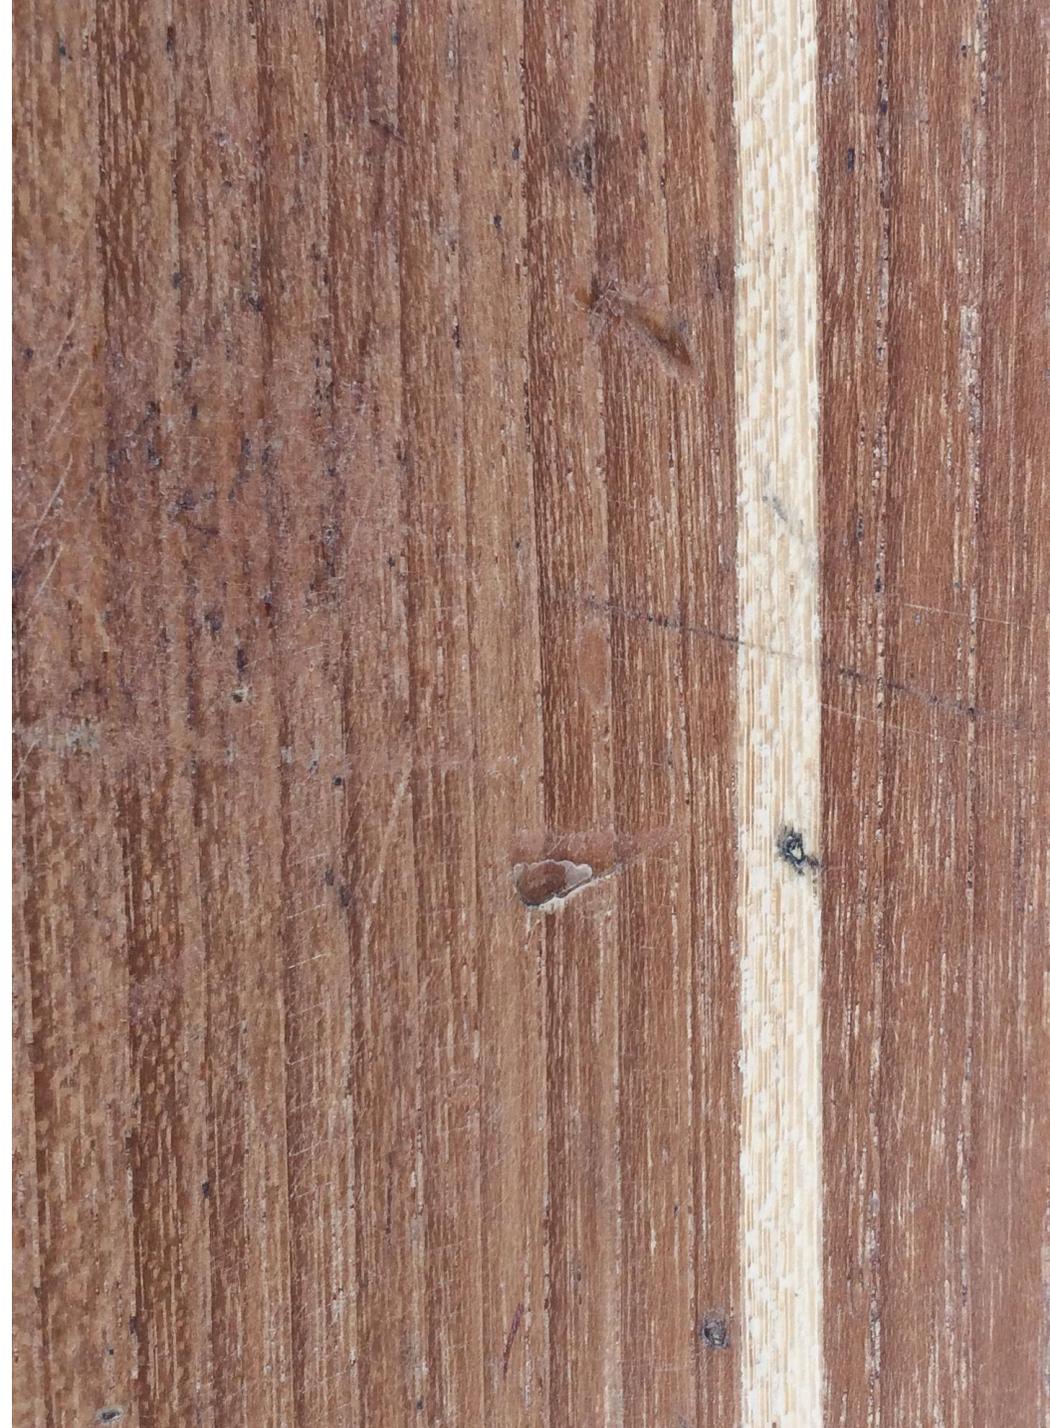
All of these marks can be cleaned up.
My favourite tool is a snap off knife,
but using the rough broken edge of
the blade not the ground sharp edge.
You can scrape flat areas, dips or to
scrape old finish out of dents.

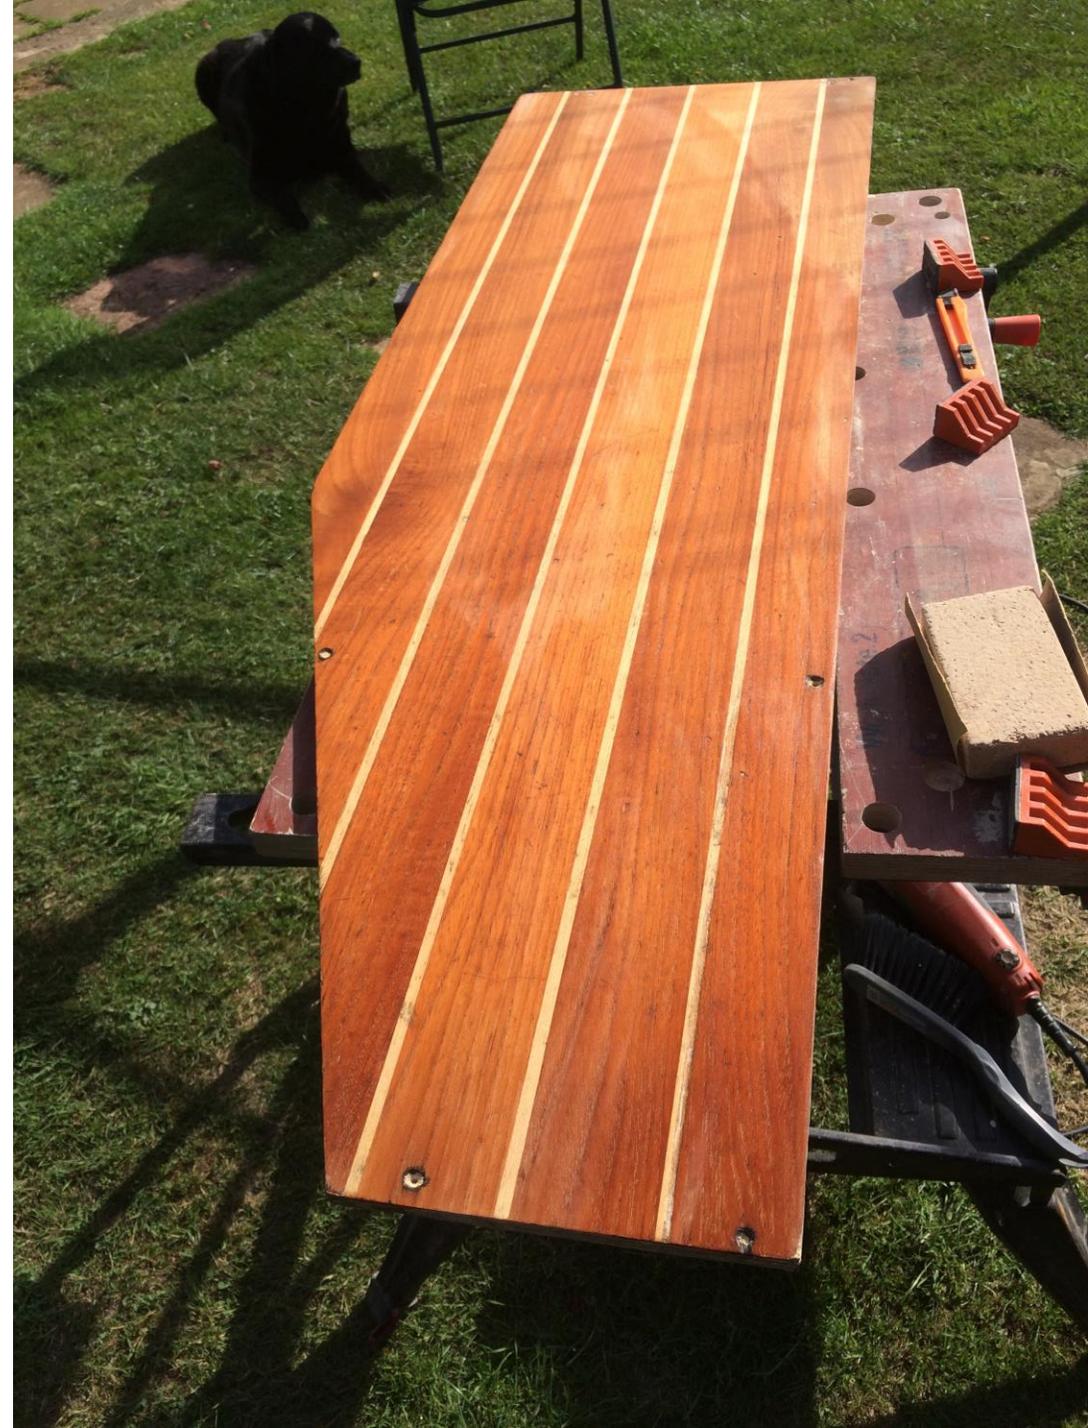
Once the panel has been hand sanded with 180 grade along the grain, wipe it down with a wet J cloth. If any existing finish is present, the moisture does not soak into the wood. If so, leave to dry and sand some more.

A tip from a furniture restorer to remove oil stains. Clean any finish off and then pour some methylated spirits on and set light to it. The wood will not burn, but the oils are pulled out of the wood. It may need to be repeated.

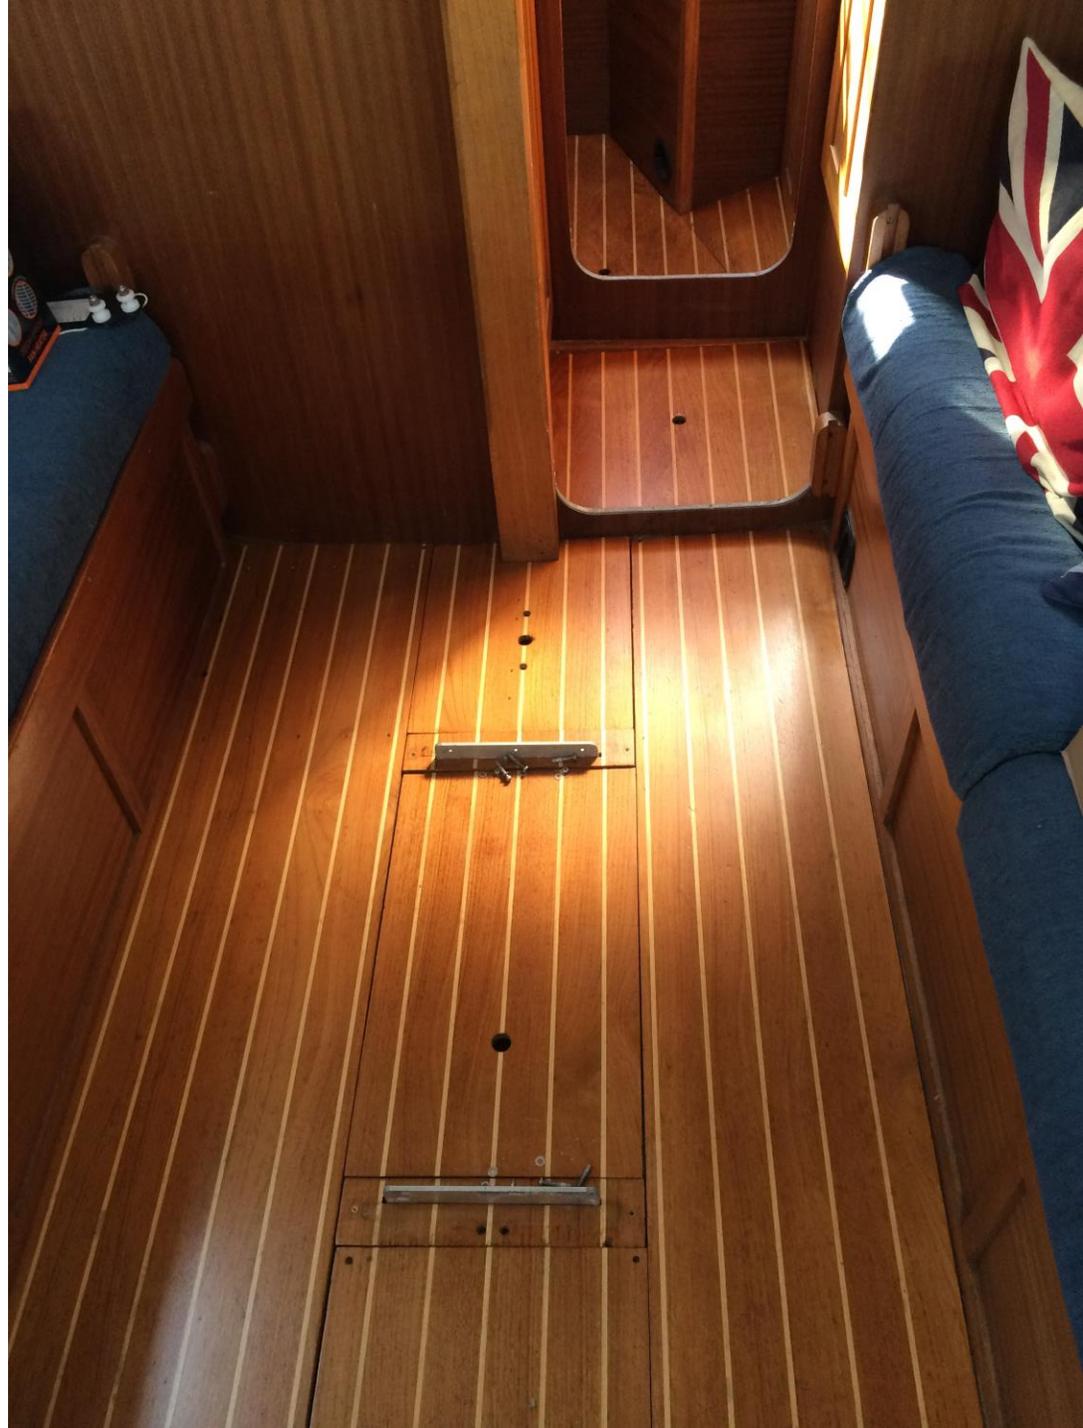
The sole boards were finished with Morrells 8SM/284B induro[®] XL1 in 30% semi-matt floor lacquer. This is a water based lacquer designed for high traffic areas and sports floors. This has been brushed on with 3 coats. These sole boards are 40 years old and look almost like new.

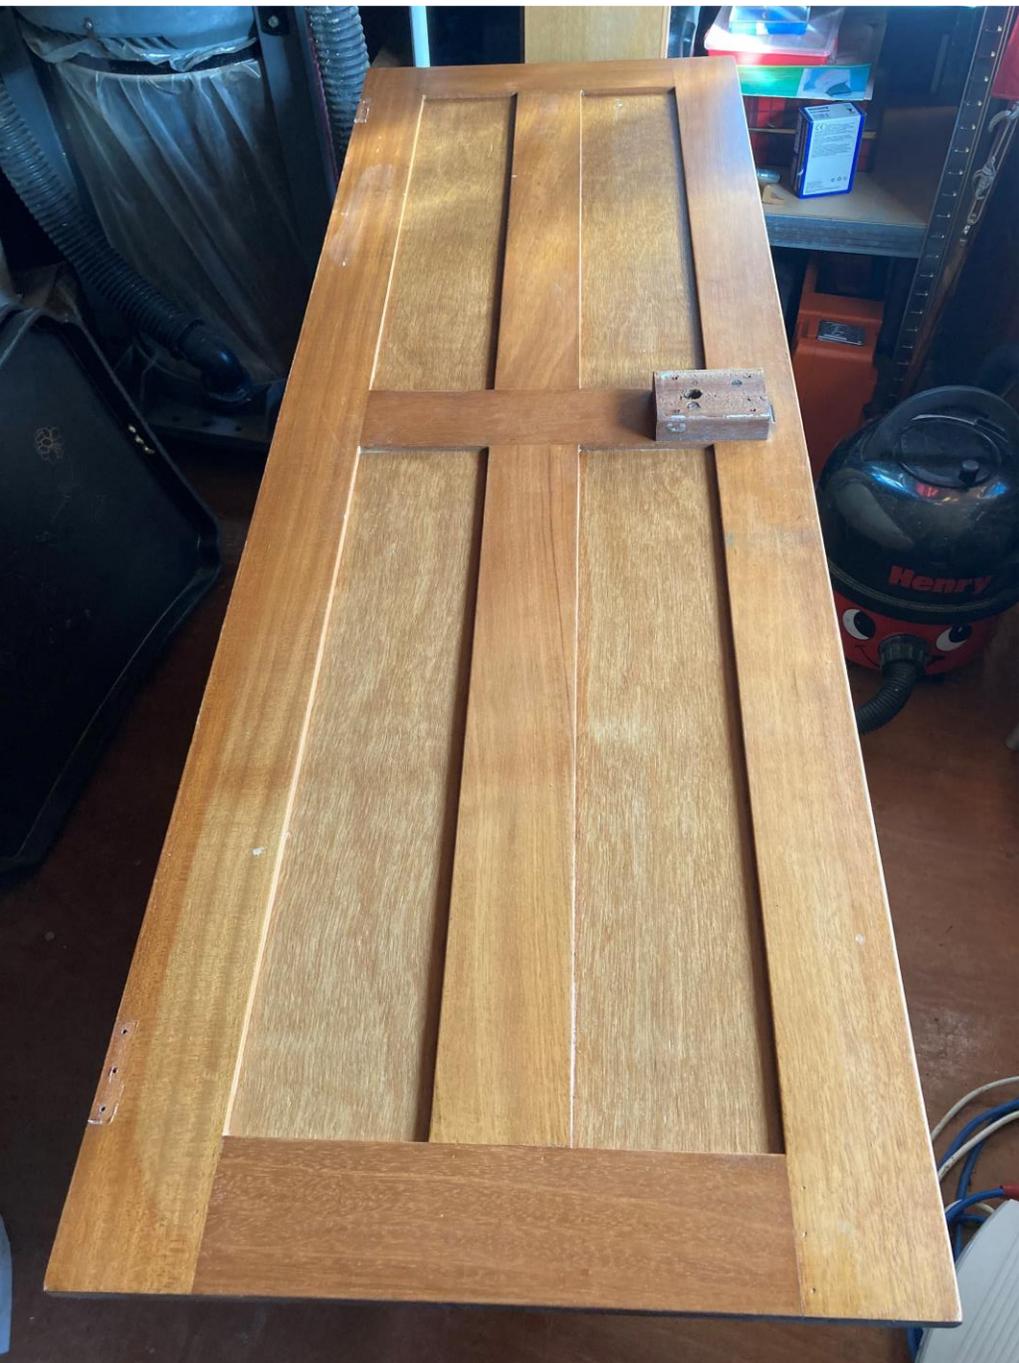
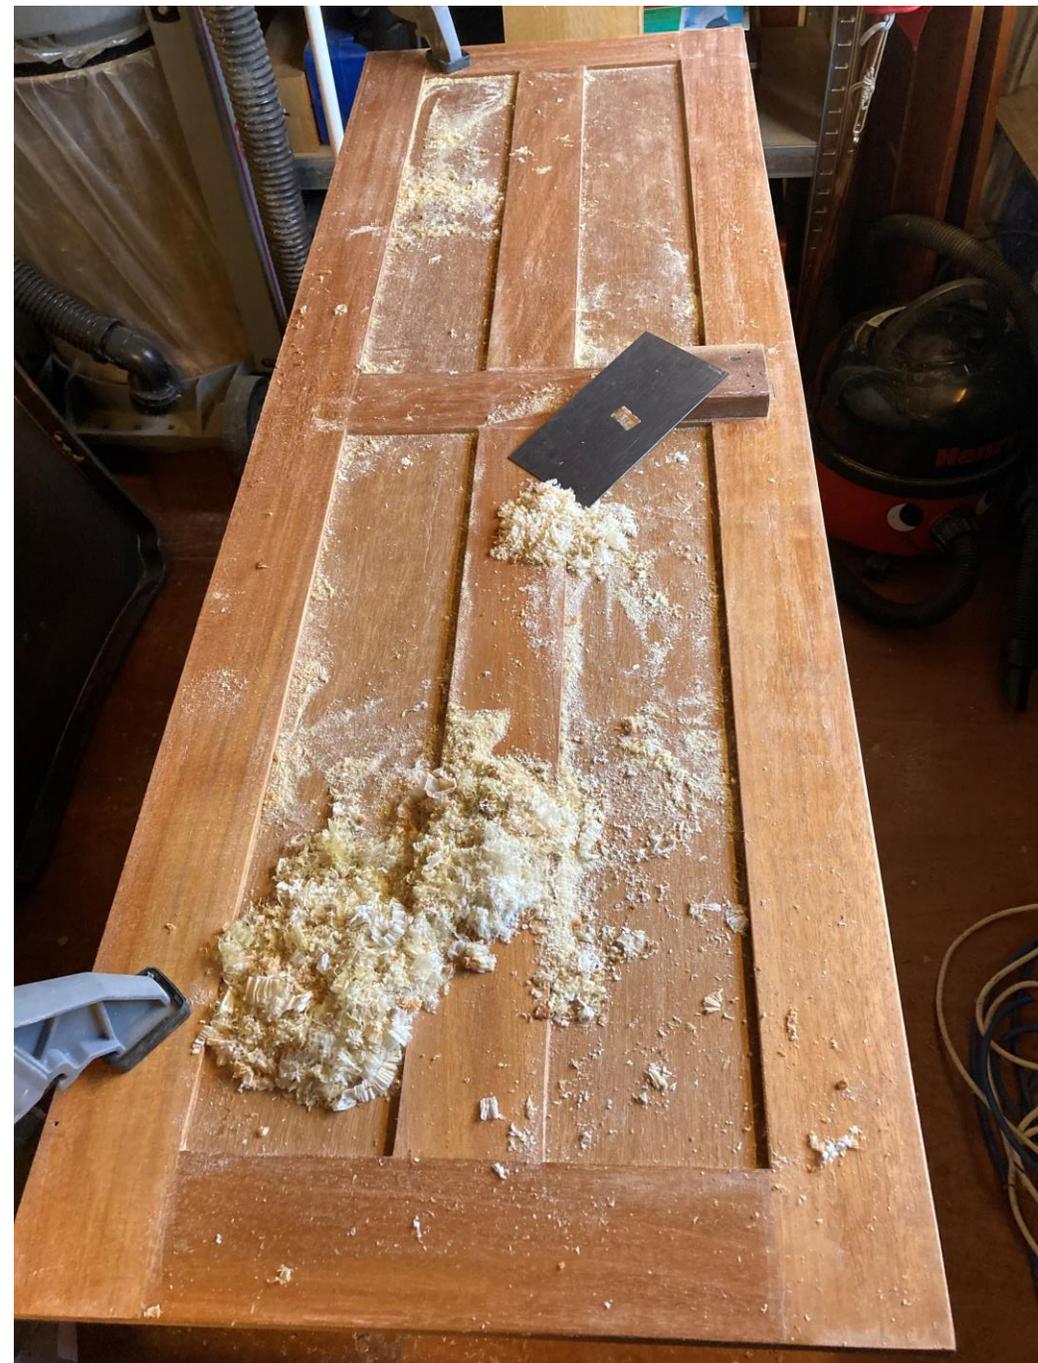
This panel door shows the change in colour by removing the old lacquer using a cabinet scraper.

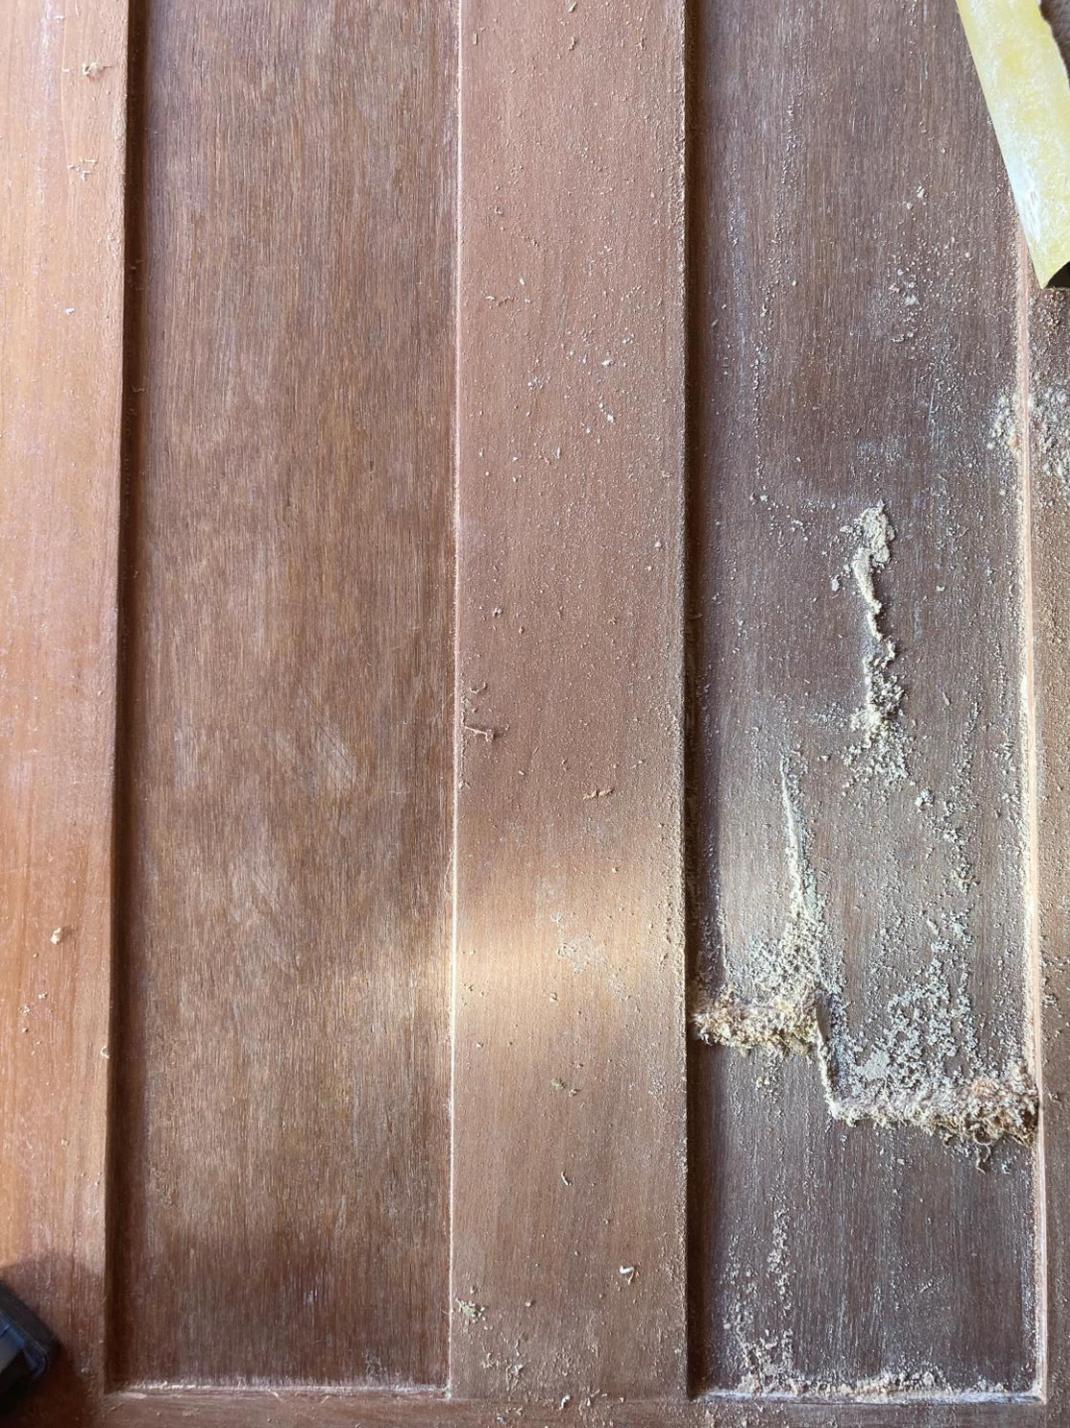
The left side has been cabinet scrapped, but I noticed some residual bits of lacquer. The right side shows it being hand sanded with 120 grade sandpaper.

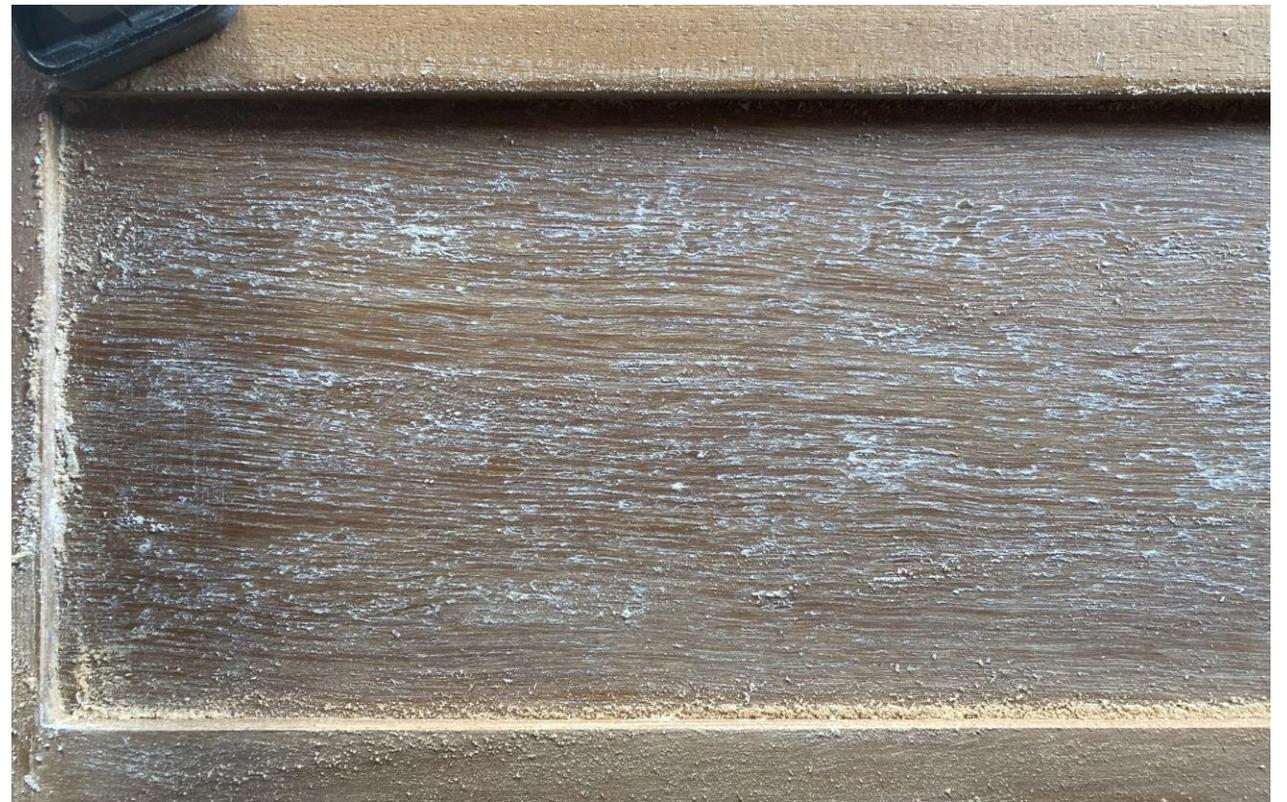
The photo below shows the patches of rubbed lacquer as white during sanding.

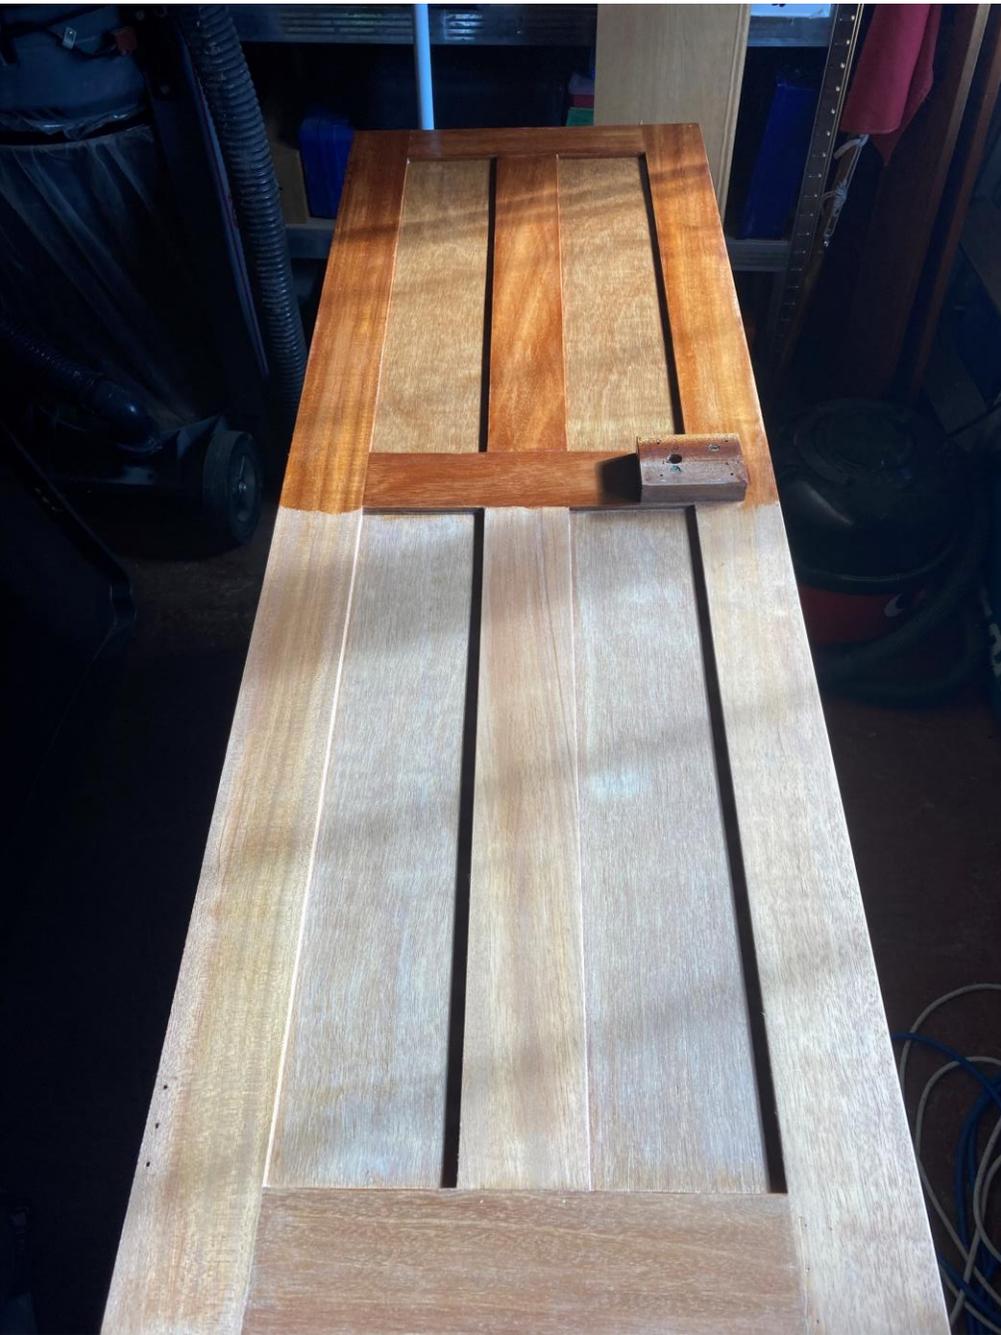
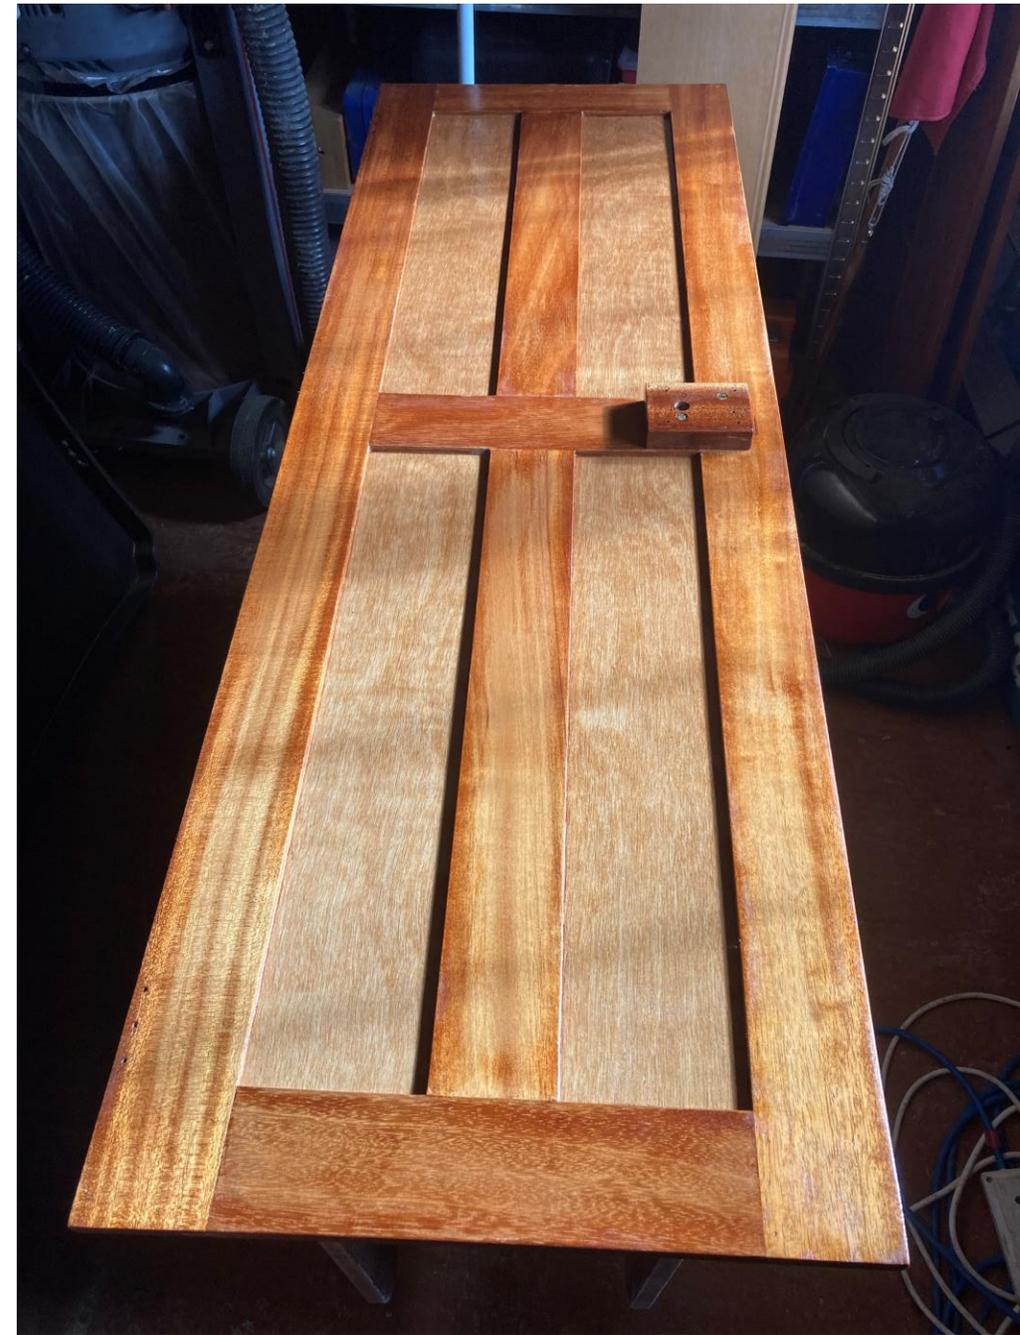
The first coat of lacquer is being applied. It is mixed at 9 parts to 1 of catalyst. It is touch dry in 30 minutes, and recoatable after 2 hours. So, 3 or 4 coats can be applied in a day.

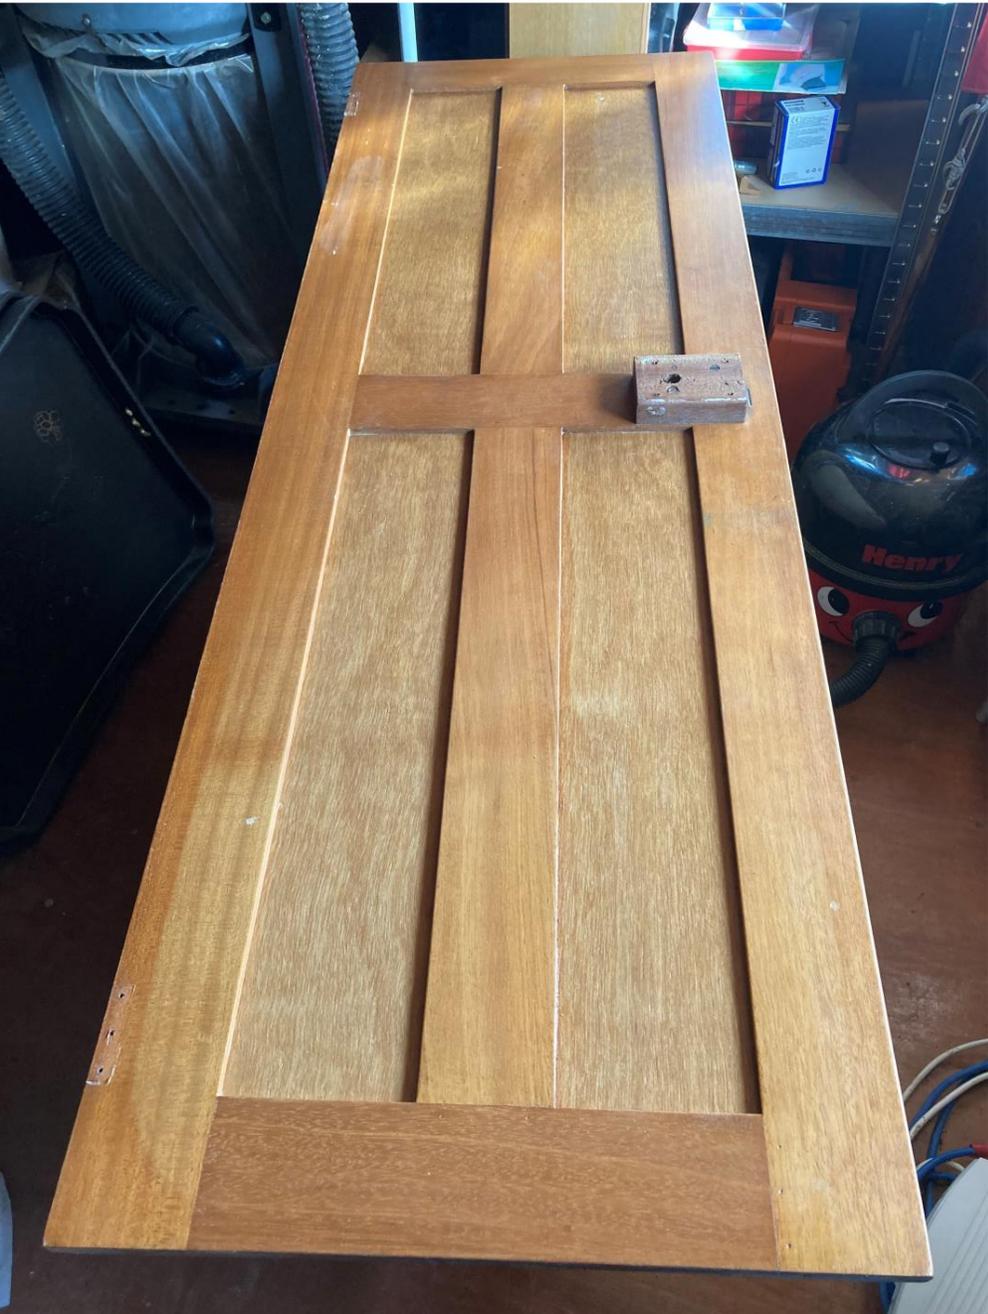
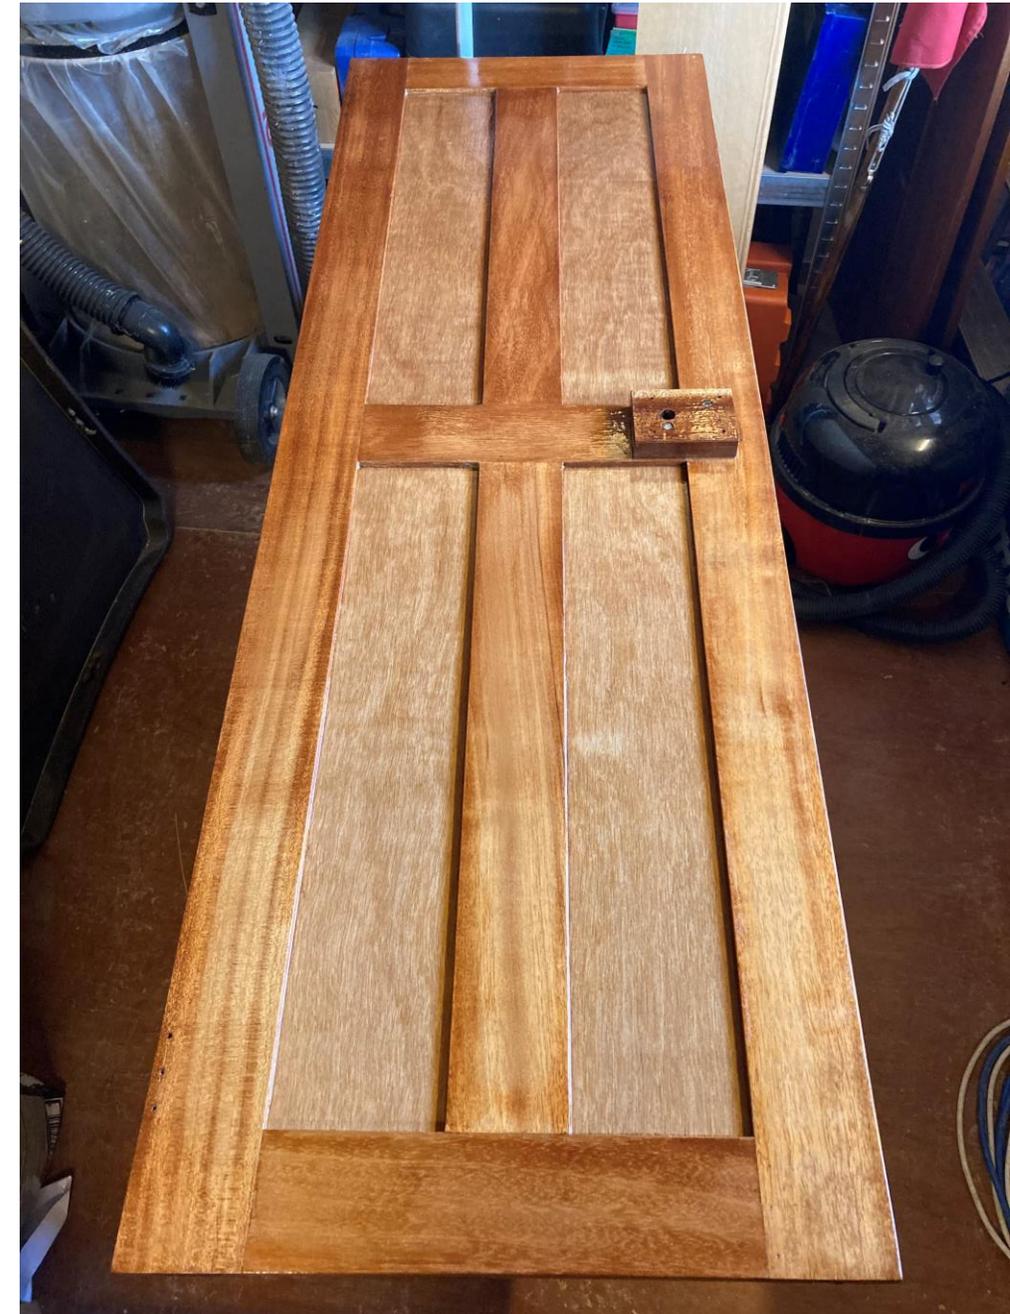
Before
and after
photos
shows
how the
colour of
the wood
and
plywood
has
changed.

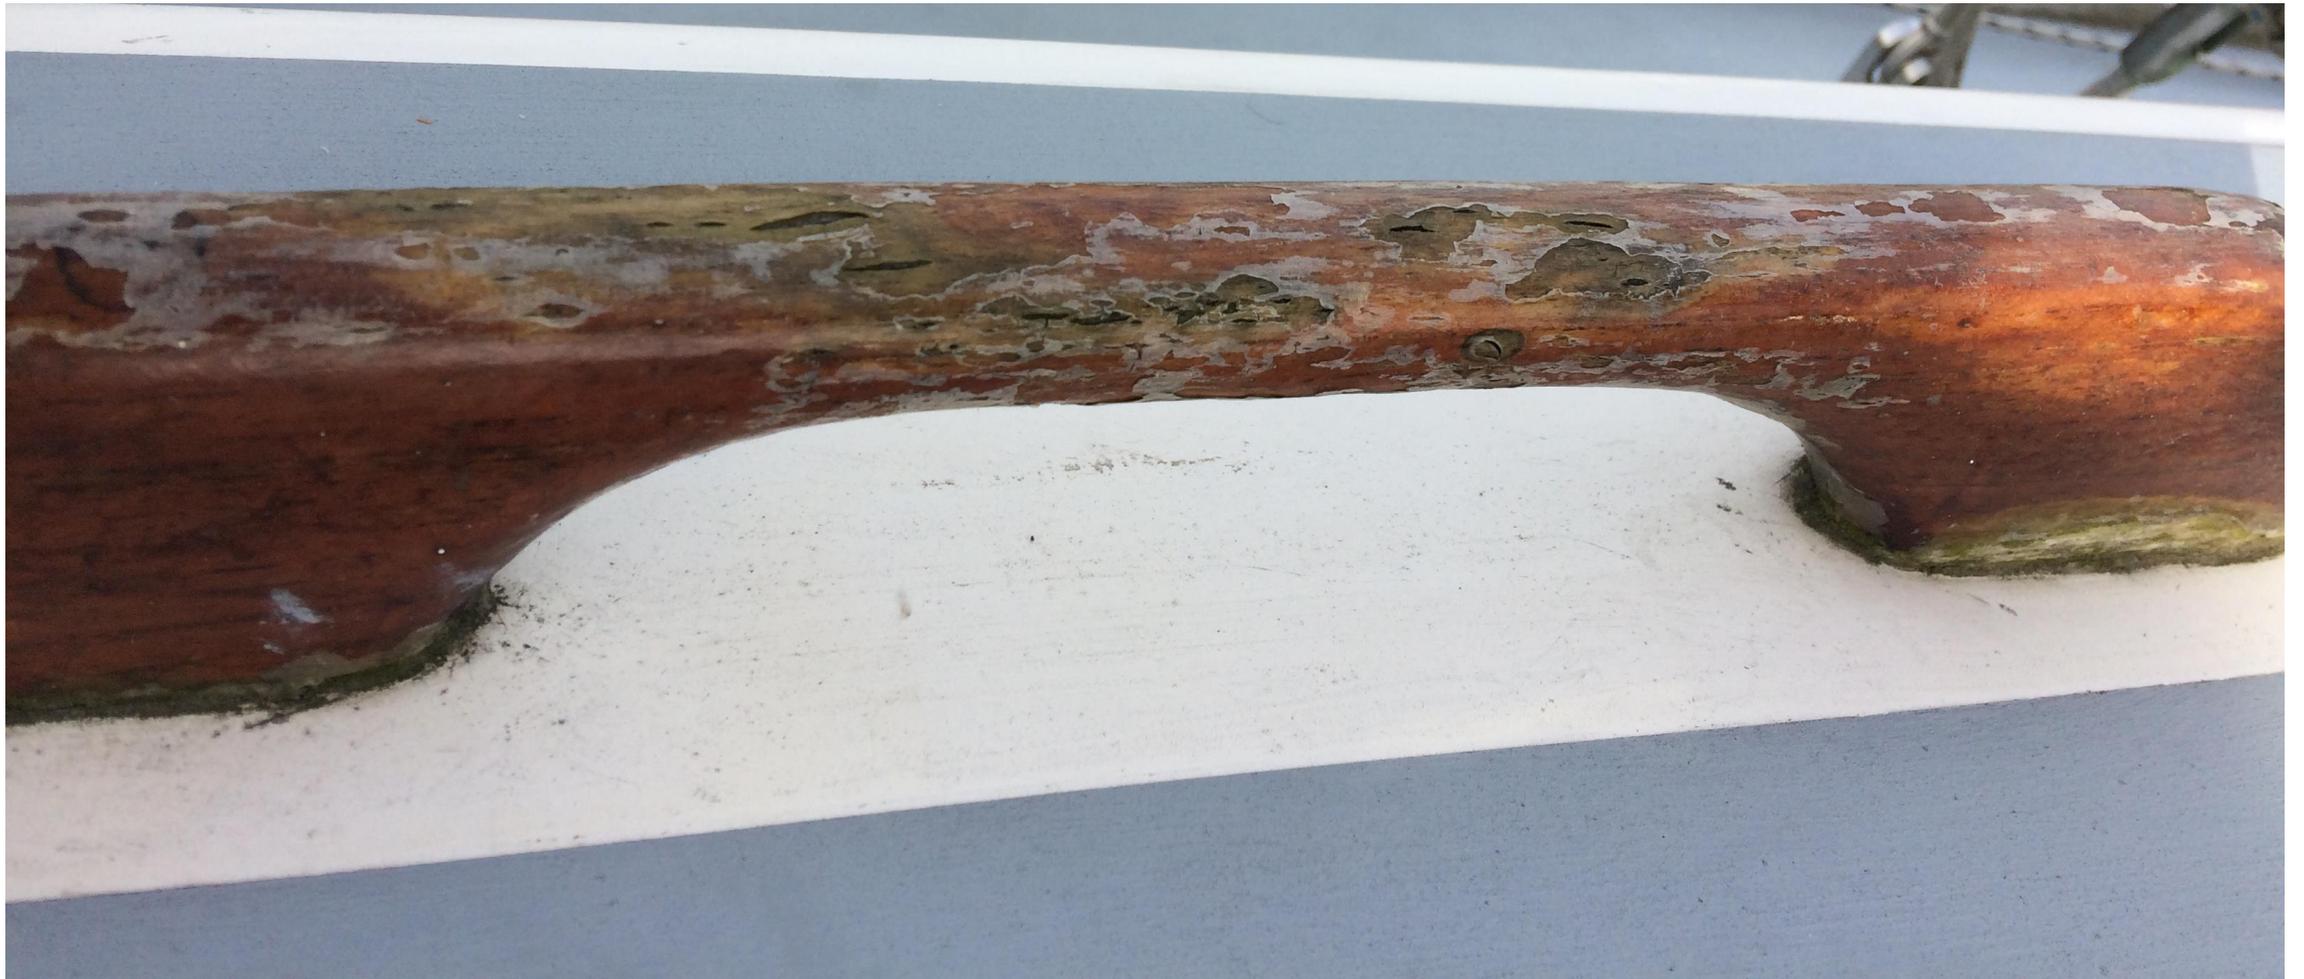
This was the condition of the handrails before I started work. This was a polyurethane varnish that cracked and allowed water enter.
