Woodwork Refinishing

Fulmar Concerto FR38

Westerly Owners Association

Zoom Clinic 24 February 2021

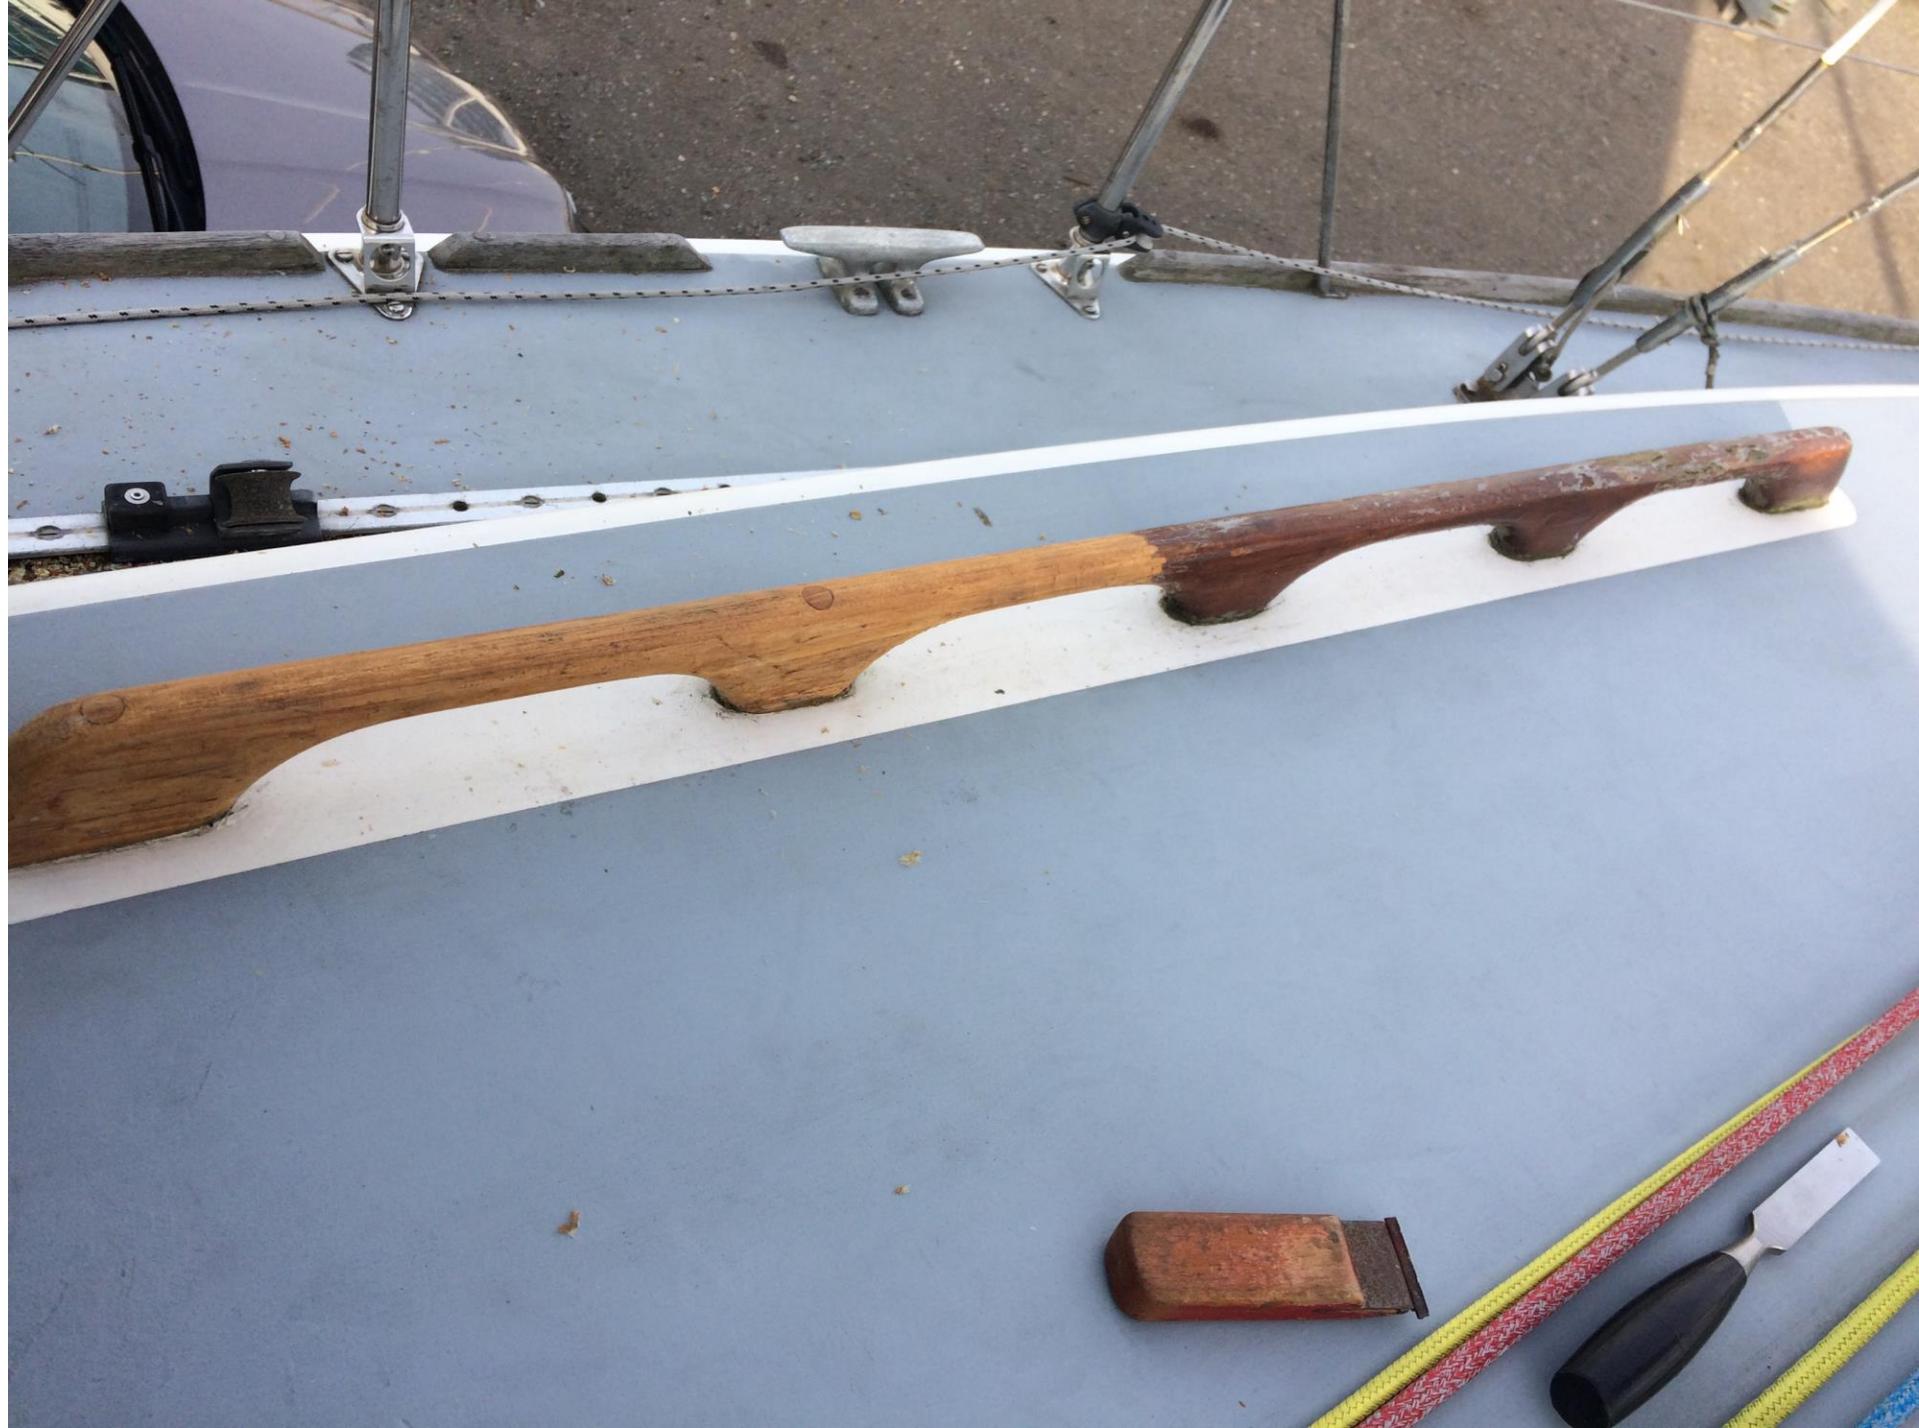
Using a Skartsen scraper and a chisel to remove the varnish. Before sanding, the wood was surprisingly clean and unstained.

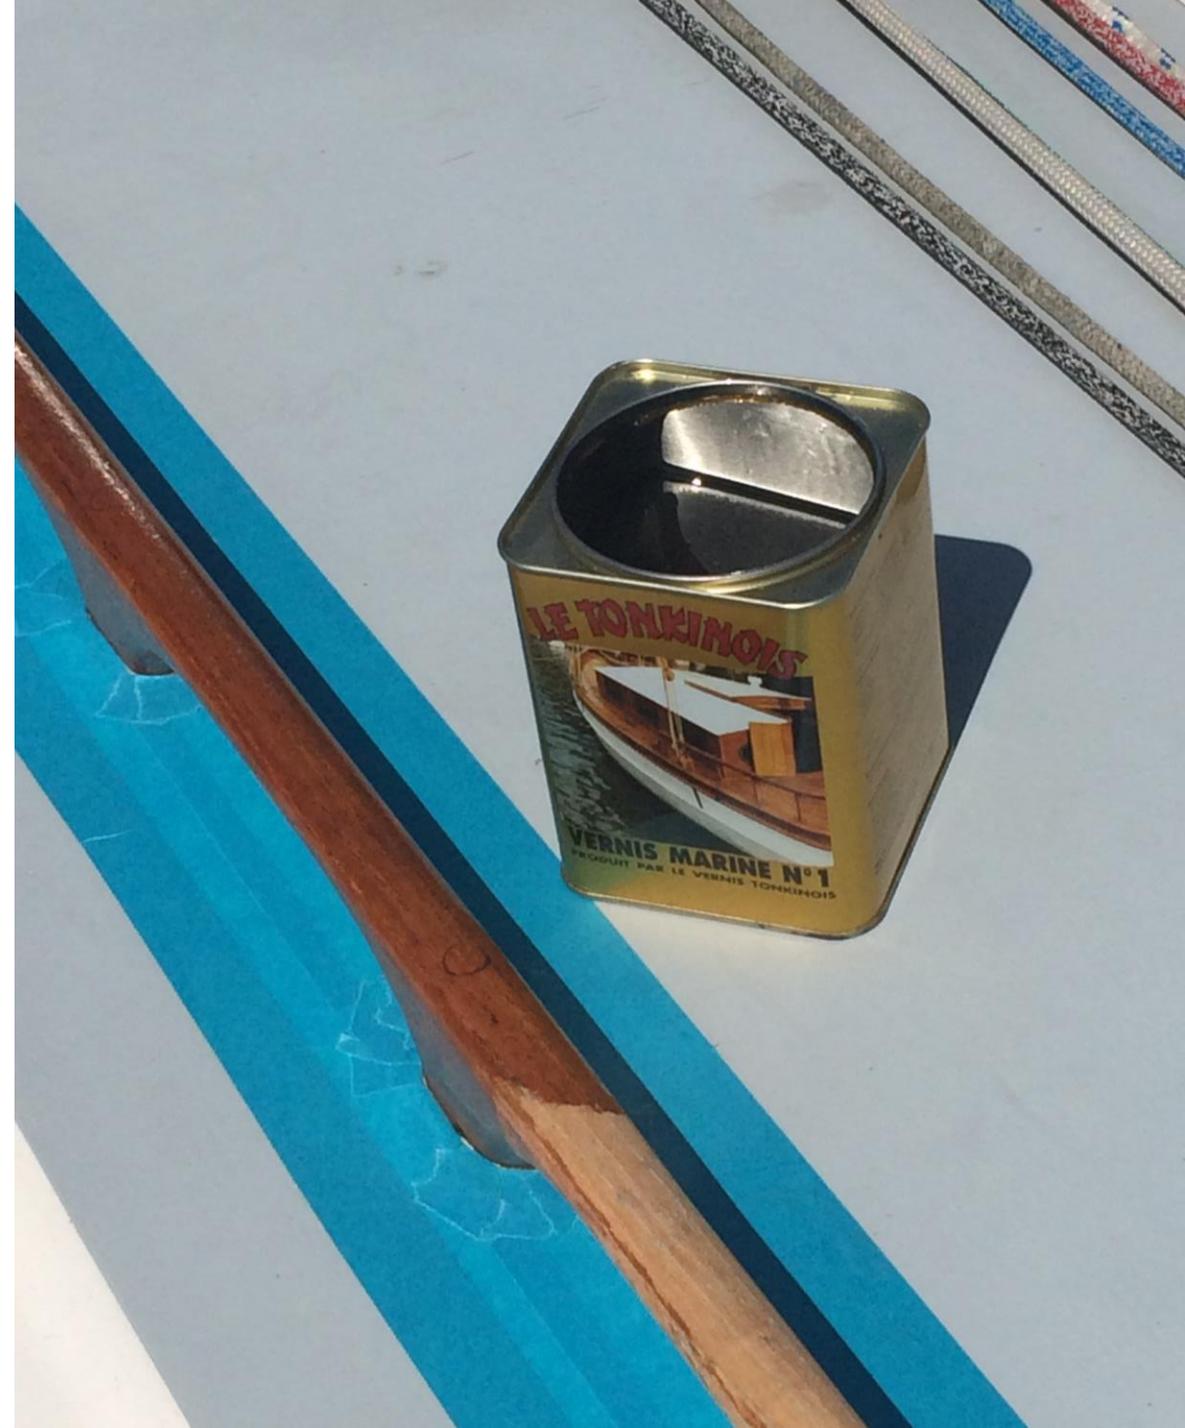
The deck has been protected with 3M 2090 ScotchBlue 14 day Outdoor Masking Tape. Notice how the tape has been torn to fit around the curves. 8 coats of Le Tonkinoise Vernis Marine No.1 were applied. This is a traditional oil based varnish that initially soaks into the wood. Not as hard as polyurethane, but flows to a high shine and can easily be patch repaired if damaged. To keep looking nice just requires a couple of coats every other year.

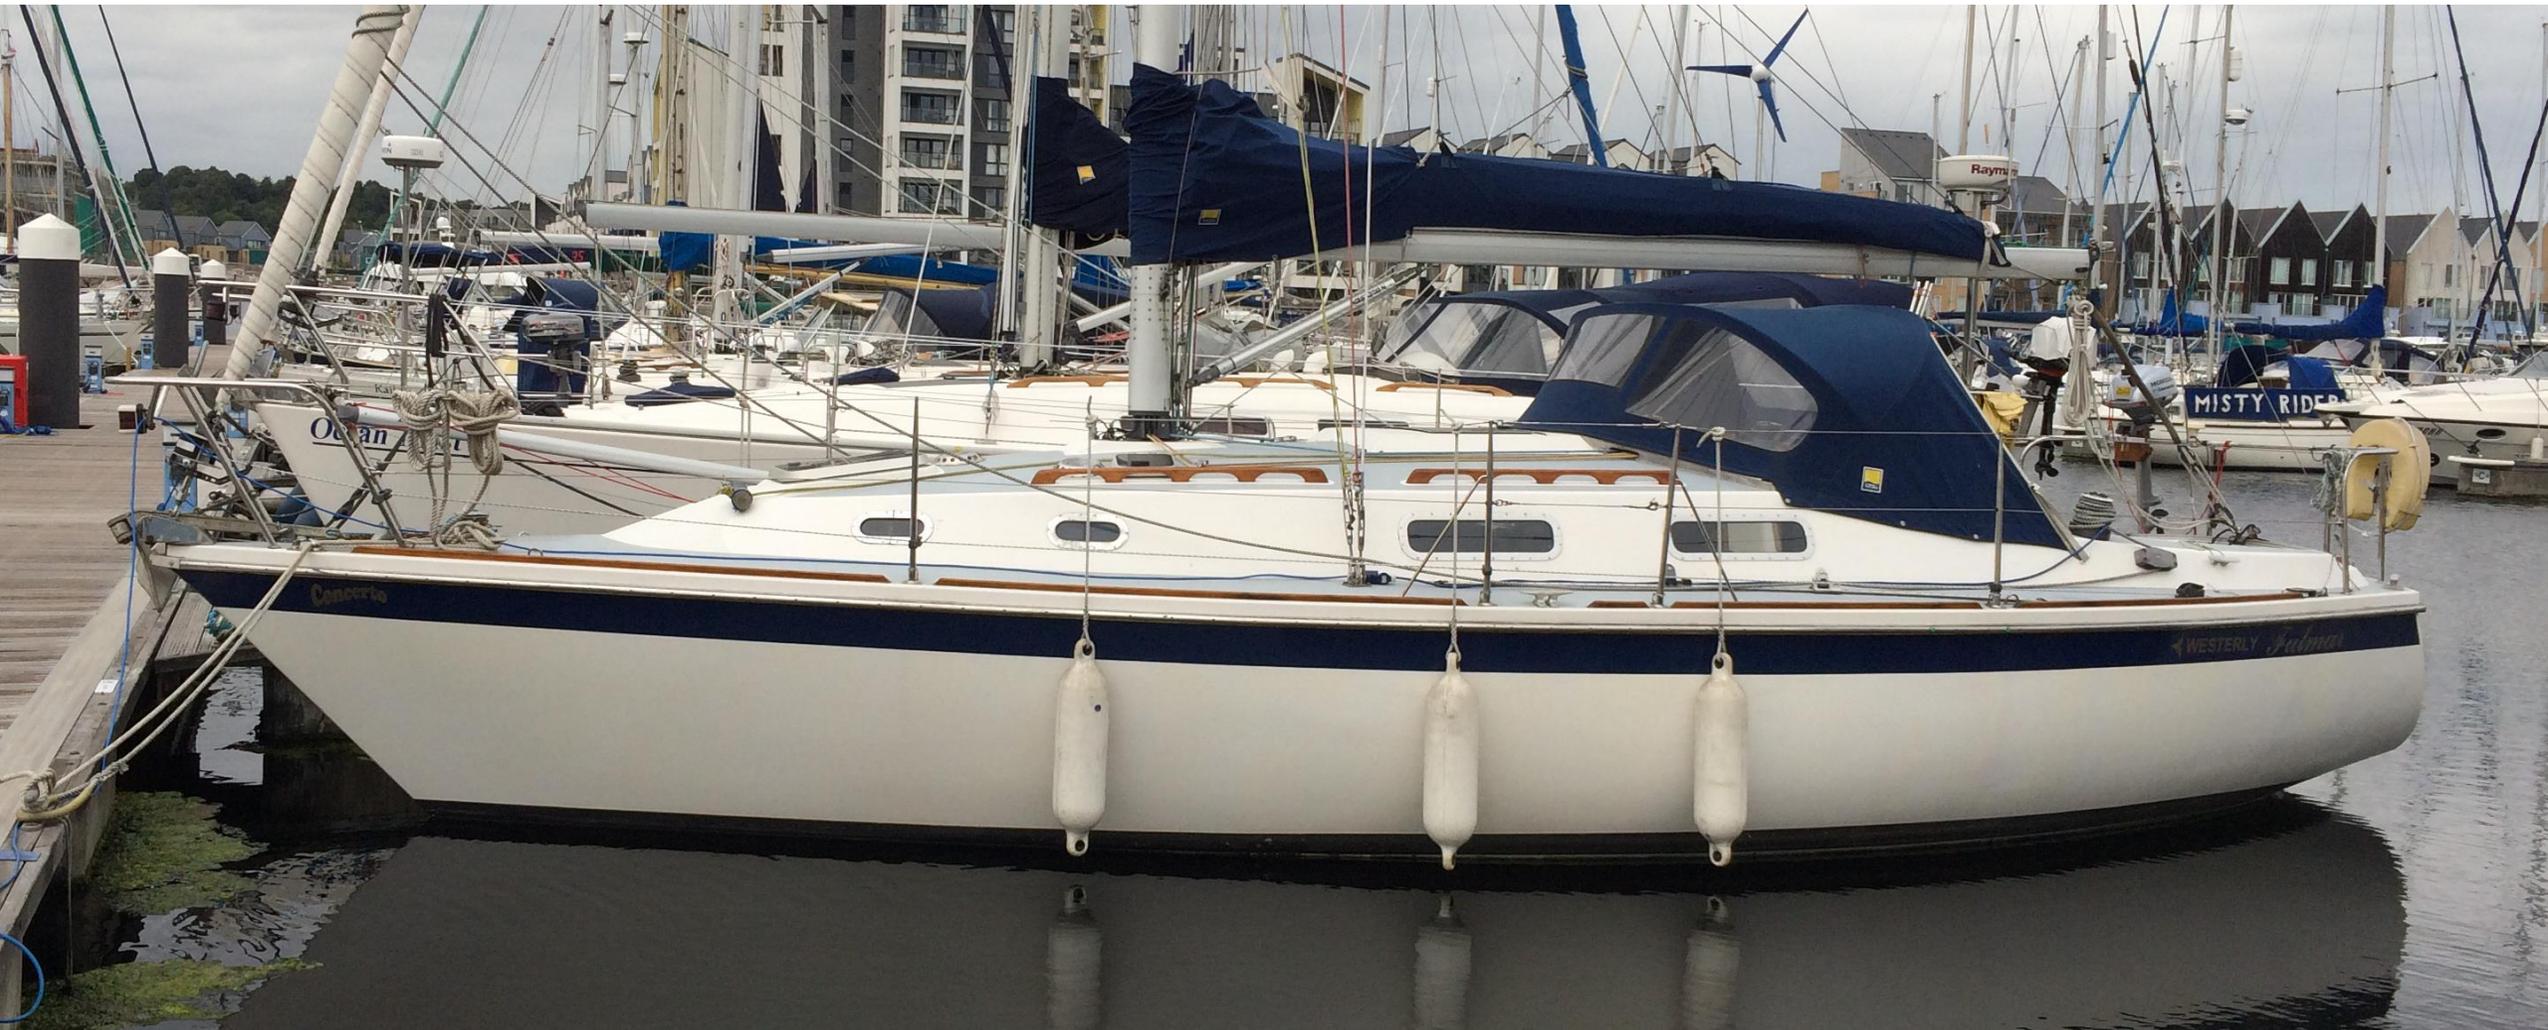
Varnished handrails and toe rails help edge the look of Concerto and helps to make her look younger than 40 years old.
