Marine Aluminum Plate - ASTM Standard Specification B 928 And The Events Leading To Its Adoption.

During the winter of 2001-2 over 200 aluminum vessels, ranging from four to forty four meters in length were diagnosed as having been built with 5083-H321 temper aluminum plate that was susceptible to intergranular corrosion. This resulted both severe pitting and extensive stress corrosion cracking. Many of the vessels involved will require new hulls and superstructures. This paper traces the discovery of the problem, the forensic process, and the short term aluminum purchase specifications used during the start of the repairs. It also introduces the new ASTM B 928 Standard Specification for High Magnesium Marine Aluminum Alloy Sheet and Plate for Marine Service and discusses the ramifications for the shipbuilding industry.

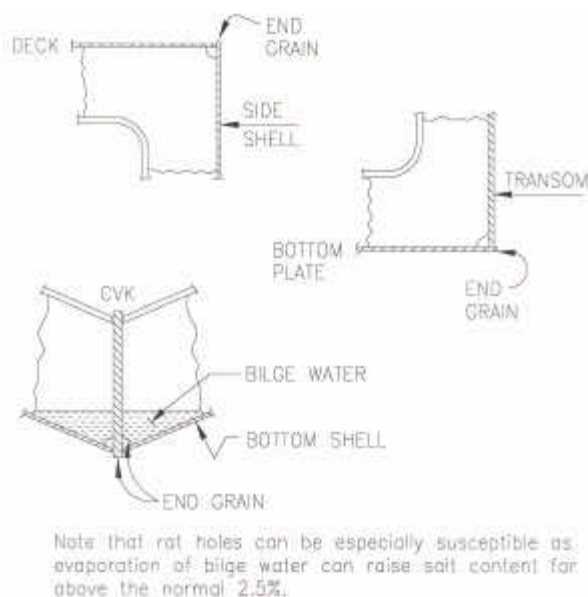
These were added as many marine construction details leave the end grain of the metal exposed (see Fig. 12), whereas previously the examination site was left to the individual metallurgist's discretion. Better results are usually exhibited at the rolled surface, as opposed to the plate end. If the alloy temper passes these tests, a photomicrograph is taken that is used as the comparison for metallographic examination for lot release.

Fig. 12 Typical Marine Construction Details
