Composites Science and Technology 59 (1999) 179–200

Mechanical performance of carbon-fibre- and glass-fibre-reinforced epoxy I-beams: III. Fatigue performance

M.D. Gilchrist^{a,*}, A.J. Kinloch^b, F.L. Matthews^c

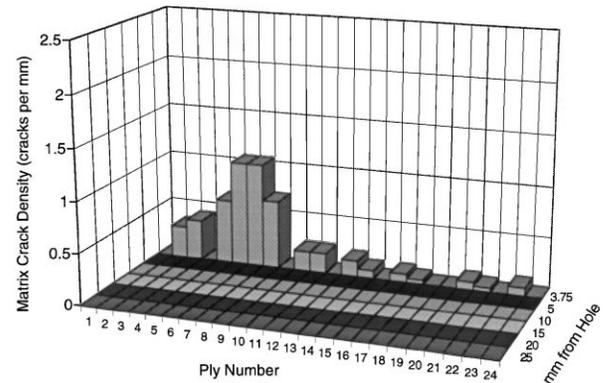
Fig. 10. (a) Density of matrix cracking in quadrant Tt of beam Carbon N2 after 0.5×10^6 cycles. The damage in each of the 24 plies at different distances ahead of the edge of the 60 mm diameter notch is identified. The local orientation of plies 1–24 is $(0/-45/90^\circ)_{2s}(90/-45/0^\circ)_{2s}$, respectively.

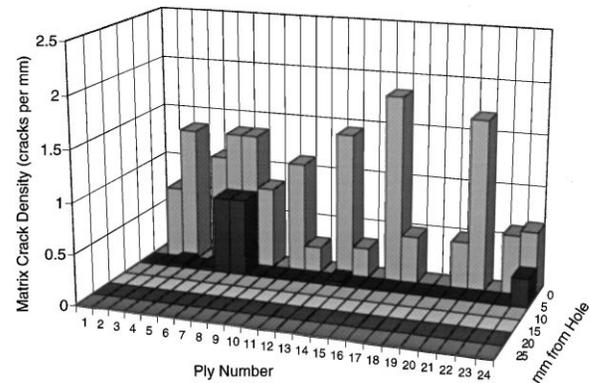
Fig. 10. (b) Density of matrix cracking in quadrant Tt of beam Carbon N3 after 2.43×10^6 cycles. The damage in each of the 24 plies at different distances ahead of the edge of the 60 mm diameter notch is identified. The local orientation of plies 1–24 is $(0/-45/90^\circ)_{2s}(90/-45/0^\circ)_{2s}$, respectively.

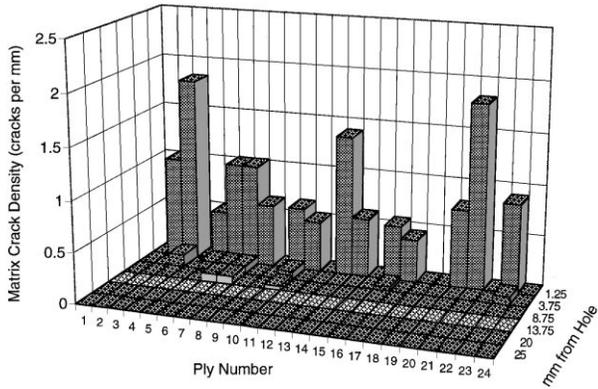
Fig. 10. (c) Density of matrix cracking in quadrant Tt of beam Carbon N4 after 4.5×10^6 cycles. The damage in each of the 24 plies at different distances ahead of the edge of the 60 mm diameter notch is identified. The local orientation of plies 1–24 is $(0/-45/90^\circ)_{2s}(90/-45/0^\circ)_{2s}$, respectively.

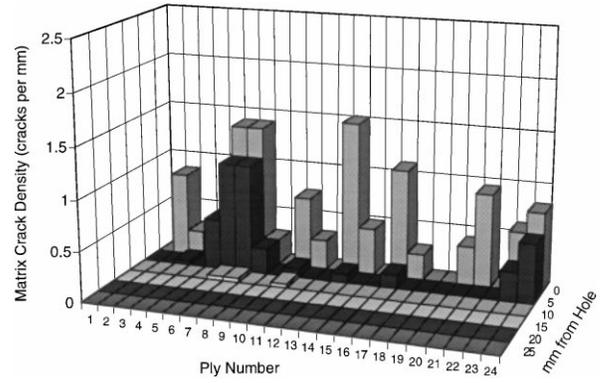
Fig. 11. (b) Density of matrix cracking in quadrant Tc of beam Carbon N3 after 2.43×10^6 cycles. The damage in each of the 24 plies at different distances ahead of the edge of the 60 mm diameter notch is identified. The local orientation of plies 1–24 is $(0/-45/90^\circ)_{2s}(90/-45/0^\circ)_{2s}$, respectively.

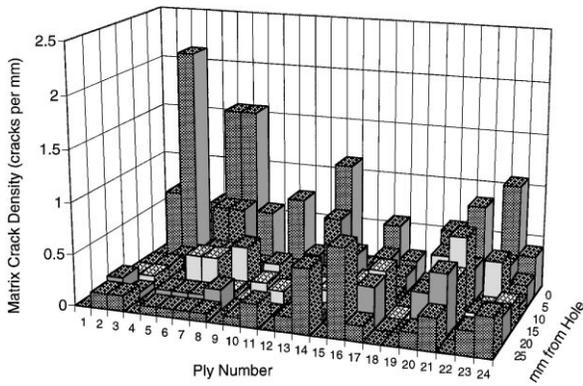
Fig. 10. (d) Density of matrix cracking in quadrant Tt of beam Carbon N5 after 4.78×10^6 cycles. The damage in each of the 24 plies at different distances ahead of the edge of the 60 mm diameter notch is identified. The local orientation of plies 1–24 is $(0/-45/90^\circ)_{2s}(90/-45/0^\circ)_{2s}$, respectively.

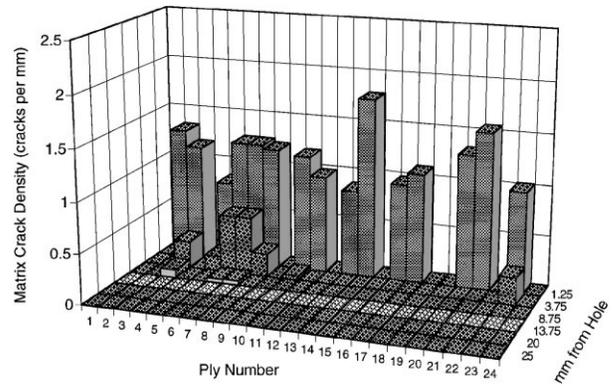
Fig. 11. (c) Density of matrix cracking in quadrant Tc of beam Carbon N4 after 4.5×10^6 cycles. The damage in each of the 24 plies at different distances ahead of the edge of the 60 mm diameter notch is identified. The local orientation of plies 1–24 is $(0/-45/90^\circ)_{2s}(90/-45/0^\circ)_{2s}$, respectively.

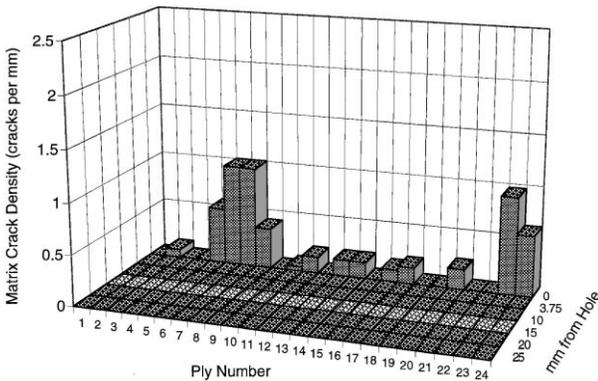
Fig. 11. (a) Density of matrix cracking in quadrant Tc of beam Carbon N2 after 0.5×10^6 cycles. The damage in each of the 24 plies at different distances ahead of the edge of the 60 mm diameter notch is identified. The local orientation of plies 1–24 is $(0/-45/90^\circ)_{2s}(90/-45/0^\circ)_{2s}$, respectively.

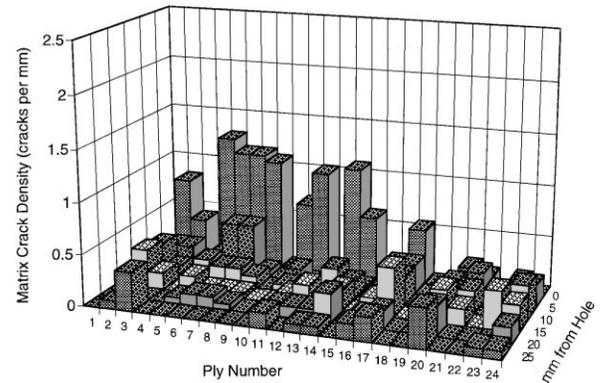
Fig. 11. (d) Density of matrix cracking in quadrant Tc of beam Carbon N5 after 4.78×10^6 cycles. The damage in each of the 24 plies at different distances ahead of the edge of the 60 mm diameter notch is identified. The local orientation of plies 1–24 is $(0/-45/90^\circ)_{2s}(90/-45/0^\circ)_{2s}$, respectively.

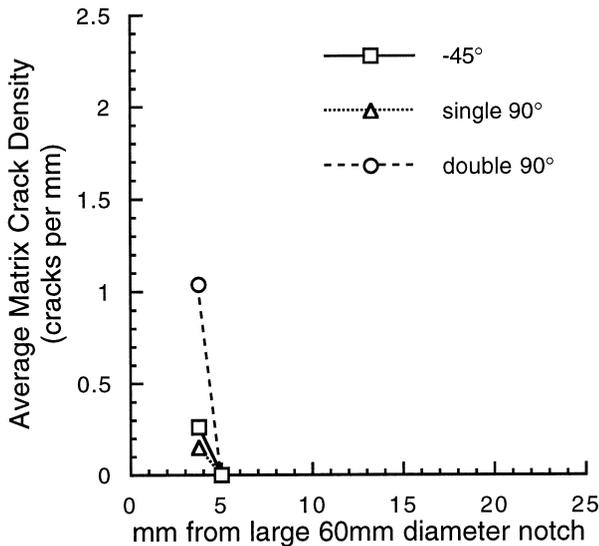
Fig. 12. (a) Average density of matrix cracking in quadrant Tt of beam Carbon N2 after 0.5×10^6 cycles. The average damage in locally oriented -45° plies, single 90° plies and double 90° plies is identified at different distances ahead of the edge of the 60 mm diameter notch.

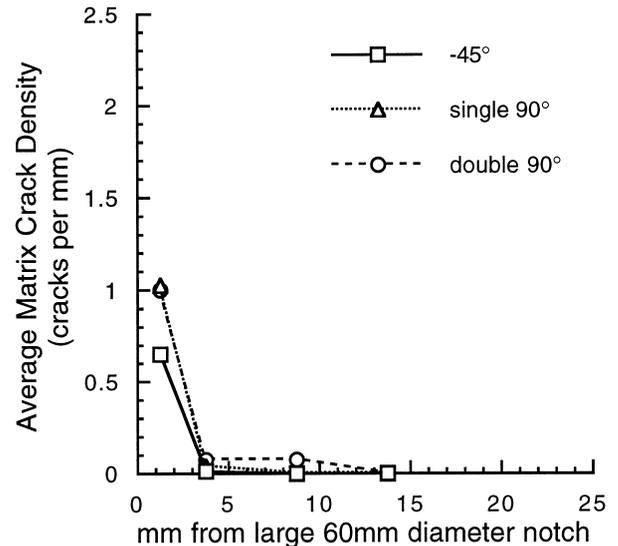
Fig. 12. (c) Average density of matrix cracking in quadrant Tt of beam Carbon N4 after 4.5×10^6 cycles. The average damage in locally oriented -45° plies, single 90° plies and double 90° plies is identified at different distances ahead of the edge of the 60 mm diameter notch.

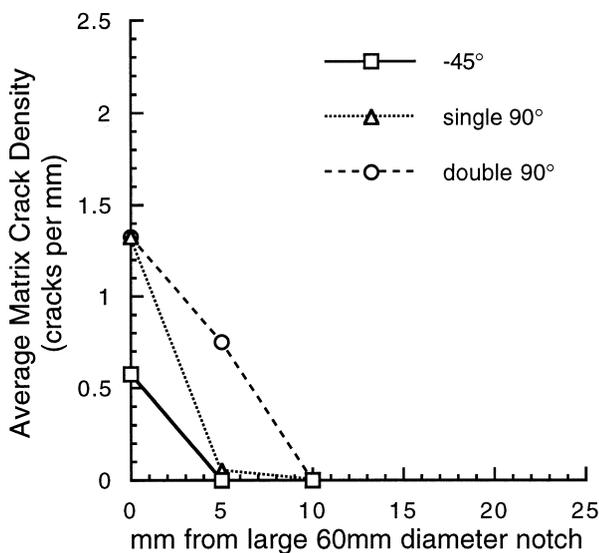
Fig. 12. (b) Average density of matrix cracking in quadrant Tt of beam Carbon N3 after 2.43×10^6 cycles. The average damage in locally oriented -45° plies, single 90° plies and double 90° plies is identified at different distances ahead of the edge of the 60 mm diameter notch.

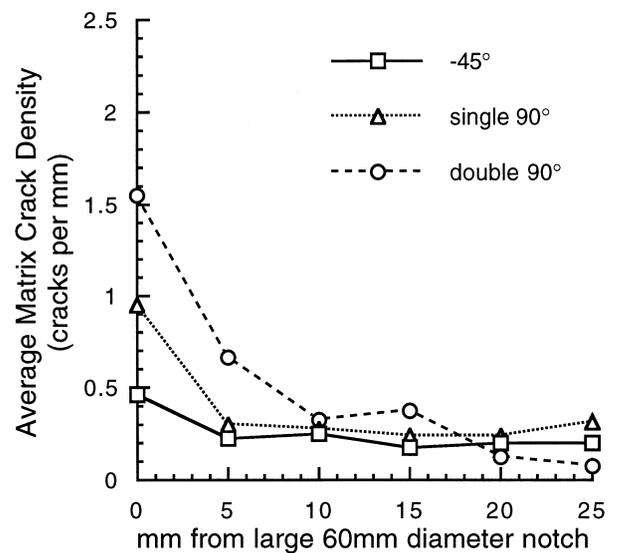
Fig. 12. (d) Average density of matrix cracking in quadrant Tt of beam Carbon N5 after 4.78×10^6 cycles. The average damage in locally oriented -45° plies, single 90° plies and double 90° plies is identified at different distances ahead of the edge of the 60 mm diameter notch.

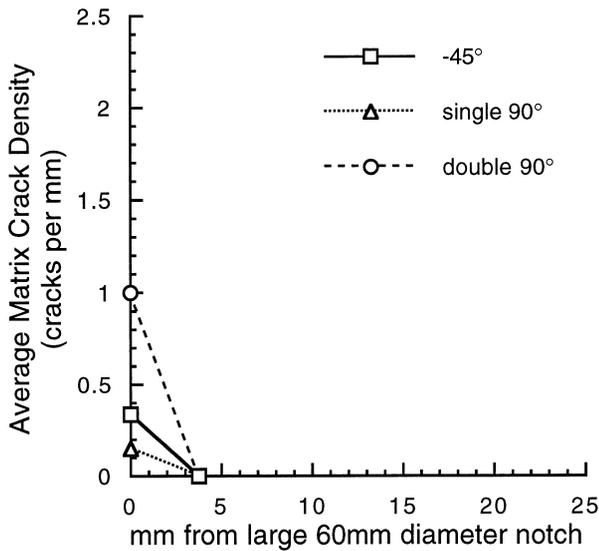
Fig. 13. (a) Average density of matrix cracking in quadrant Tc of beam Carbon N2 after 0.5×10^6 cycles. The average damage in locally oriented -45° plies, single 90° plies and double 90° plies is identified at different distances ahead of the edge of the 60 mm diameter notch.

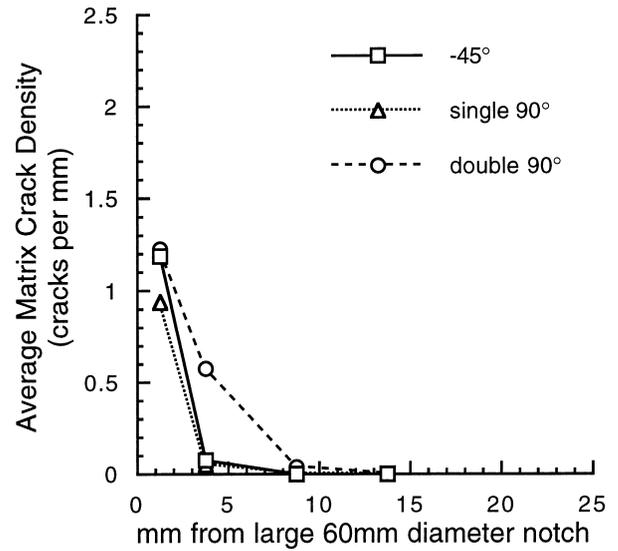
Fig. 13. (c) Average density of matrix cracking in quadrant Tc of beam Carbon N4 after 4.5×10^6 cycles. The average damage in locally oriented -45° plies, single 90° plies and double 90° plies is identified at different distances ahead of the edge of the 60 mm diameter notch.

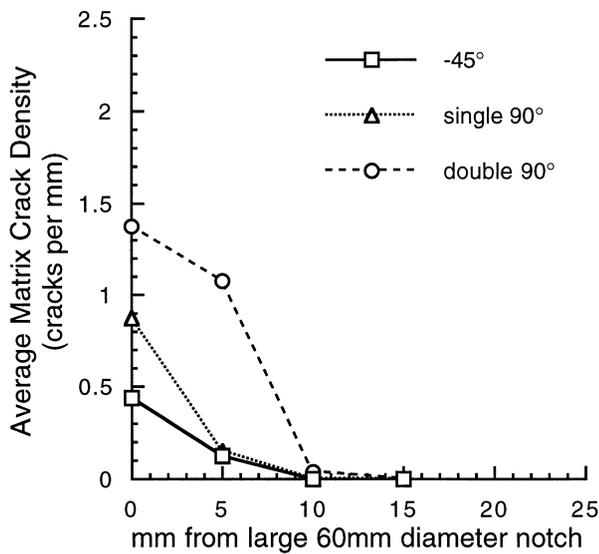
Fig. 13. (b) Average density of matrix cracking in quadrant Tc of beam Carbon N3 after 2.43×10^6 cycles. The average damage in locally oriented -45° plies, single 90° plies and double 90° plies is identified at different distances ahead of the edge of the 60 mm diameter notch.

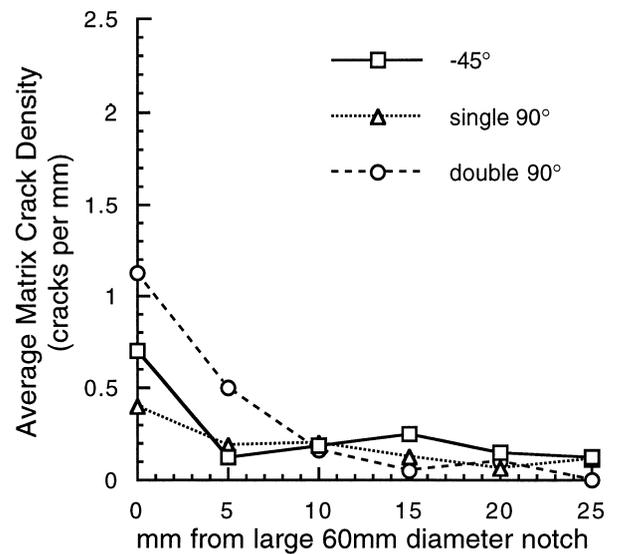
Fig. 13. (d) Average density of matrix cracking in quadrant Tc of beam Carbon N5 after 4.78×10^6 cycles. The average damage in locally oriented -45° plies, single 90° plies and double 90° plies is identified at different distances ahead of the edge of the 60 mm diameter notch.

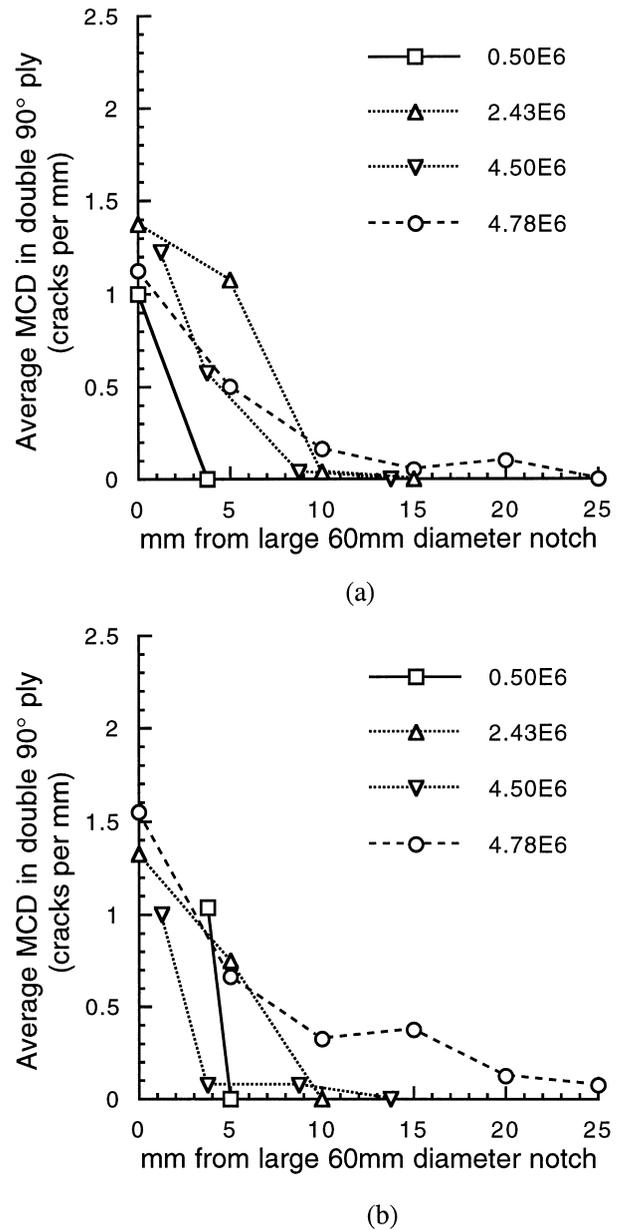
Fig. 14. Average density of matrix cracking in local double 90° plies (a) in quadrants Tc and (b) in quadrants Tt. The average damage is identified at different distances ahead of the edge of the 60 mm diameter notch and at different numbers of fatigue cycles.

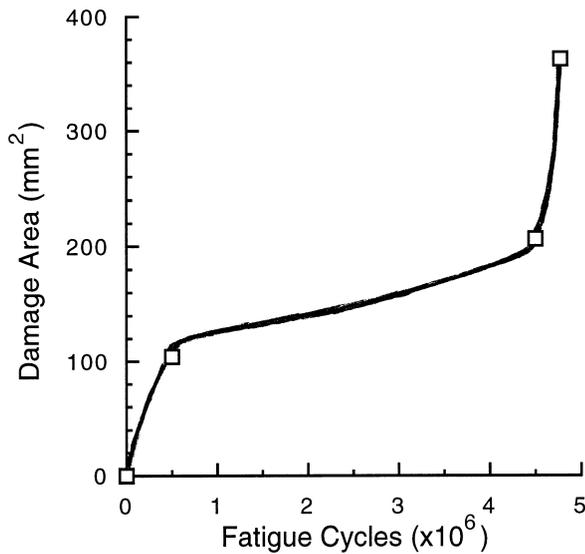
The rate of damage evolution has been described qualitatively from the ultrasonic C-scans and the X-radiographs of Figs. 3, 5 and 6, and to some extent quantitatively in Figs. 10–14. The matrix cracking in the local 90° plies is believed to be the critical damage mechanism that leads to fibre fracture and, hence, ultimate failure of the web region of the carbon beams. The preceding X-radiographic evidence can be analysed further to relate the area of matrix damage in the local 90° plies with the number of fatigue cycles, as shown in Fig. 15. These results have been calculated directly from the X-radiographs of Fig. 6(a–c) by measuring the areas of matrix cracking in single and double 90° plies around the large holes. (It is important to note that these data do not distinguish between single and double 90° plies and are given in terms of per unit area of beam surface.) By examining Fig. 15 it is possible to obtain some indicative estimates of the growth rate damage area in the single and double local 90° plies with the number of fatigue cycles. The slopes of the various stages of damage development in Fig. 15 indicate that the initial and final stages of growth were almost an order of magnitude faster than that of the intermediate stage.

Fig. 15. Approximate area of matrix cracking in local single 90° plies and double 90° plies around the 60 mm diameter notch (average of quadrants Tt and Tc) as a function of the number of fatigue cycles.
