## IMPALA

LOA 56'10", LWL 40', Beam 12'6", Draft 7'8", Displacement 52,000 lbs

Designer: Sparkman and Stephens

Built 1954 by Abeking and Rasmussen

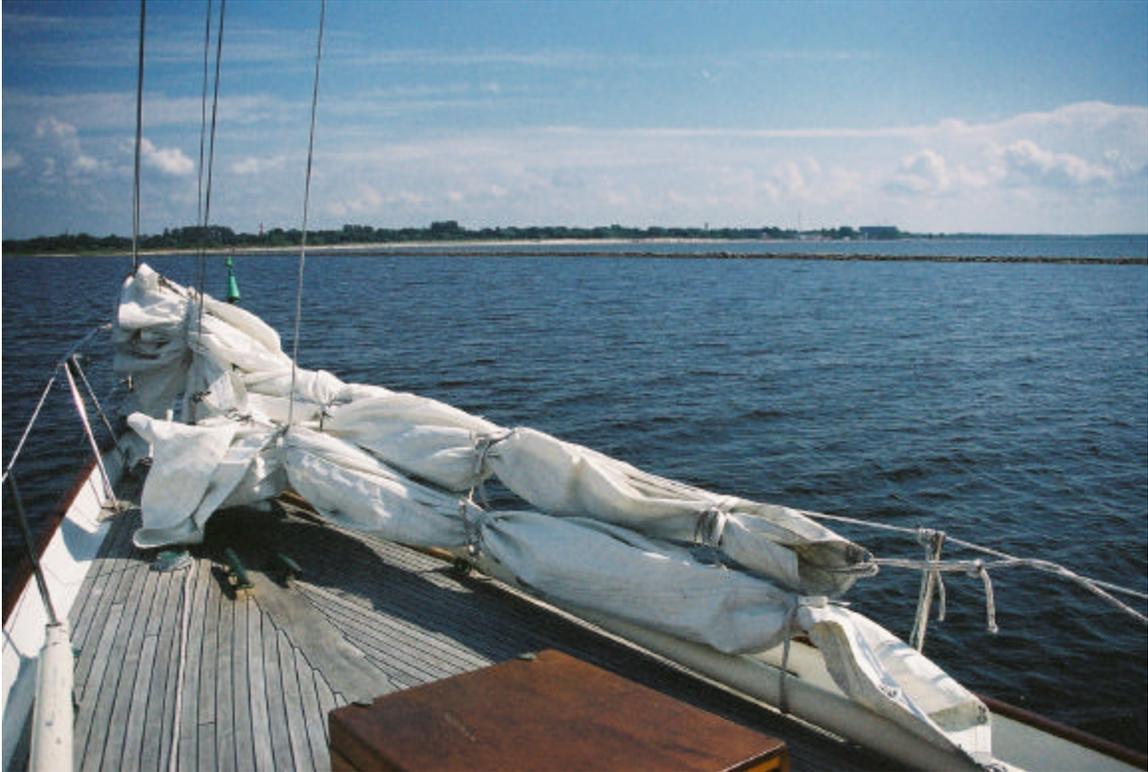
View of the foredeck with headsails furling to the lifelines

The sails are raised, lowered and reefed at the mast; the headsails are furled on the foredeck. Deck boxes at the mast hold the winch handles, sail stops and other gear used to work the sails. The decks have been kept uncluttered to make moving and working forward easy. All unnecessary equipment has been removed, including the anchor windlass.

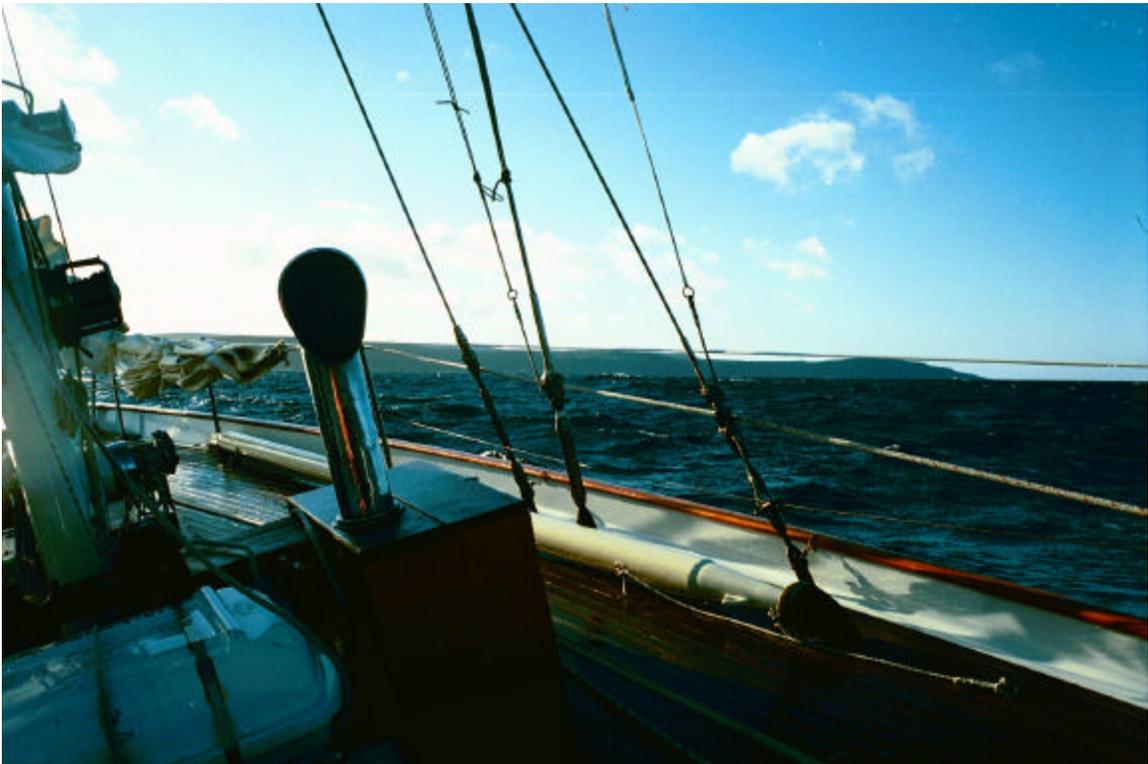
Sailing in Newfoundland. Note the integral deck boxes and tall Dorade ventilators.

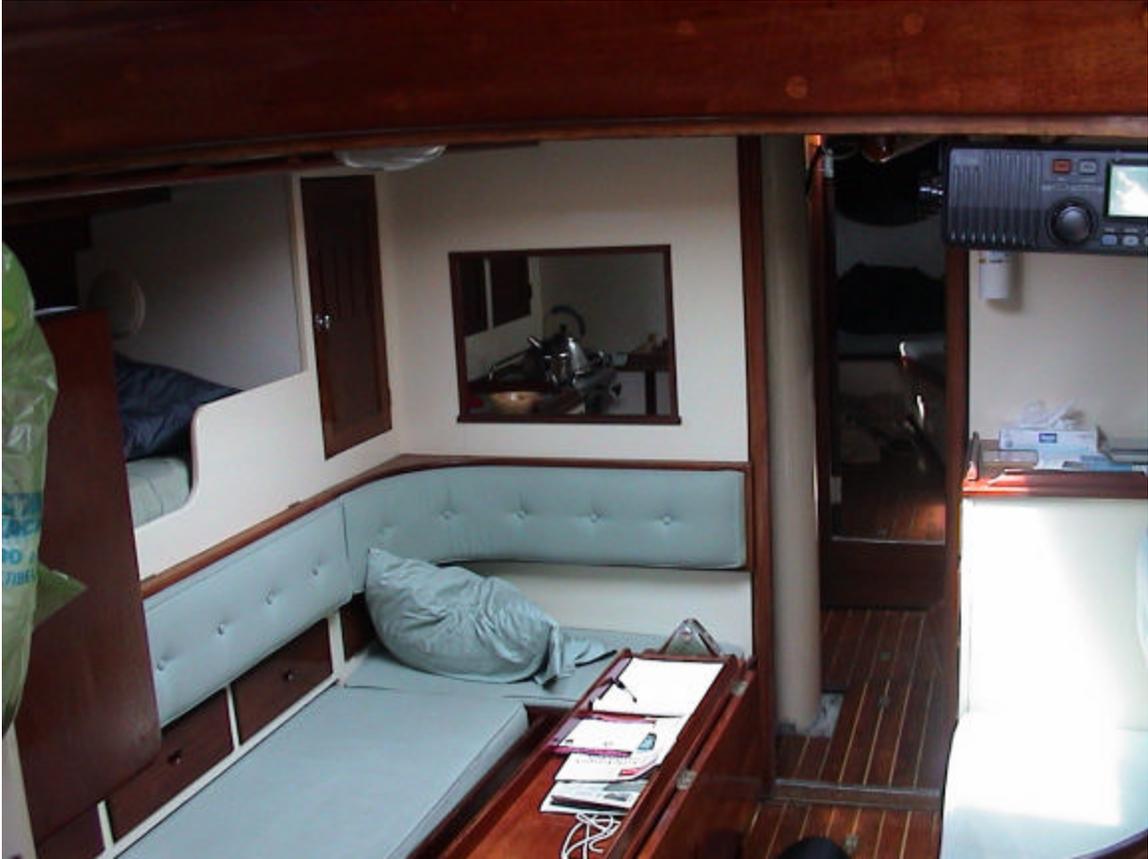
Main cabin looking forward.

Down below, *Impala* was built as a luxury (1950's style) cruiser. She has a beautiful owner's cabin aft with a double and a single berth, chart table and head at the companion, a main saloon with outboard pilot berths amidships, and her galley forward. The fo'castle has a good bunk and extra storage for sails and the galley. The forepeak holds the anchors and rodes.

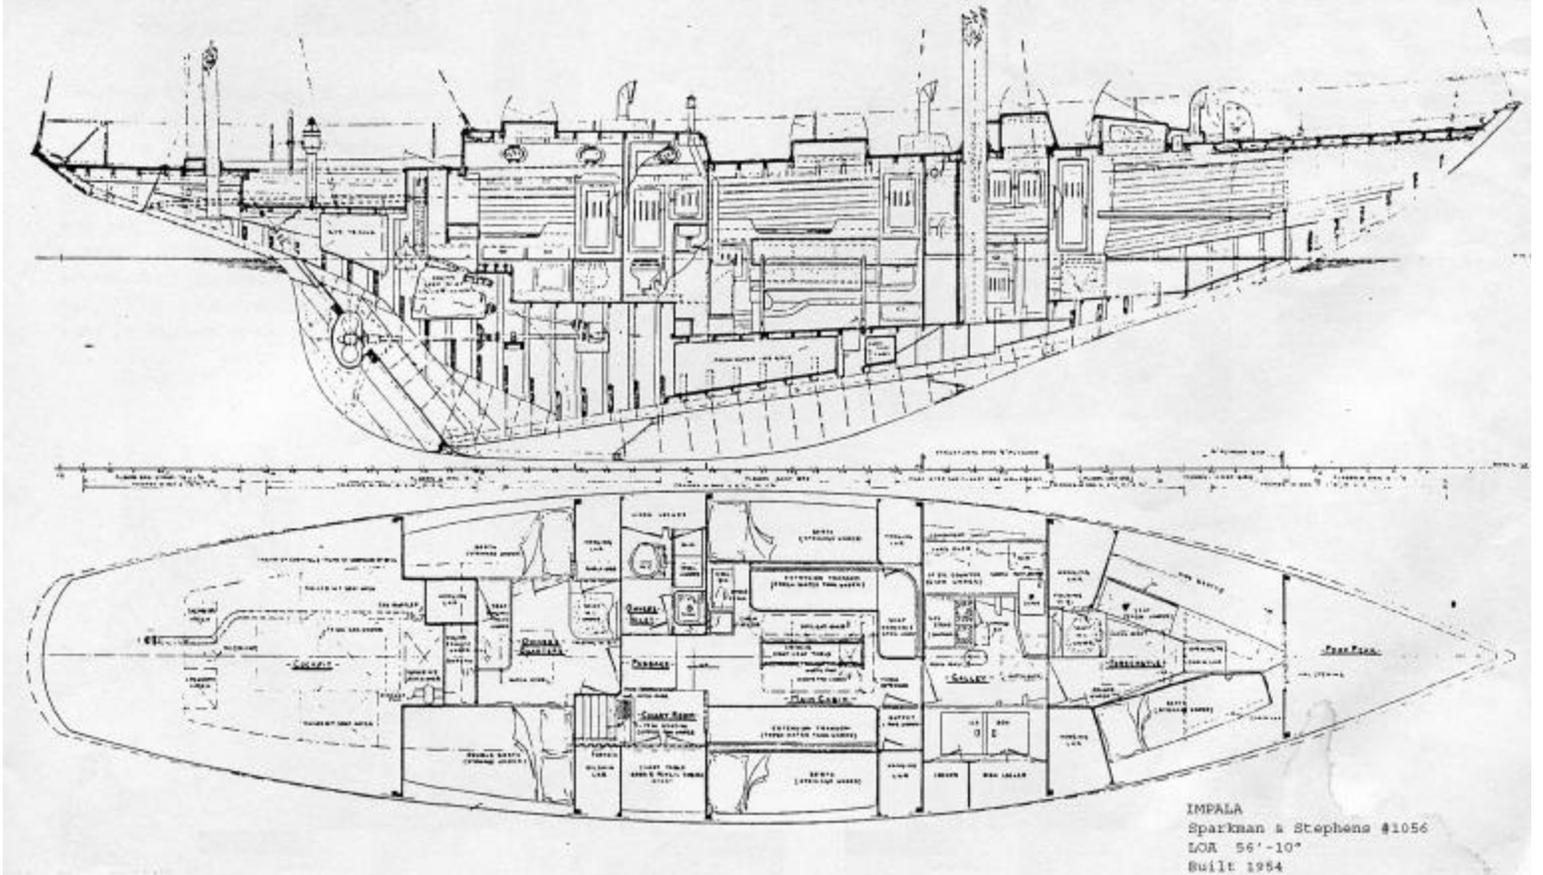
IMPALA

Sparkman & Stephens #1056

LOA 56'-10"

Built 1954
