Repairing boats with Fibreglass Reinforced Plastics

a **Fibreglass
Limited** publication
in collaboration with
Tyler Boat Co. Ltd.

Fibreglass Reinforced Plastics

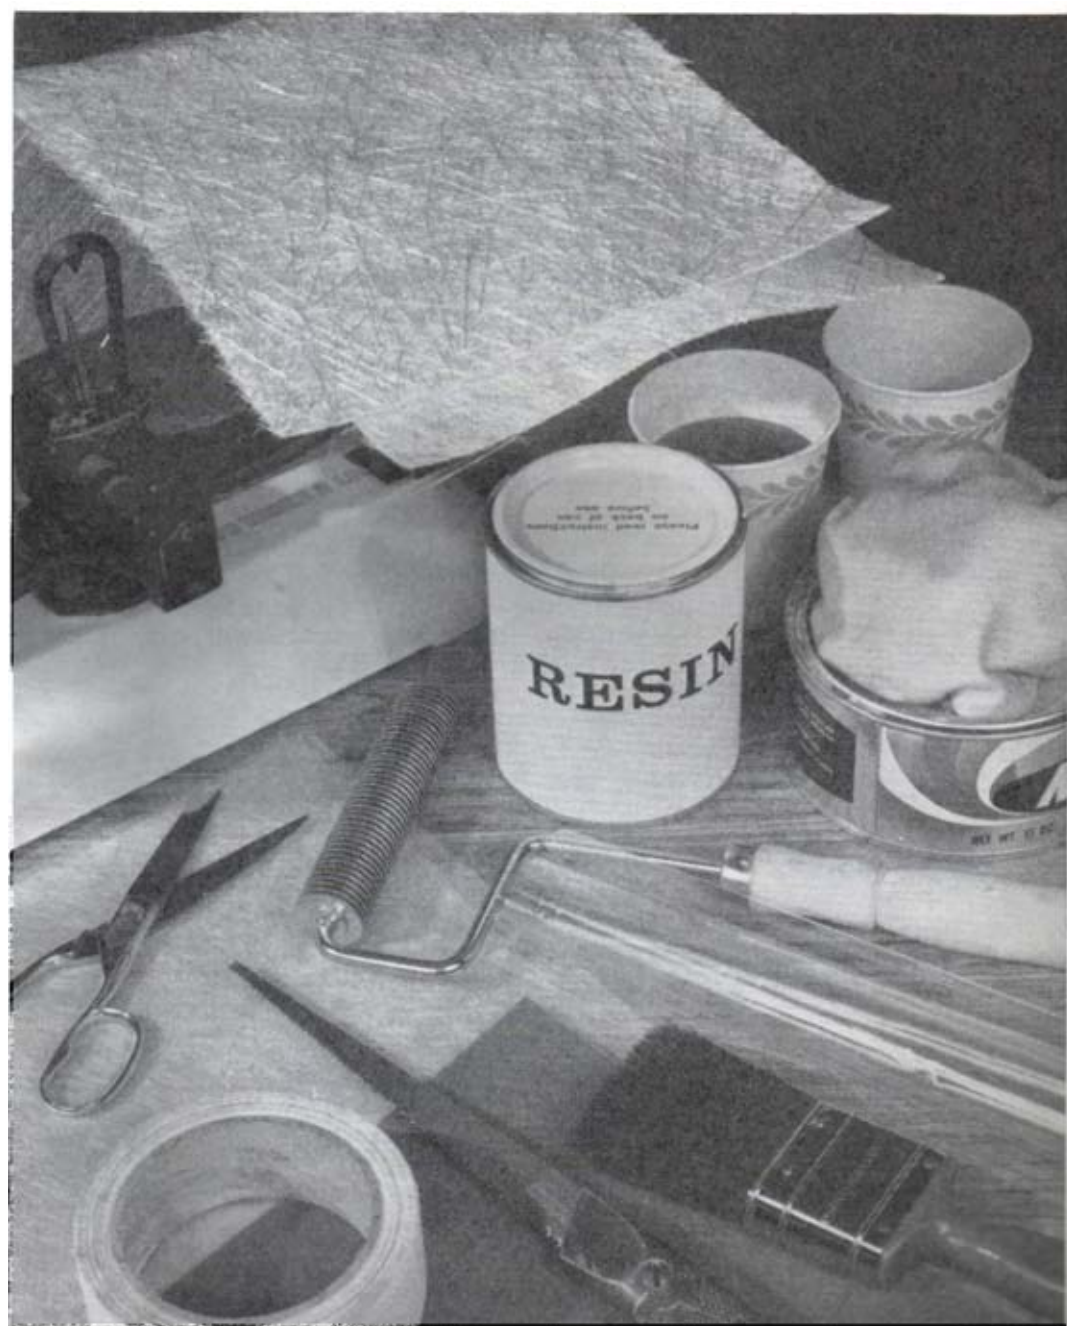
10. Split washer roller this is one item unlikely to be readily to hand. It is a roller on which are several washers, with radial slots, spaced by smaller washers. One can be made using two sizes of washer, and is quite effective without the radial slots (see illustration), or the genuine article can be obtained from one of the suppliers listed.

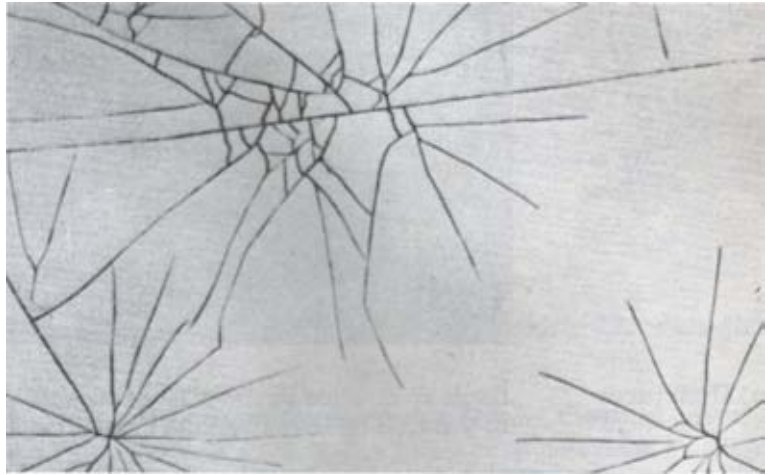
a) Hairline fractures

are cracks which are confined to the surface gel-coat and do not penetrate into the main laminate.

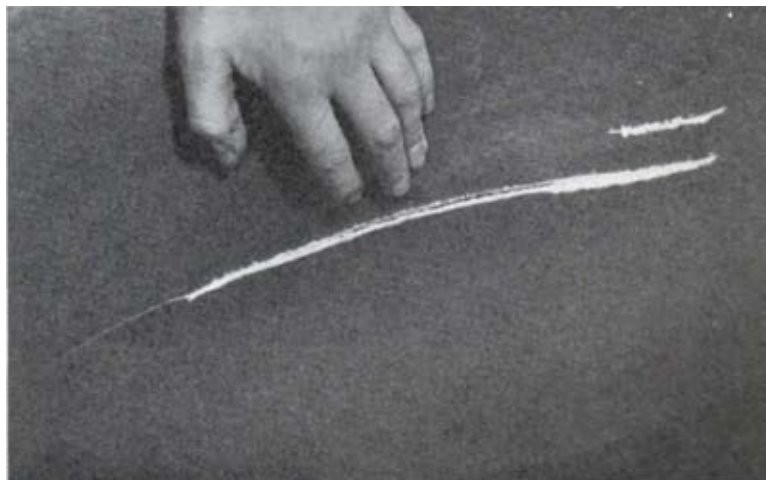
b) Grazes

are the result of abrasion rubbing off the gel-coat and exposing the Fibreglass reinforced laminate beneath.

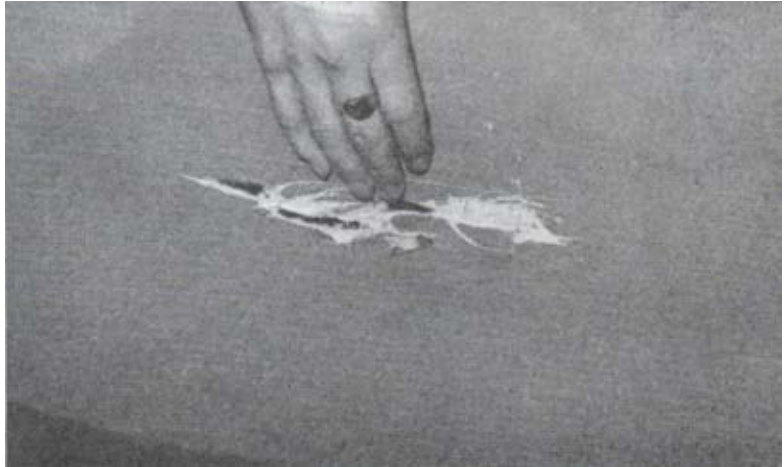
c) Impact fractures

are caused by a hard blow. In this case the laminate itself is crazed and damaged, although it is not completely penetrated.

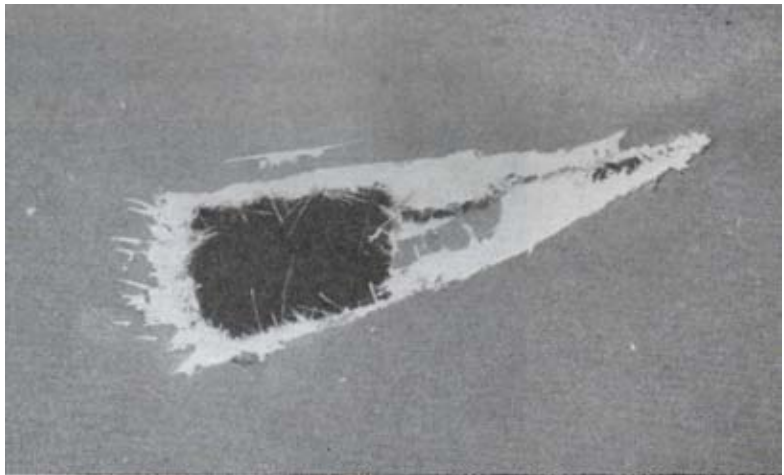
d) Punctures

result from a harder blow or impact with a pointed object and in this case there is a definite hole through the laminate.

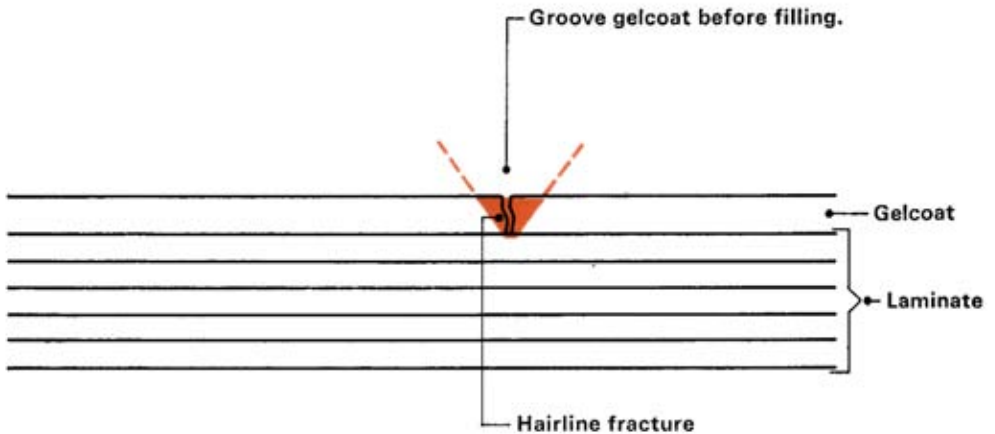
Repairing a hairline fracture

- (a) Remove any external obstruction covering the damaged surface.
- (b) Enlarge the hairline fracture into a definite V-shaped groove, using the corner of a chisel or a file. The groove must be deep enough to penetrate the gel-coat completely and expose the main Fibreglass Reinforced Plastics laminate beneath.

- (c) Prepare and activate a small quantity of resin. A filled resin is the best to use for this type of repair. Failing this, a general purpose resin can have filler-powder added. Work this into the groove, using a broad knife, until it is slightly proud of the external surface. Leave the repair to cure completely.

- (d) After the repair has cured, fair-in the surface with grade 320 wet-and-dry abrasive, used wet on a rubber block. Rub lightly in one direction only to prevent the area surrounding the repair becoming depressed. Too vigorous rubbing down can result in the original gel-coat surrounding the repair being depressed or even removed to expose the glass reinforced main laminate beneath.

- (e) If a sizeable area has been treated in this way it is sometimes noticed after rubbing down that a gap has appeared between the repair and the original laminate. This is not unusual and is caused by shrinkage. To remedy this fault stage 'c' should be repeated,

this time treating only the gap which has opened up. After curing, this secondary repair is again rubbed down.

(f) The 320 grade abrasive may have left scratches on the surface of the repair and its surrounds. Remove these by rubbing down with grade 400 abrasive, used wet, and finish off with a fine cutting compound. A final surface can be obtained with Simoniz wax polish, or the repair can be painted to match the finished colour of the hull.

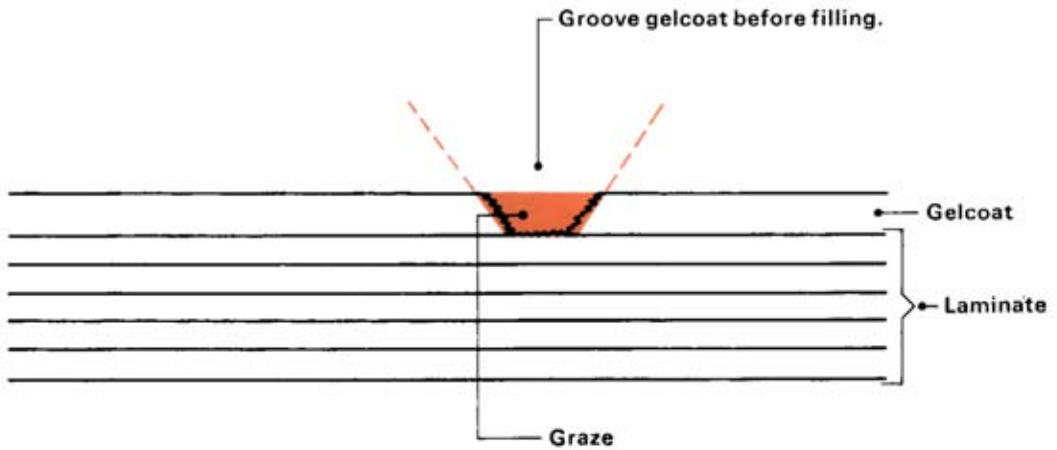
Repairing a graze

The repair procedure recommended for this type of damage is identical to that used for a hairline fracture. However, a graze is likely to be more extensive and, instead of a V-notch, a larger section of the surface will require cutting back to the main laminate. Note item 'e' above shrinkage of the repair is more likely to take place in the case of more extensive replacement of the gel-coat surface.

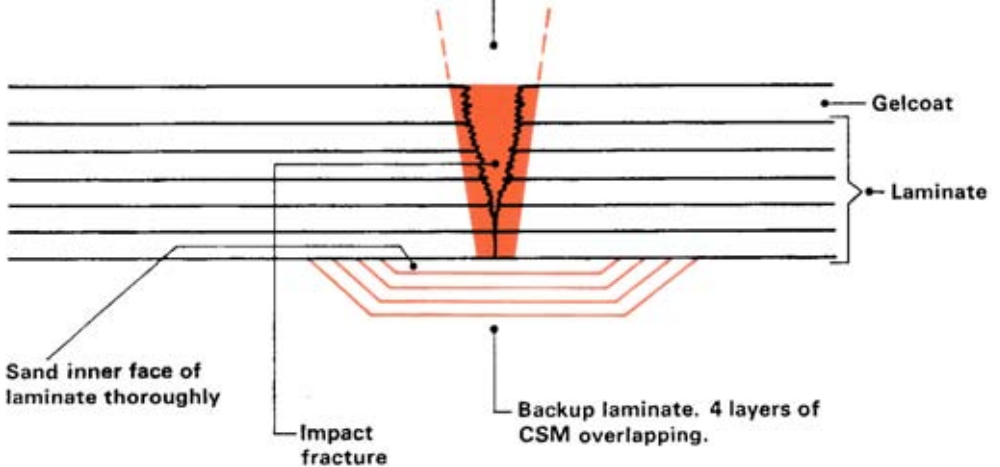
Repairing an impact fracture

Cut away all damaged laminate and fill with dough mixture or small pieces of pre-impregnated CSM to within $\frac{1}{10}$ in of surface.

- (a) Remove any external or internal obstruction in way of damaged area.
- (b) Enlarge the fracture into a V-shaped groove, taking care that all the damaged laminate is removed to the full depth of the fracture. To do this it may be necessary to continue the groove right through the laminate and form a slot in the internal face of the hull.
- (c) If a slot has been formed, sand the inside face of the old laminate thoroughly for at least 3 in all round the slot and brush off any loose powder.
- (d) Cut four strips of $1\frac{1}{2}$ oz/ft² CSM. The smallest should be 1 in larger all round than the slot. The other three should increase in size progressively by $\frac{1}{2}$ in all round.
- (e) Pour 1 lb of resin into a suitable container a 'potty' or a waxed paper carton and mix in the chemicals.

(f) Brush a liberal coat of activated resin over the whole of the sanded area, then lay the first and smallest strip of CSM in position covering the slot. Dip the brush into the activated resin and stipple the resin on to the CSM. Take care not to press the CSM into the slot concentrate on stippling the area of overlap on the old laminate. When the CSM is thoroughly impregnated it will have a clear, even, 'golden syrup' appearance. Roll carefully and gently to remove air stippled-in. Place the next larger piece of CSM in position on top of the first piece.

(i) The repair is then completed using 'c' to 'f' of the procedure for repairing a hairline fracture.

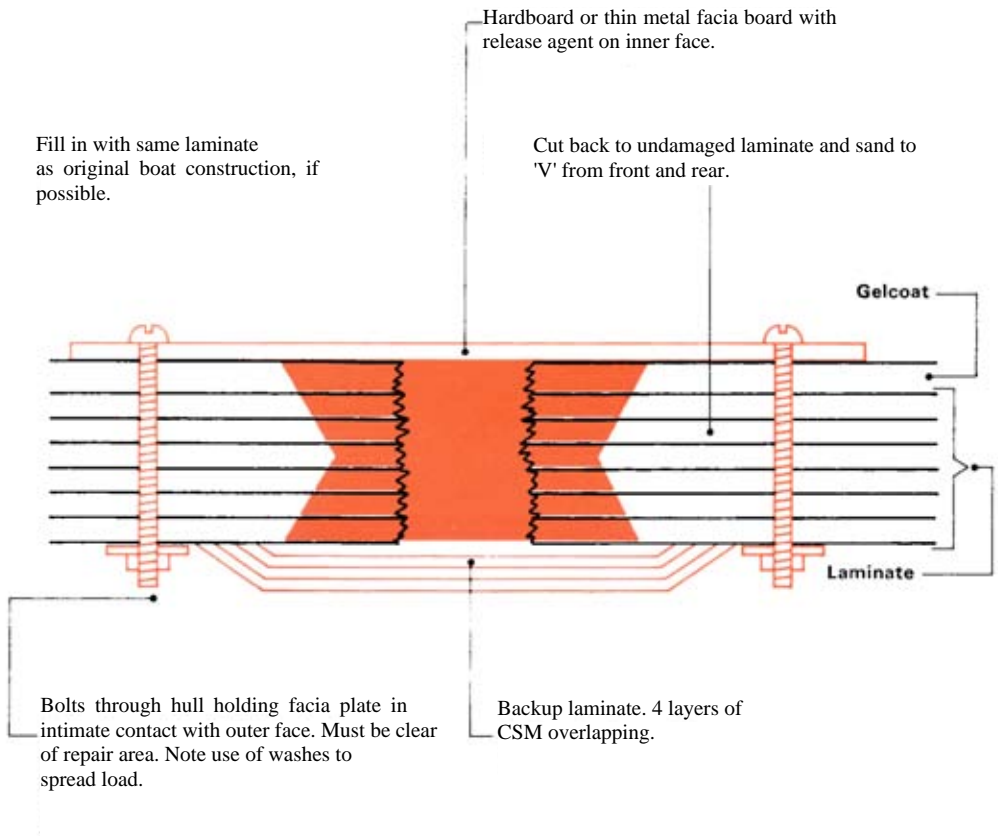
Repairing a puncture

(a) Remove any external or internal obstruction in way of damaged area.

(b) All jagged edges and damaged laminate around the puncture must be cut back to a clean even line using a hacksaw.

(e) The whole area should be brushed free of loose glass, powder, etc., before the next step is started.

(f) Firstly, cut a quantity of CSM and woven rovings of identical weights to the original laminate, tailored to the total area of the hole. Details of the original laminate will generally be given by the boat builder on request. The backing laminate for the hole can also be tailored to suit the sanded area and layers should increase in size as in the repair of an impact fracture.

(g) Next a facia board is prepared and fixed to the external surface. This must be larger all round than the hole that has been cut and sufficiently flexible to pull to the exterior contour of the hull. This is bolted through the hull. The bolts must be as close as possible to the hole yet remain clear of the backing laminate repair area. Use enough bolts to pull the facia board into intimate contact with the exterior of the hull and to hold the edges of the hole in true alignment.

On smaller repairs a piece of hardboard, smooth face inwards, will form a suitable facia board. A sheet of aluminium is equally effective.

(k) The backing laminate can now be applied. This will usually consist of 4 to 6 layers of 1¹/₂ oz CSM but, where extra strength is required, a layer of 10 or 16 oz/yd² WR may be substituted for one or two layers of CSM. The size of the patches should be staggered as for the repair to an impact fracture.

(m) Any low spots on the exterior surface should be filled with pigmented resin, then sanded down and polished as previously indicated. The holes left by the bolts should also be filled at this stage. It must be appreciated that when large punctures are repaired the external finish is unlikely to be as good as the original. However, matching polyurethane paint can be obtained for most of the polyester colour pastes and, with careful application, a reasonably good overall finish can be achieved.

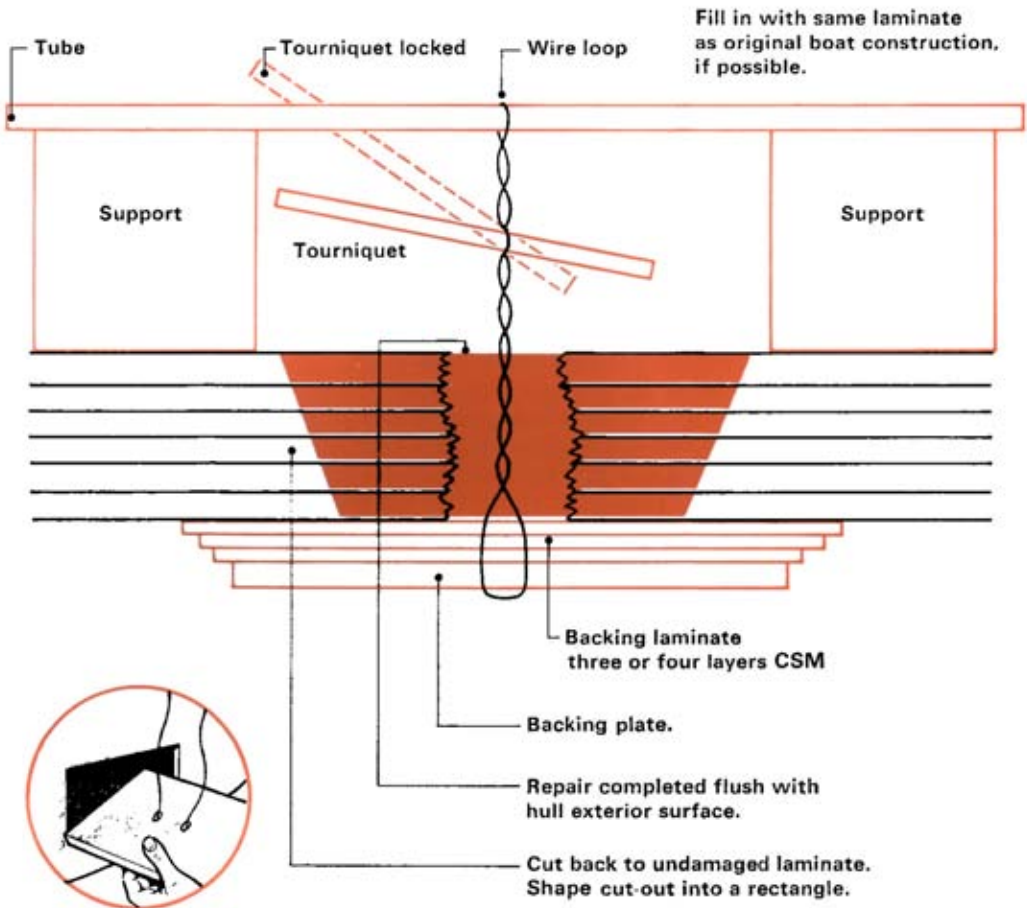
Repairing a blind panel

(a) In many boats it is impossible to reach the inner face of the hull in certain areas. When damage of the impact fracture or puncture type takes place in such a location a special repair technique has to be employed.

(b) The extent of the damage is first determined and a rectangular hole is then cut which removes any damaged laminate completely.

(f) The reverse facia plate and laminate are then passed through the cut-out and are pulled back into position so that the wet laminate is pressed hard into contact with the interior of the hull shell. Tension is applied to the wire to maintain this contact. An easy way to do this is to bridge the repair with a bar placed on stand-off blocks at each end. Fix the wire on a loop over this bar, then apply tension with a tourniquet.

(h) Build up the repair with further layers as used in the hull construction until it is just below the hull exterior. Finish with a generous coat of resin.

(i) The repair can be left to cure as it is, but a better finish will be achieved if a piece of Cellophane is squeegeed down over the repair and left in position. This will simply peel off after cure.

(j) Use wet-and-dry paper on a rubber block and plenty of water to blend the repair in to the hull contours.

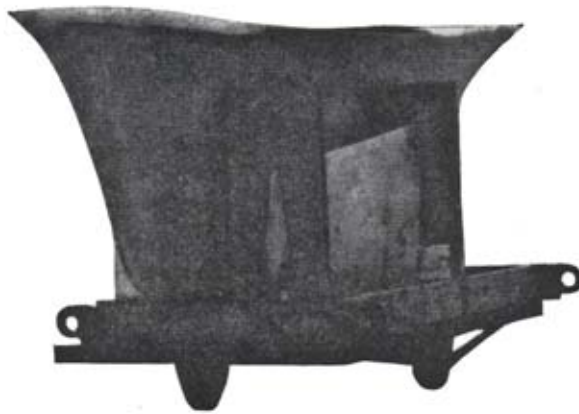
Inspection revealed that damage was mainly confined to the keel, but through continuous pounding on the reef this was indeed extensive. A large section has been worn and gouged away and, in consequence, most of the bonded-in ballast had been lost; of the original total of 2 tons 15 cwts under 1 ton remained. The owner suggests that it was this loss of ballast which made the boat light enough to float off the reef as the gale died down and it was probably the bonded-in petrol and water tanks which gave

sufficient buoyancy for this to happen. The rudder plate was also damaged beyond repair, but had remained in place and was used for steering the boat home.

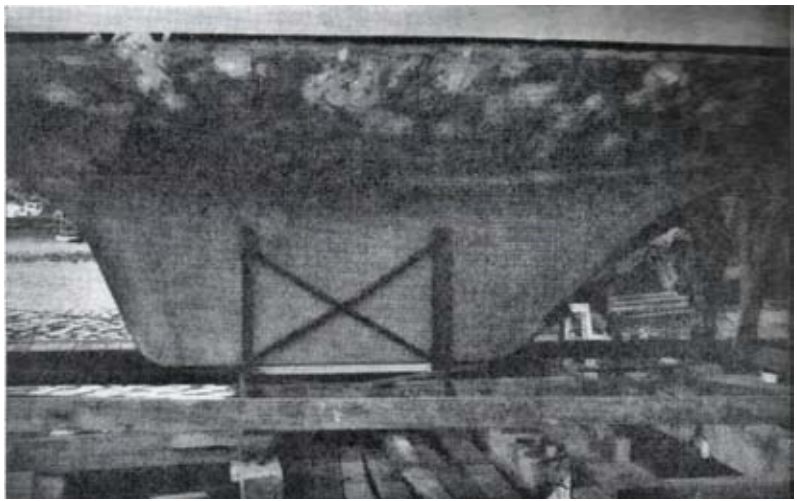
- i. The old keel section was measured carefully and cut off so that the hull of the boat would align with the newly moulded unit.
- ii. After removing the tanks tacked to it, the new keel section was offered up and aligned carefully with the cut-away hull. When a good joint had been achieved the section was clamped rigidly into position.
- iii. The new keel was bonded into the hull of 'Merlin' using a generous laminate of Fibreglass Reinforced Plastics.

- iv. The pre-fabricated tanks were next installed and tested, and these too were bonded into position with FRP.
- v. The exterior joint line between the old hull and the new keel was then filled and faired carefully into the contours of the boat.
- vi. Other minor damage to the hull was repaired and faired-in.
- vii. The final operation was repainting of the hull. The result 'Merlin' had an almost 'as new' appearance.
